FAILURE ANALYSIS & MATERIAL EVALUATION
OF TMP REFINER PLATES

A dissertation submitted to the faculty of the
Oregon Graduate Institute of Science & Technology
in partial fulfillment of the requirements for the degree of
Doctor of Philosophy
in
Materials Science & Engineering

July 1996

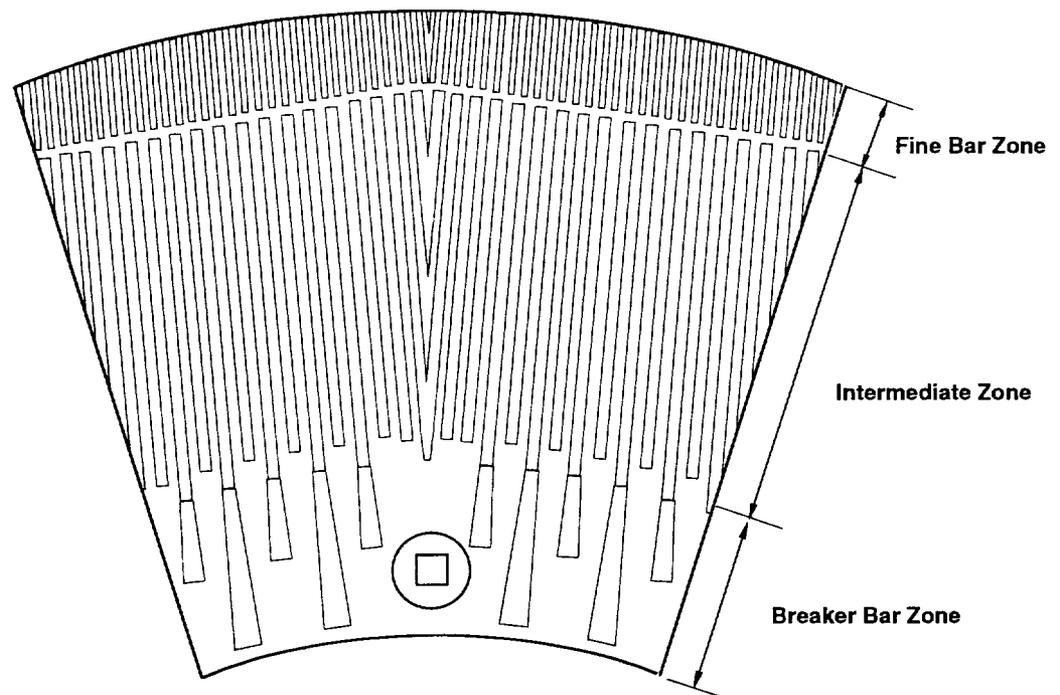
Figure 2.7. A typical TMP refiner plate.

Plates are key to successful operation of TMP refiners and there are three main criteria for selection of plates: good pulp quality, low energy input, and low plate cost per ton of production [8]. These criteria depend heavily on many plate design characteristics including the patterns of bars, grooves, and dams, as well as plate taper. The primary purpose of plate design is to overcome the centrifugal forces and keep the pulp between the plates so that the required energy can be applied [10]. Although numerous plate patterns are used, the plate design is still a trial and error process and no one plate pattern is suitable to all wood species [11-12]. Figure 2.7 shows a typical

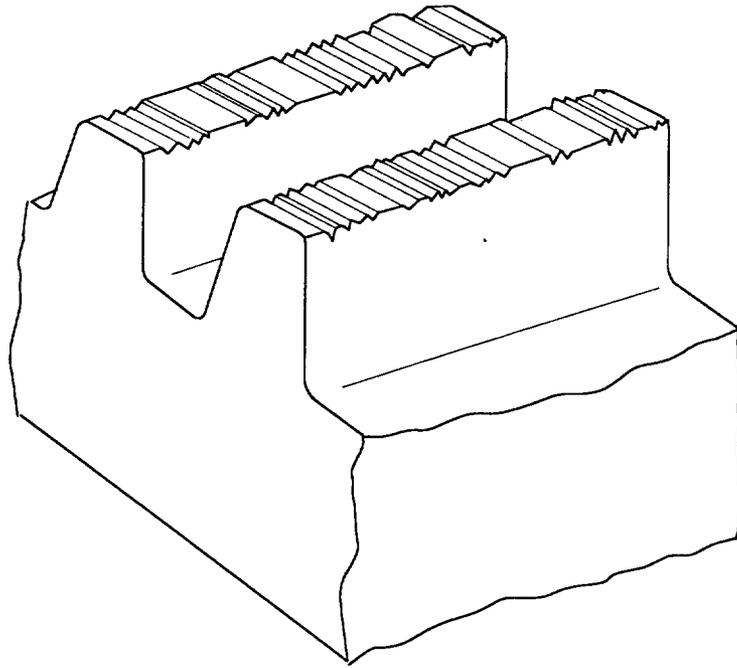
Figure 2.12. Serration damage.

Serration. Serration is characterized by deep circumferential grooving on bar top surface, usually towards the plate periphery. Serration damage initiates from somewhere in the refining zone but never extends to the breaker bar zone, being widely attributed to plate clashing during refining. If the plate-to-plate contact is severe, it may induce heat cracking and eventually break up entire segments, with possible major damage of the refiner [10]. Loss of bar height can attain a depth of several millimeters, as indicated by the lip of material left protruding above the serrated plate surface. After serration damage, the ridges formed on one set of plates exactly matches grooves in the mating plates and vice versa. Although many ridges and grooves can be seen visually (Figure 2.12), microscopically the serrated bar surface can be very smooth. The surface is usually heavily deformed in the direction of disk rotation. Grains are smeared in layers across the serrated bar tops. Localized melting and micro-cracking on the bar surface can also be observed. There are often material build-up and material flow which are particularly noticeable at the bar trailing edges. Serration should not be a common occurrence in TMP refining, but it is experienced in most mills and is most severe during start-up of an installation. It occurs more frequently in the secondary refiners than in the primary ones [2].

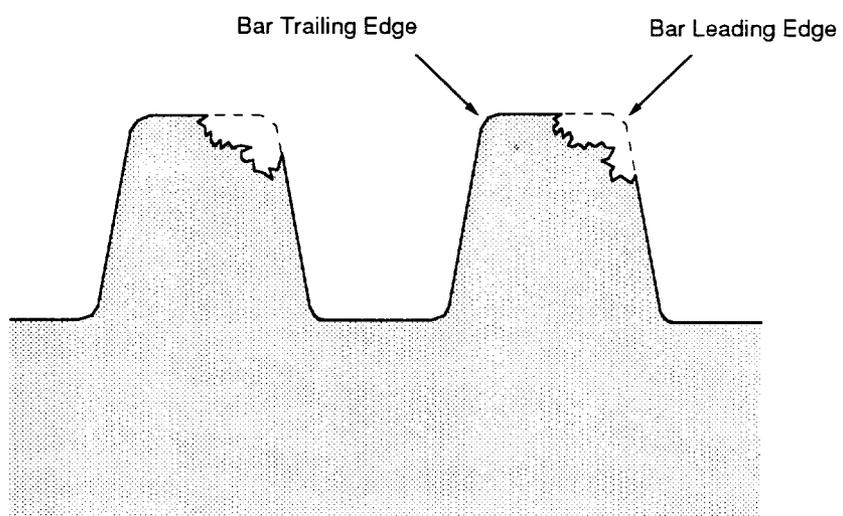
Figure 2.13. Pitting damage.

Pitting. Used refiner plates often show extensive pitting damage around the breaker bars or along the bar leading edges of the refining zone (Figure 2.13). The pitting is deep with the individual pits being inter-connected, exhibiting a honey-combed appearance [21]. It must be noted that here the term "pitting" shall not be confused with pitting corrosion. Pitting corrosion is a unique type of anodic reaction and an autocatalytic process, being a failure mechanism causing deep penetration at a number of individual spots, while pitting damage in TMP refiner plates refers to a failure mode at the bar leading edges or on the bar tops, being induced probably by a single or a

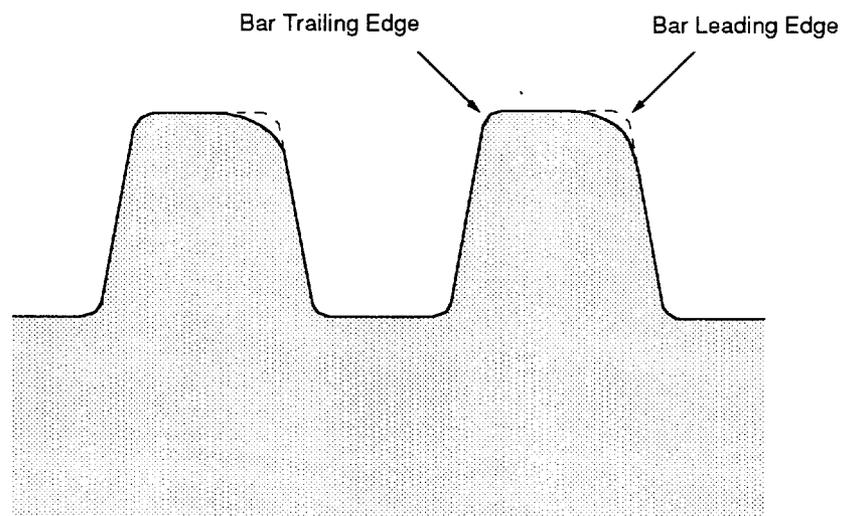
Figure 2.14. Bar rounding damage.

Bar Rounding. Similar to the pitting damage discussed above, bar rounding damage also occurs mainly at the plate bar leading edges. It is characterized by the sharpness loss of the bar leading edges, as schematically shown in Figure 2.14. Although bar rounding and pitting may overlap each other along the bar leading edges, they usually occur early and late in the plate life respectively. In other words, bar rounding is dominant in early bar leading edge damage while the pitting governs the later stage edge deterioration. As the bar rounded width may vary remarkably along the deteriorated leading edges, bar rounding damage can be better measured by maximum bar rounded width. Visual inspection can only display a basically rounded bar edge surface. On a microscale, however, the hard phases like eutectic carbides in the bar rounded areas can protrude above the matrix, while the matrix is usually covered by a number of short scratches and grooves with various orientations. These carbides are often edge rounded but seldom fractured. In addition, severe surface deformation, cracking, and spalling are basically absent.

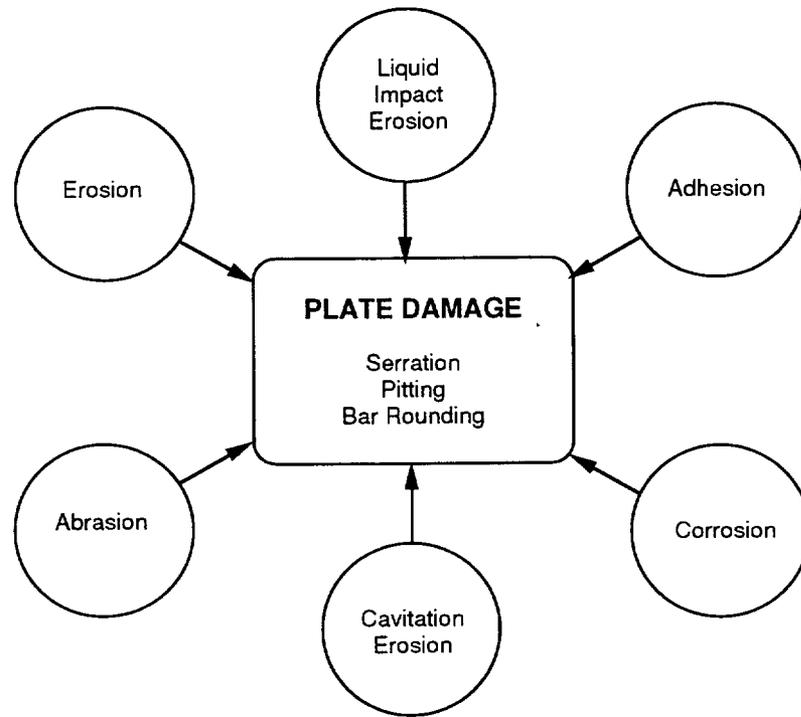
Figure 2.15. Plate deterioration modes and mechanisms.

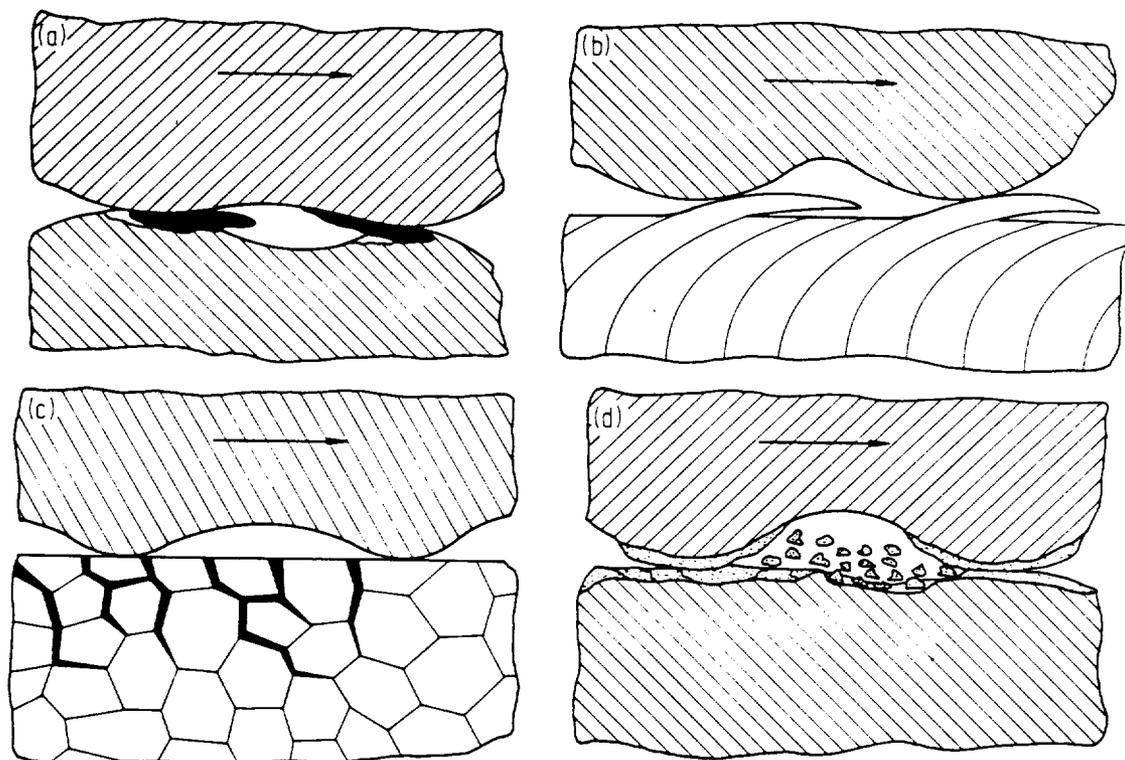
Figure 2.20. Mechanisms of wear during sliding contact [47].

- (a) Adhesive junctions, material transfer and grooving.
- (b) Surface fatigue due to repeated plastic deformation on ductile solids.
- (c) Surface fatigue results in cracking on brittle solids.
- (d) Tribochemical reaction and cracking of reaction films.

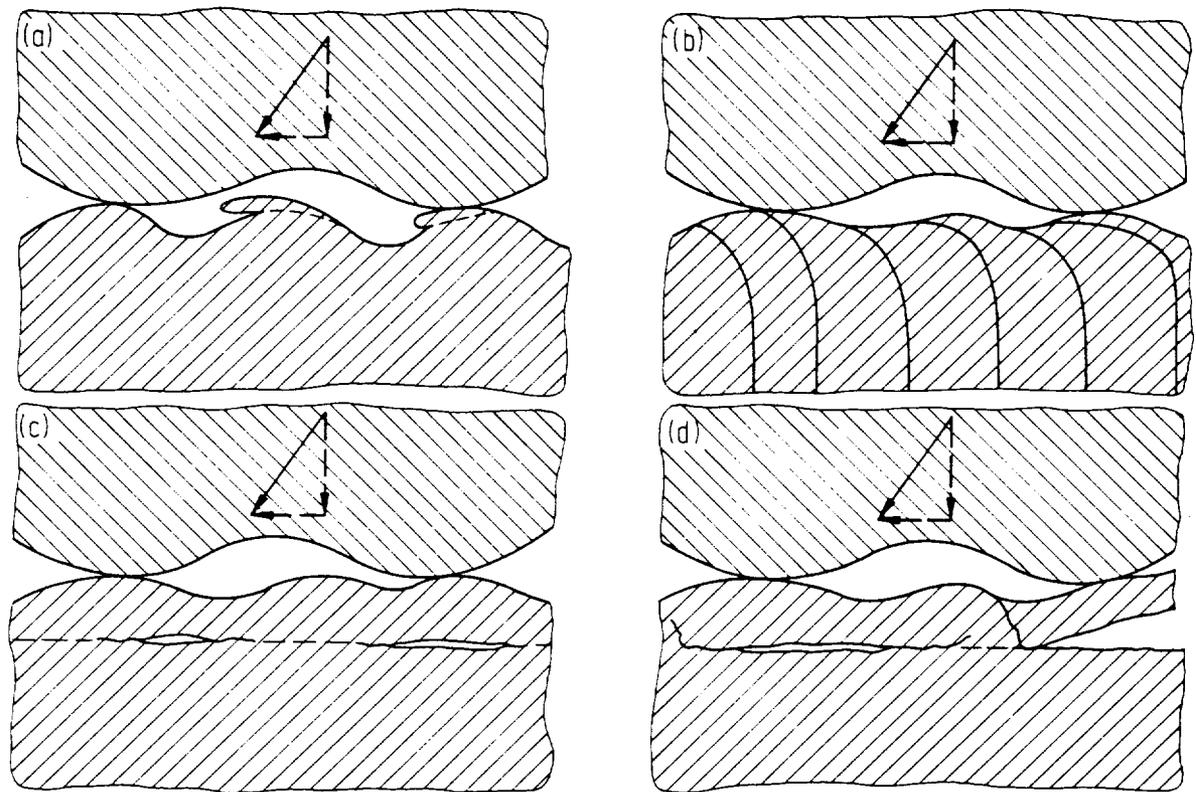
Figure 2.21. Formation of wear sheets due to delamination [47].

- (a) Smoothing of the softer surface.
- (b) Strain accumulation below the surface.
- (c) Initiation of subsurface cracks.
- (d) Formation of sheet-like wear particles.

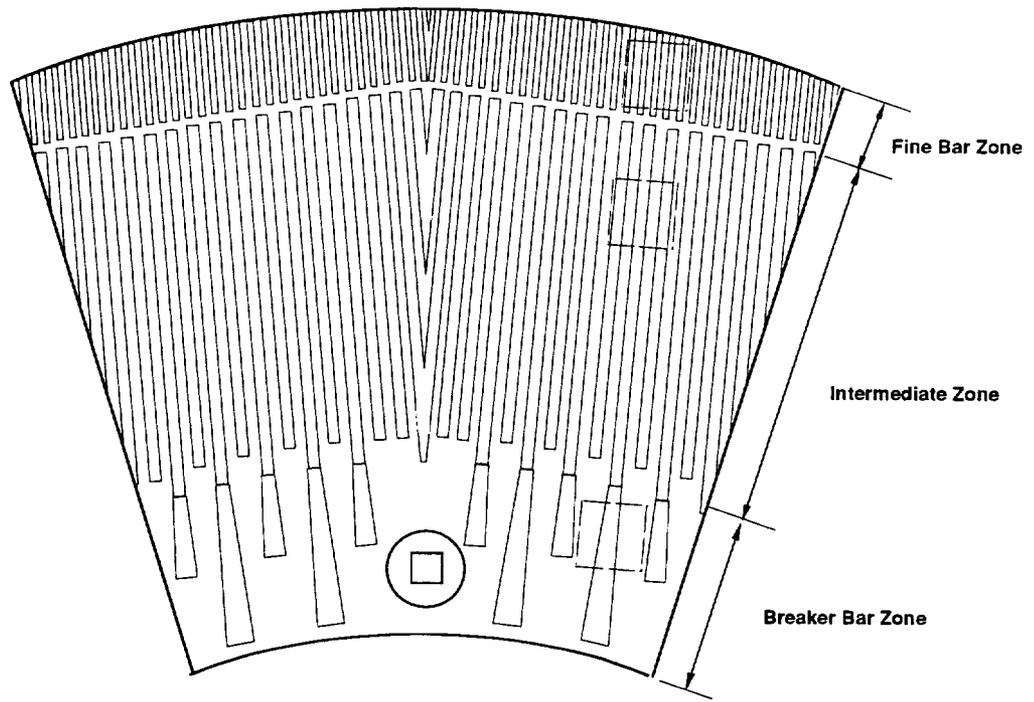
Figure 3.1. Sectioning of specimens from damaged plate.

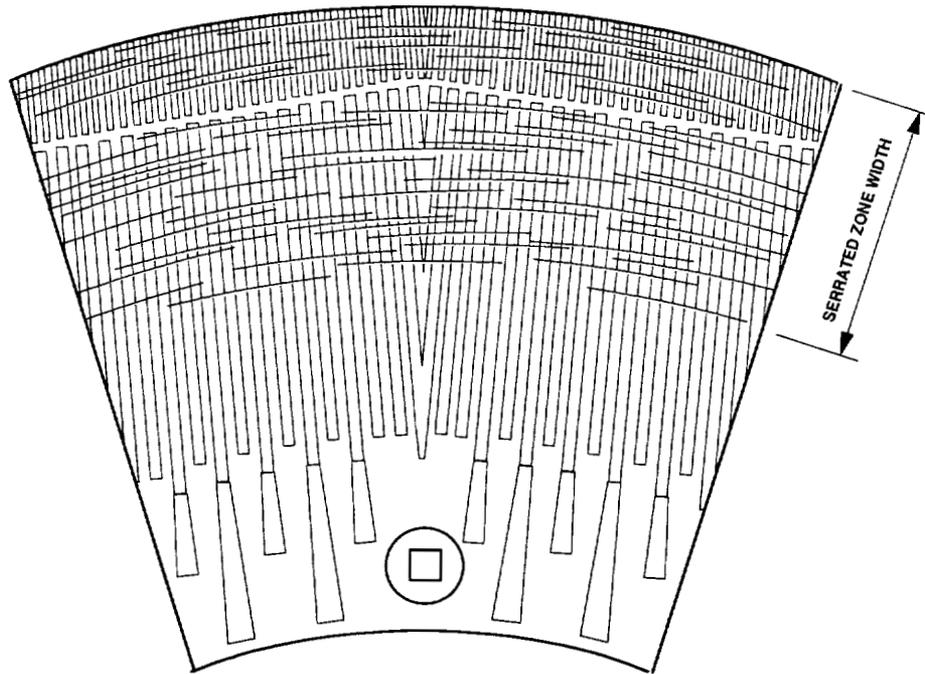
Figure 3.5. Serrated zone width.

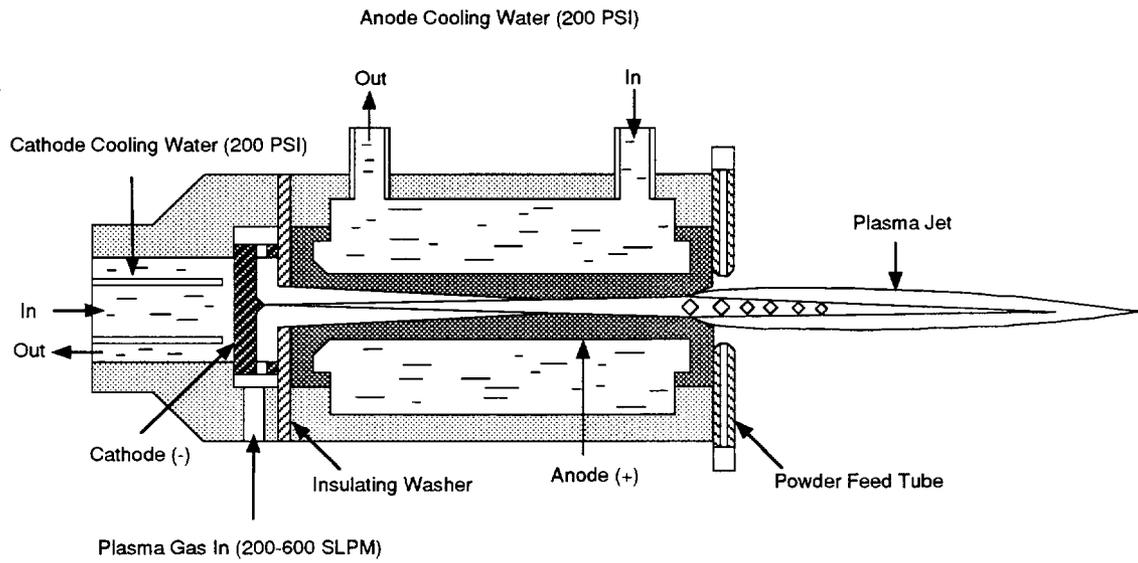
Figure 3.9. Schematic of the spray gun.

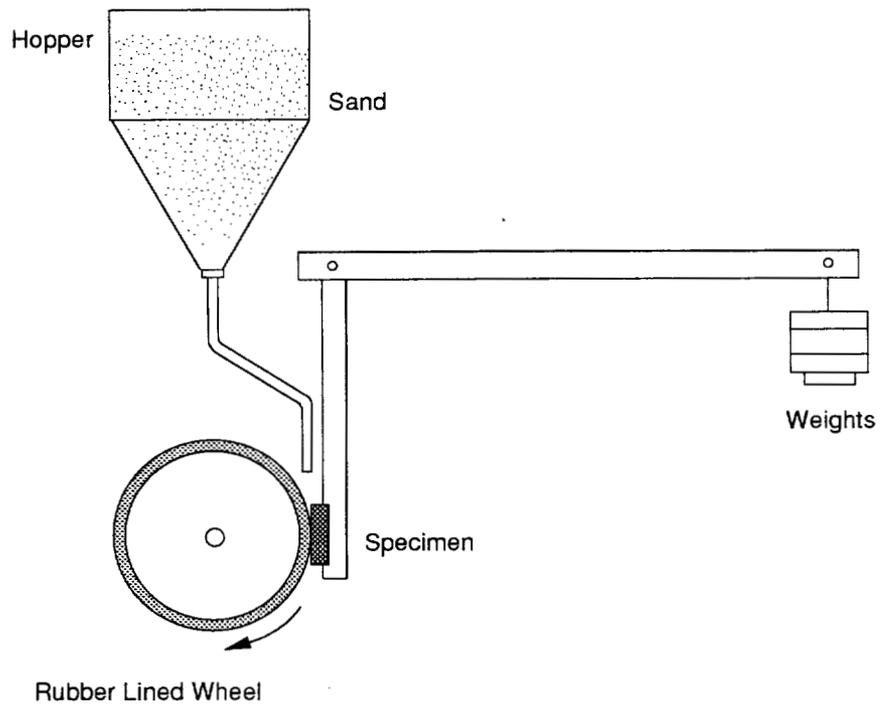
Figure 3.12. Schematic of abrasion test.

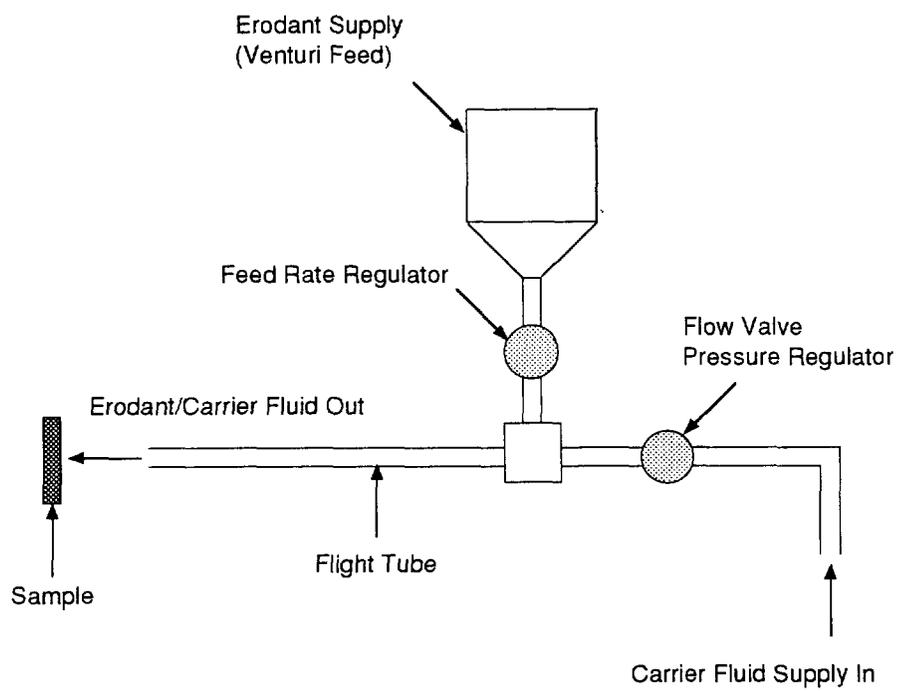
Figure 3.13. Schematic of erosion test.

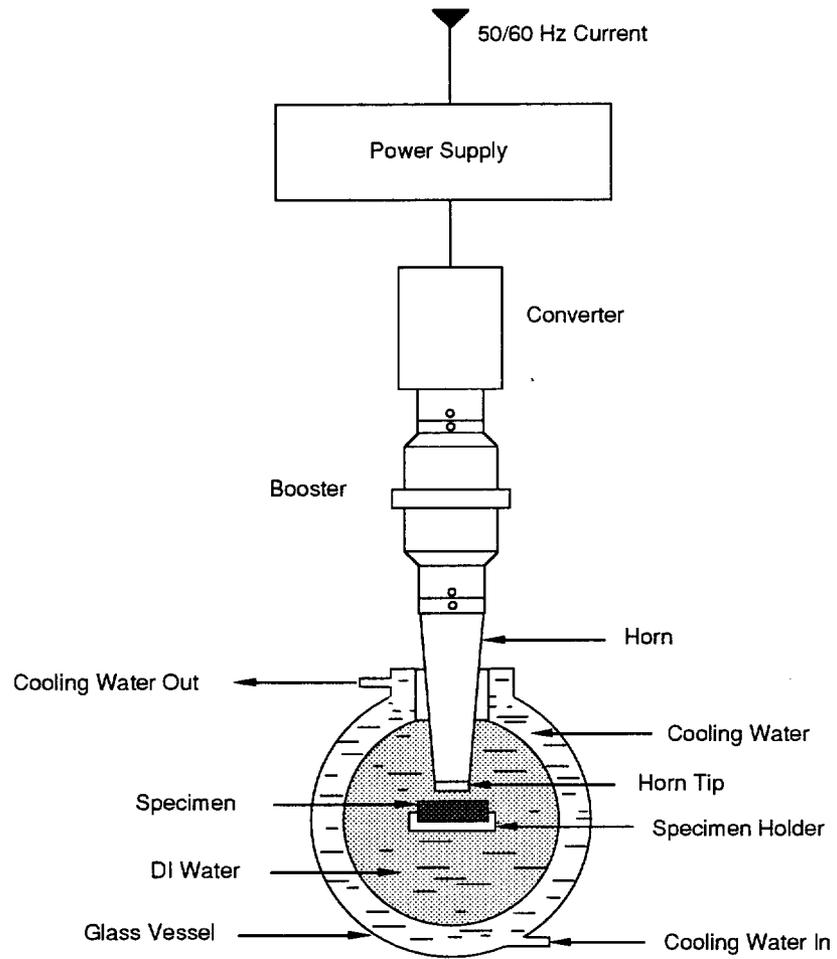
Figure 3.14. Schematic of cavitation erosion test.

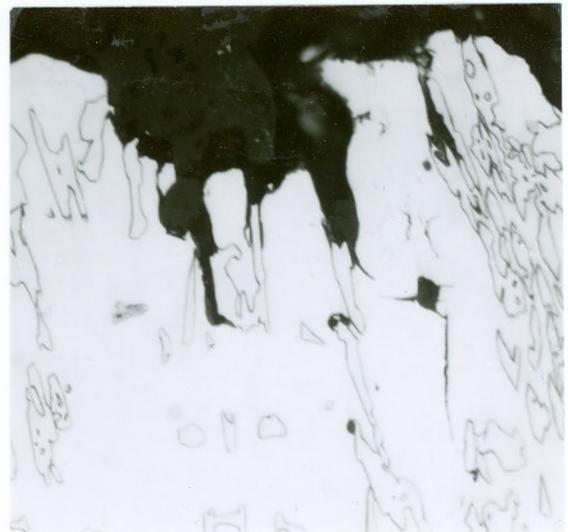
Figure 4.11. Pitting damage process in the bar leading edges of the C20 plates.

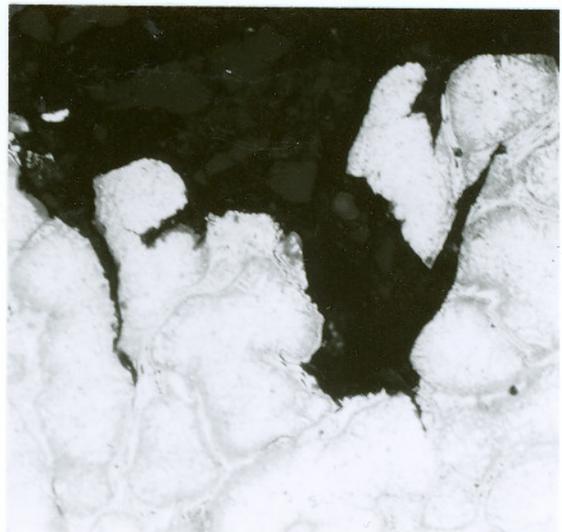
Figure 4.12. Pitting damage process in the bar leading edges of the S17 plates.

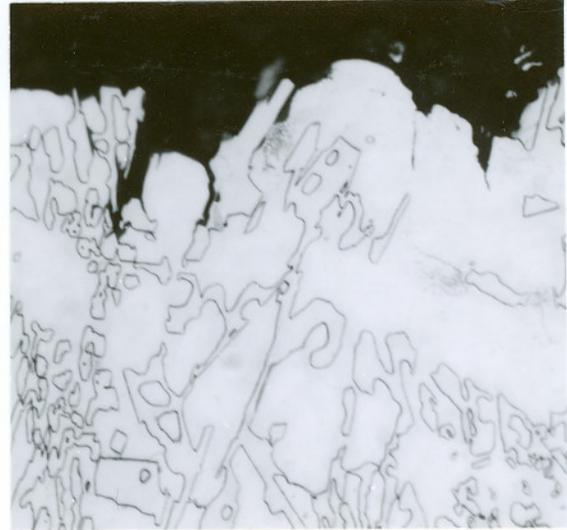
Figure 4.16. Fatiguelike cracks on the pitted C20 plate bar leading edges.

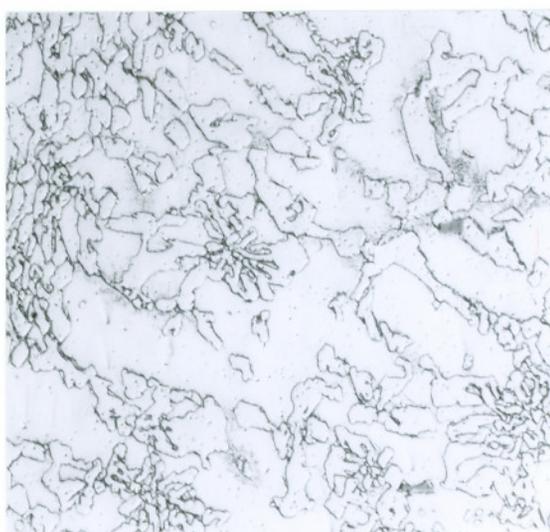
Figure 4.19. Microstructures of plate alloys: (a-b) Ni-hard white irons (eutectic M_3C carbides plus martensite); and (c-d) 20-2-1 high chromium white irons (eutectic M_7C_3 carbides plus austenite).

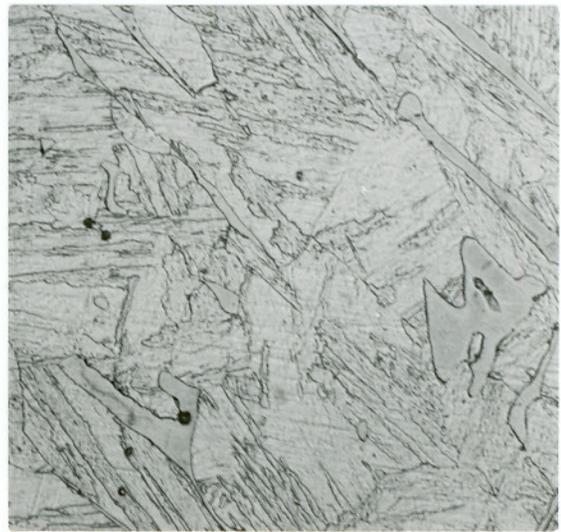
Figure 4.20. Microstructures of plate alloys: (a) 440C stainless steel (eutectic carbides plus martensite); (b) 440C stainless steel (eutectic carbides plus austenite); (c) 25Cr iron (eutectic M_7C_3 carbides plus austenite); and (d) 17-4 PH stainless steel (ferrite pools in martensite matrix).

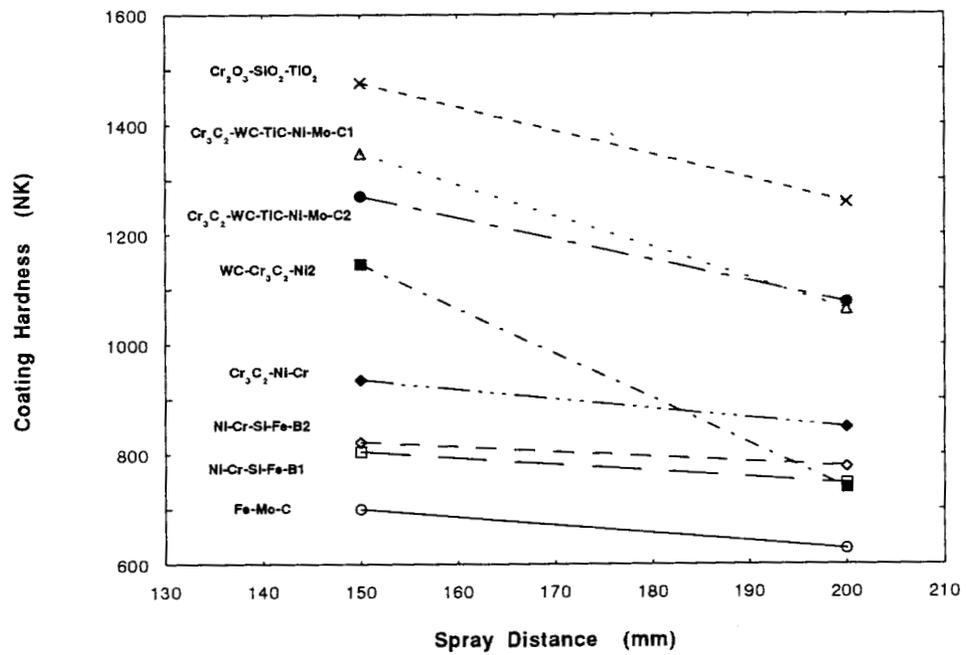
Figure 4.32. Coating hardness versus spray distance.

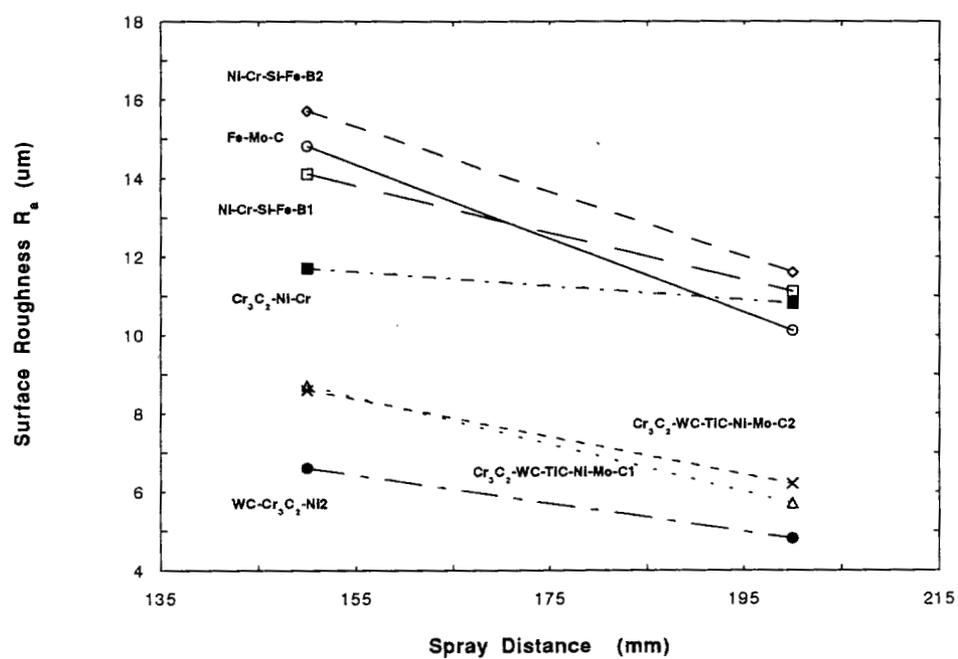
Figure 4.33. Coating surface roughness versus spray distance.

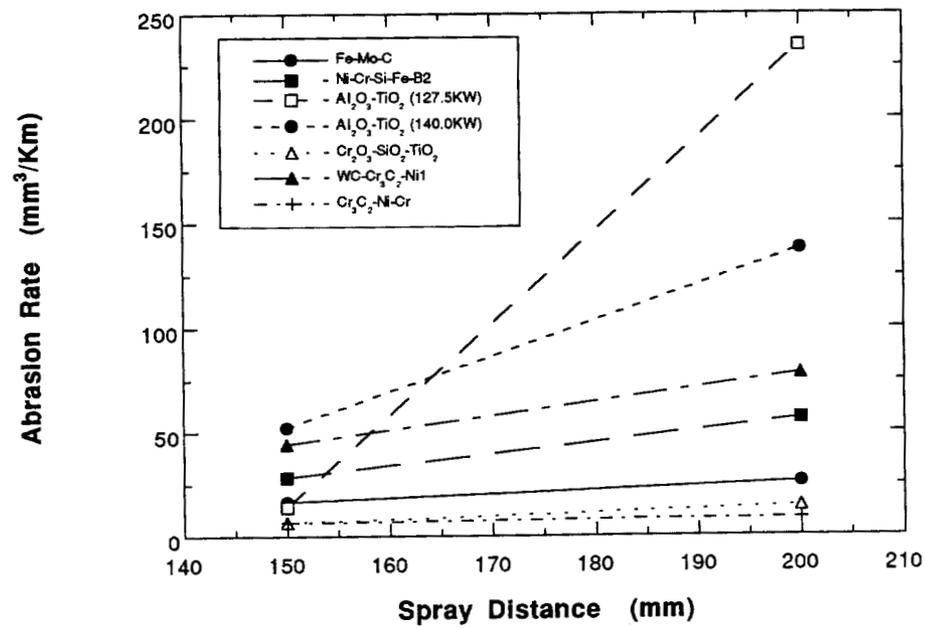
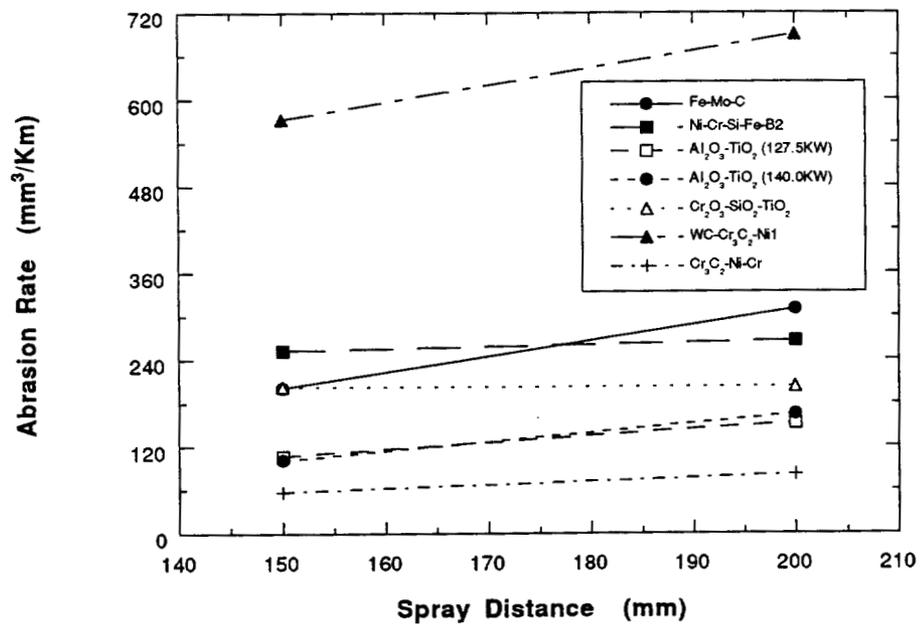
(b) Al₂O₃.Figure 4.37. Abrasion rate versus spray distance (a) SiO₂ and (b) Al₂O₃.

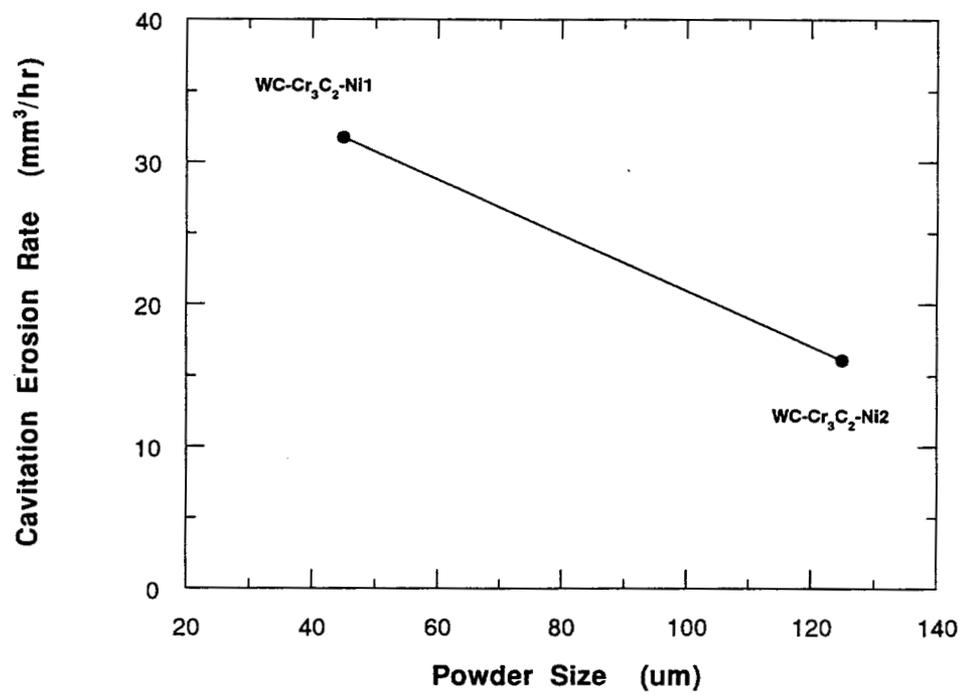
Figure 4.38. Cavitation erosion rate versus powder size.

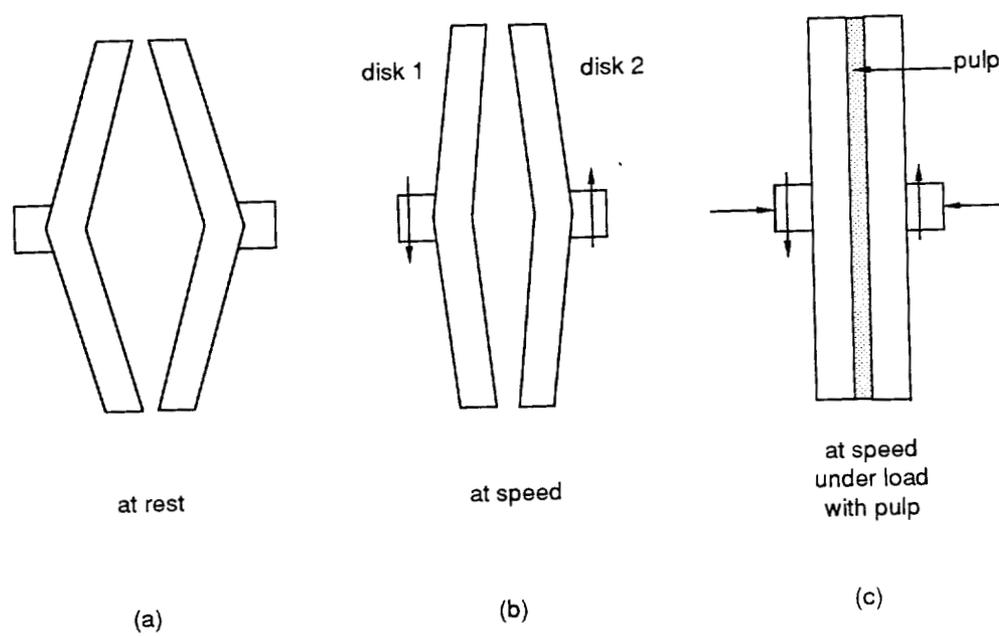
Figure 5.1. Schematic of a disk refiner set-up.

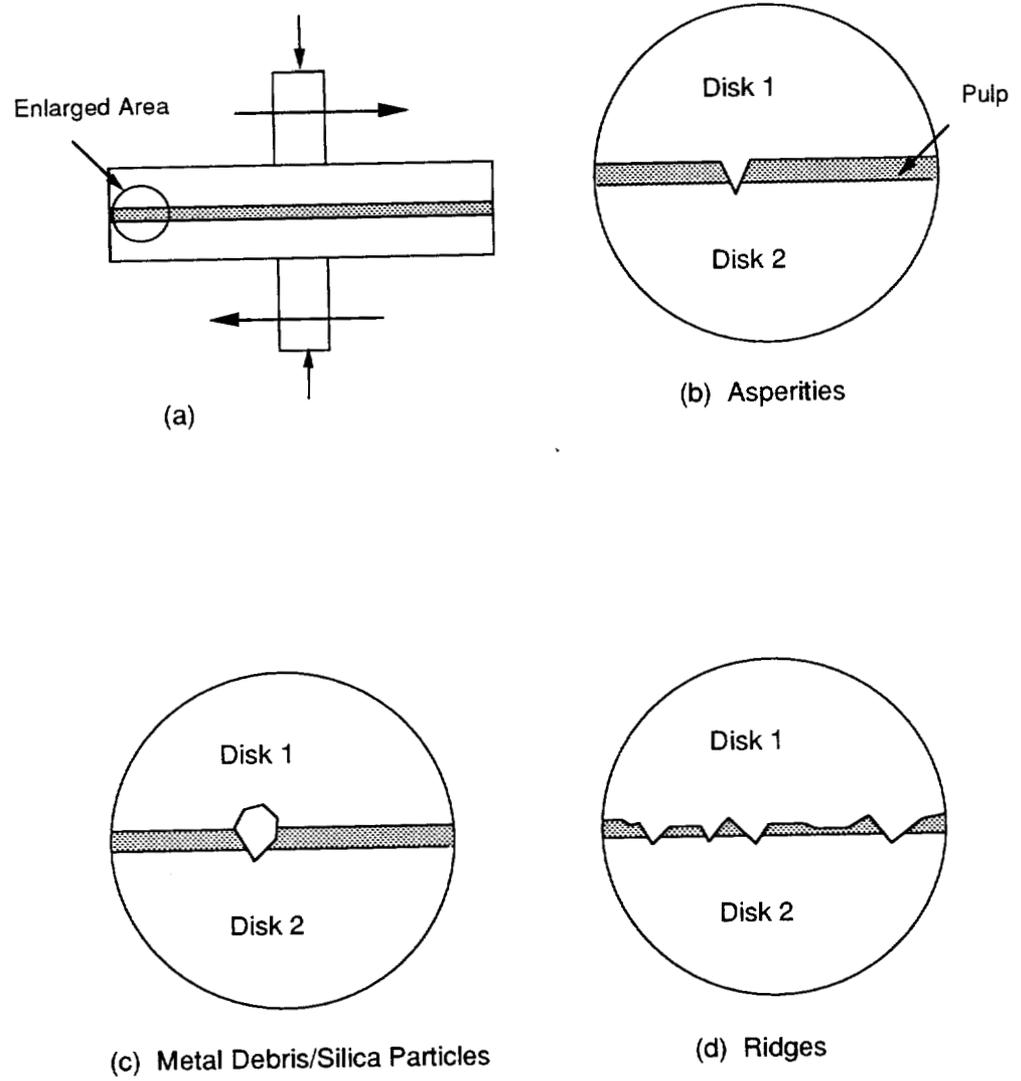
Figure 5.2. Formation of circumferential grooving.

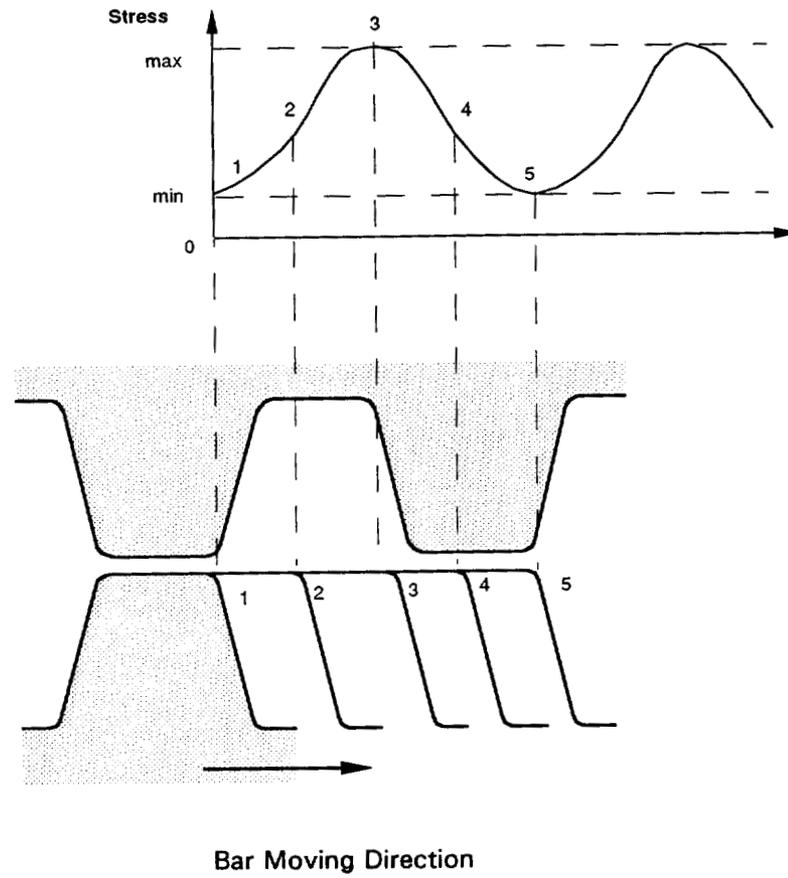
Figure 5.6. Local pressure pulse near a bar leading edge.

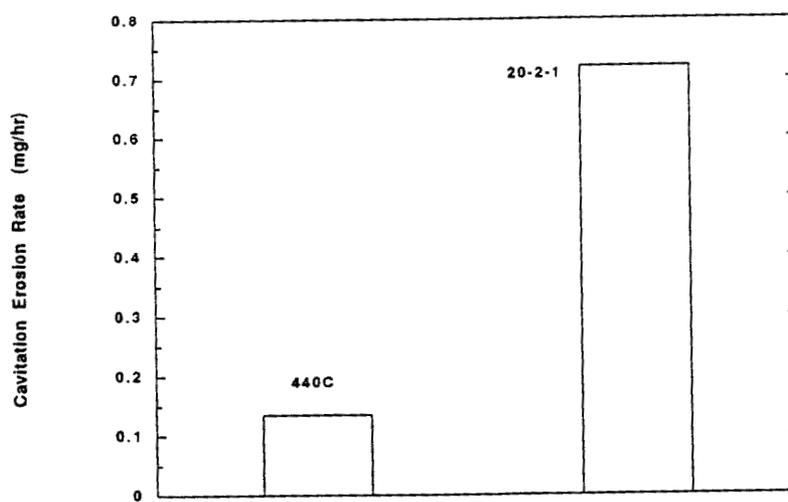
Figure 5.7. Performance ranking in pitting damage rate (a) and cavitation erosion rate (b) for 440C and 20-2-1 alloys.

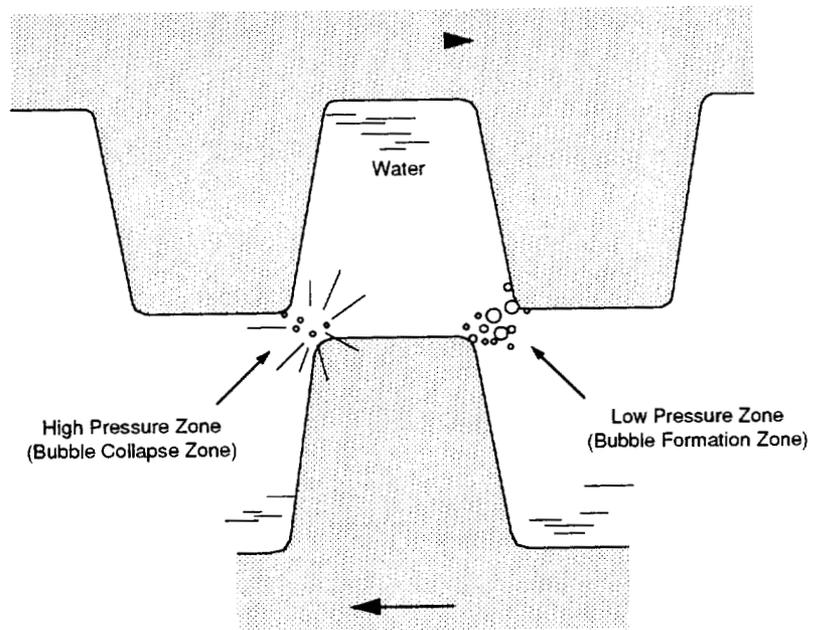
Figure 5.8. Cavitation erosion in the breaker bar zone.

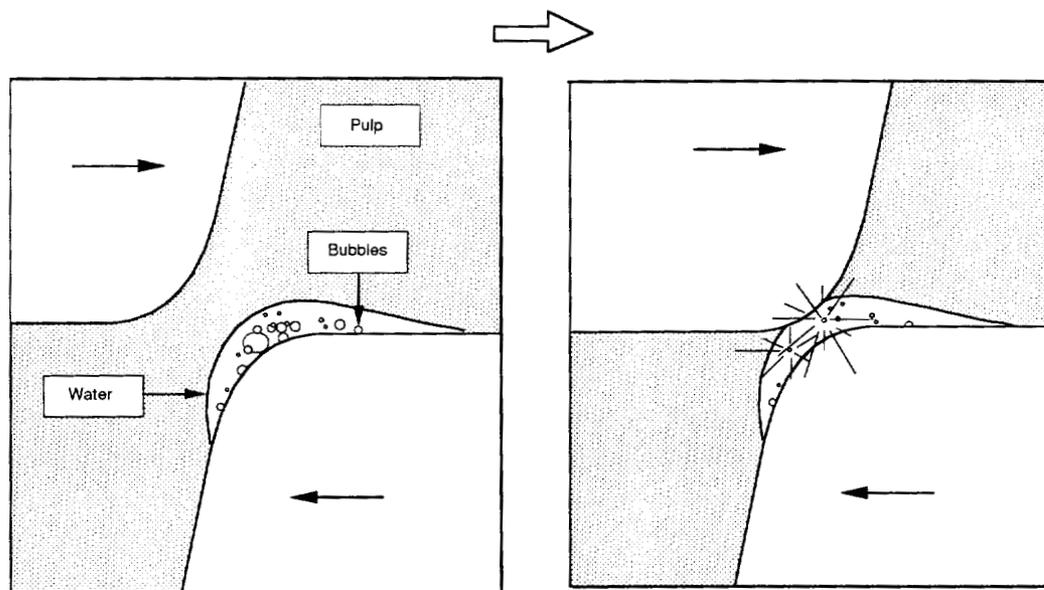
Figure 5.9. Cavitation erosion in the refining zone.

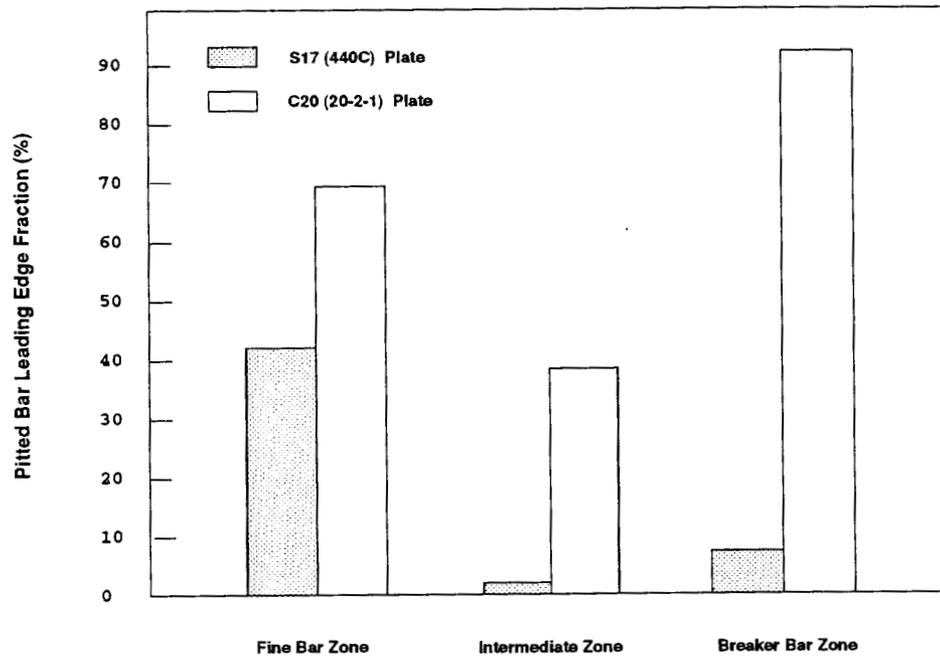
Figure 5.11. Pitting performance ranking for 440C and 20-2-1 plates worked with whitewood.

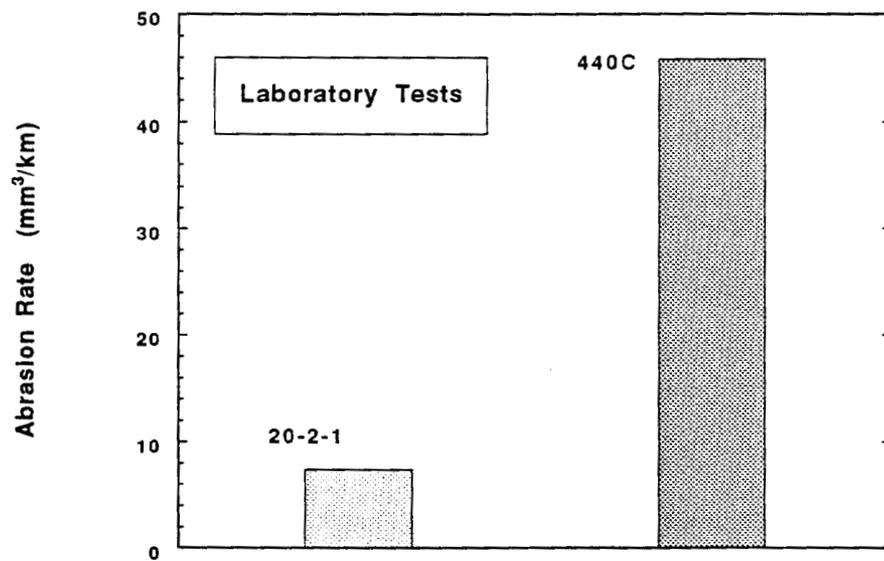
Figure 5.12. Comparison of bar rounding damage resistance (a) and abrasion resistance (b).

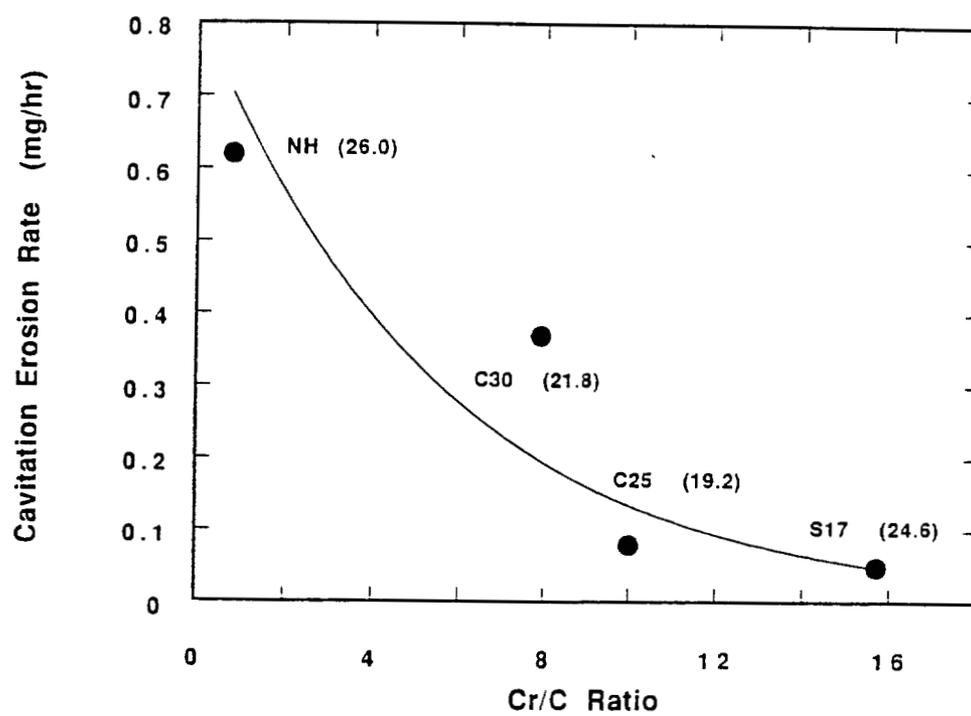
Figure 5.14. Cavitation damage versus Cr/C ratio for some carbide-containing alloys.

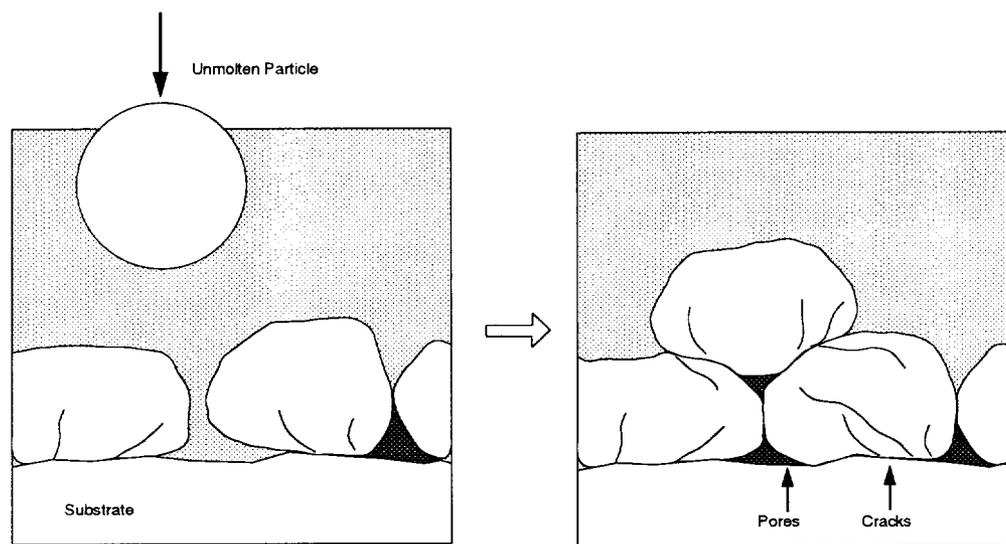
Figure 5.18. Spray energy and coating microstructure.
