**BRITTLE FRACTURE MECHANISMS OF GLASS-FIBER
REINFORCED POLYMER INSULATORS**

A dissertation submitted to the faculty of the
Oregon Graduate Institute of Science & Technology
in partial fulfillment of the requirements
for the degree Doctor of Philosophy
in
Materials Science and Engineering

October, 1995

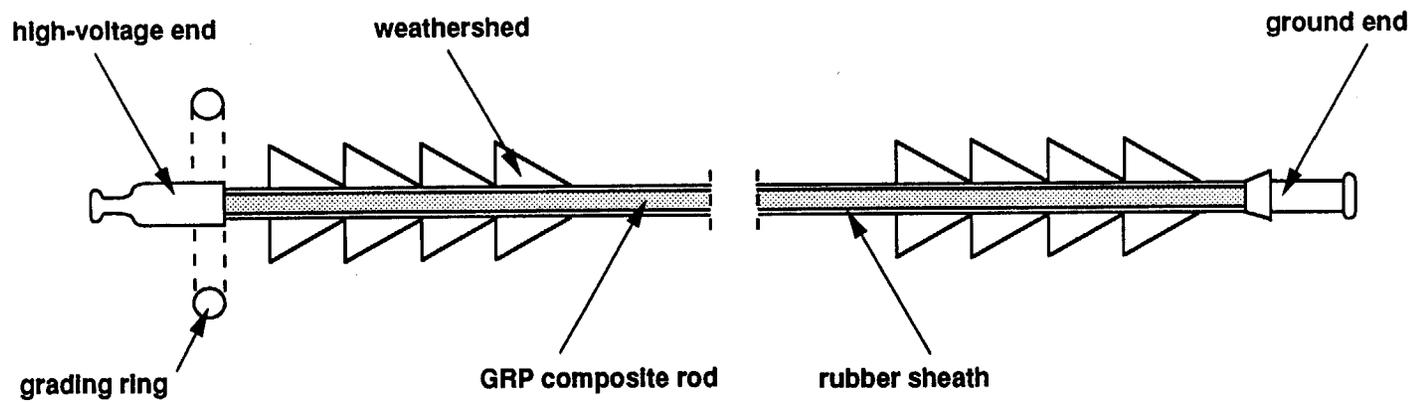
Since the design methodologies of GRP suspension insulators have not been standardized, a wide range of constructions can be found in practice. Further information regarding currently available designs can be found elsewhere.^{2,6-10}

Figure 1.2 Schematic construction of the insulator.

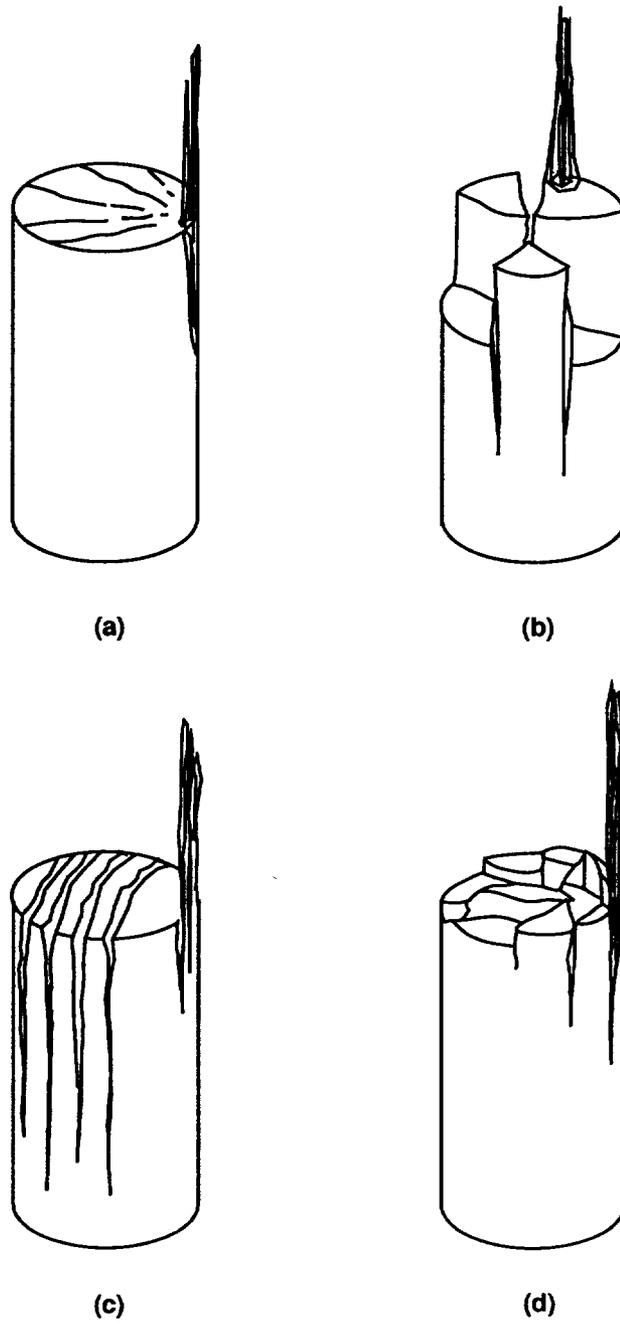
However, the occurrence of brittle fracture in service appears unpredictable. Based on field experience, brittle fractures of GRP insulators could occur within one month or 15 years later after installation. This behavior suggests that the insulator brittle fracture is likely controlled by a progressive deterioration mechanism in which other influences besides mechanical loads must be involved.

Figure 1.5 Fracture morphology of insulators.

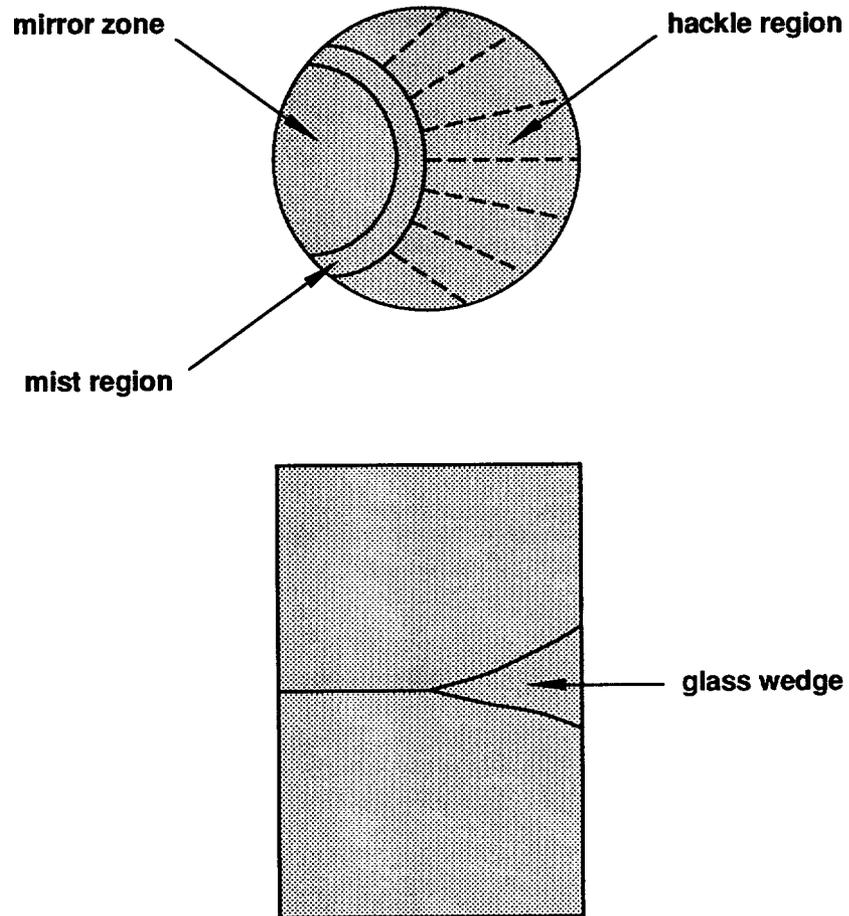
Fractography of individual fibers and local matrix not only reveals their fracture characteristics but also provides the information of the overall crack initiation and propagation. As a rule of thumb, the crack initiation site is always located in the region of fibers with relatively large mirror sizes, and the crack propagation direction can also be deduced from fiber and matrix surface markings.⁵⁰ In some cases, wide variations exist in the direction of local crack growth; some of these variations coincide with

Figure 1.6 Single fiber fracture.

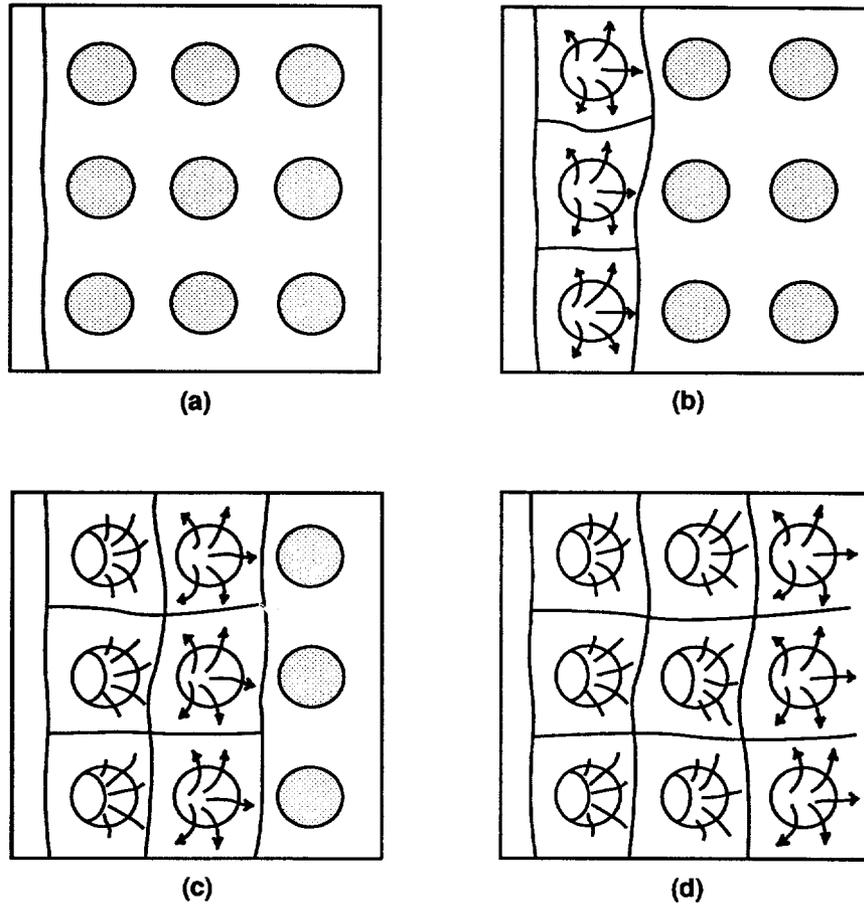
Figure 1.7 Matrix fracture markings.

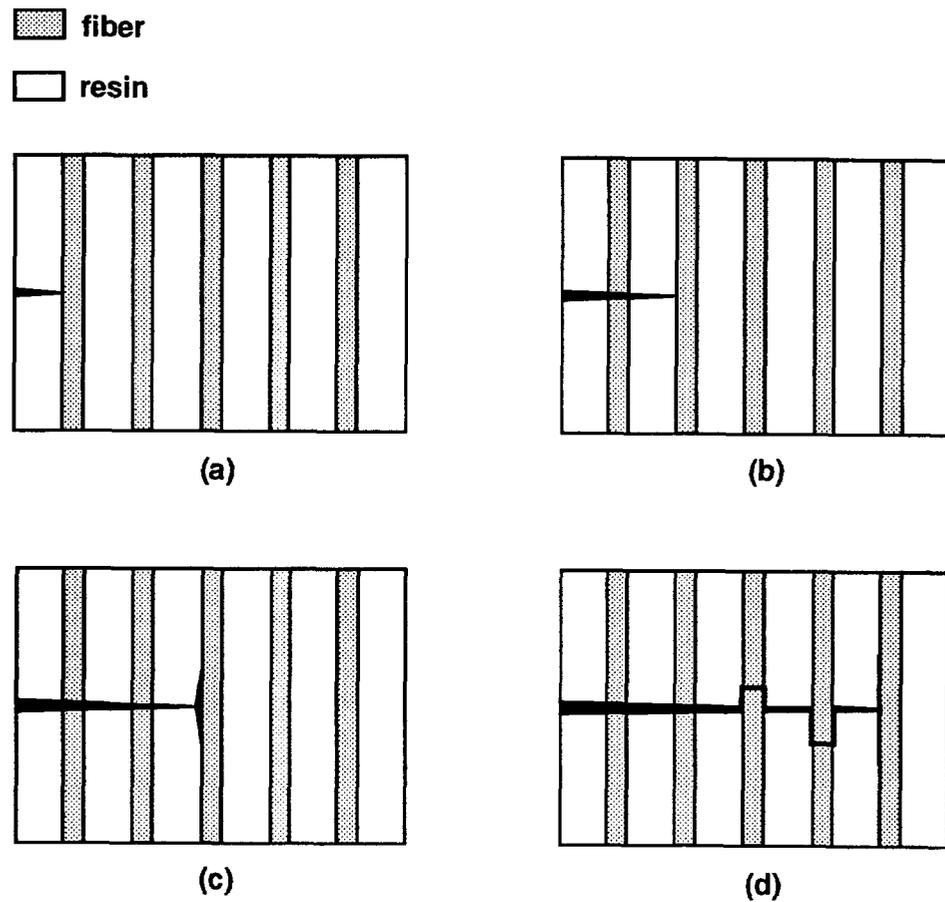
Figure 1.8 Schematic representation of crack growth in unidirectional composites in acids: (a) initial fiber and matrix fracture, (b) fracture of adjacent fibers owing to acid attack at the crack front followed by matrix fracture, (c) limited interface debonding caused by the stress at the crack front, and (d) crack growth involving increasing amount of out-of-plane fracture.

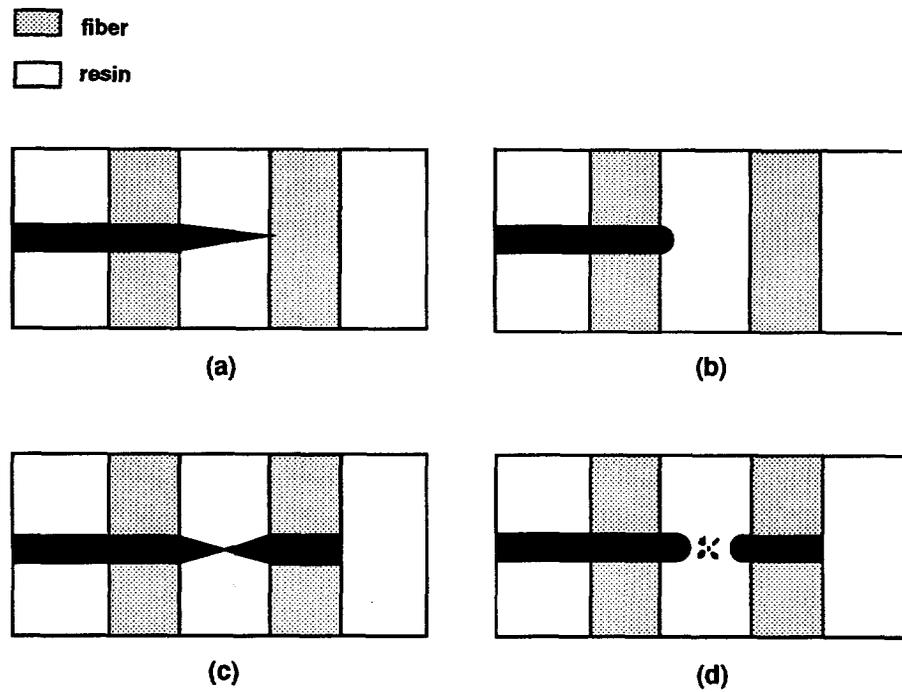
Further understanding of the matrix influence on crack propagation behavior has led to the development of the diffusion-controlled crack propagation mechanism (Figure 1.9), an improved model proposed by Hogg and Hull⁶⁸ based on their study of stress corrosion crack growth in pipes with different resin matrices. This model suggests that the fracture toughness of resin matrix is a critical parameter in determining crack propagation behavior. If the matrix is brittle, fiber fracture may simultaneously result in resin fracture, the stress corrosion crack progressing directly to the next fiber. If the matrix is tough, however, fiber fracture may not cause complete fracture of the surrounding resin web, separating the crack front from the next fiber. In this event, further acid diffusion through the unbroken resin is required to fracture the next fiber, and the crack propagation will become diffusion limited. Moreover, once the second fiber eventually fails, the resin web may or may not remain intact. Under certain circumstances,

Figure 1.9 Influence of resin toughness on crack propagation behavior: possible sequence of events at the crack front for (a) brittle resin, (b) tough resin, (c) tough resin after the second fiber break leading to resin-bridge fracture, and (d) very tough resin after the second fiber break without resin-bridge fracture.

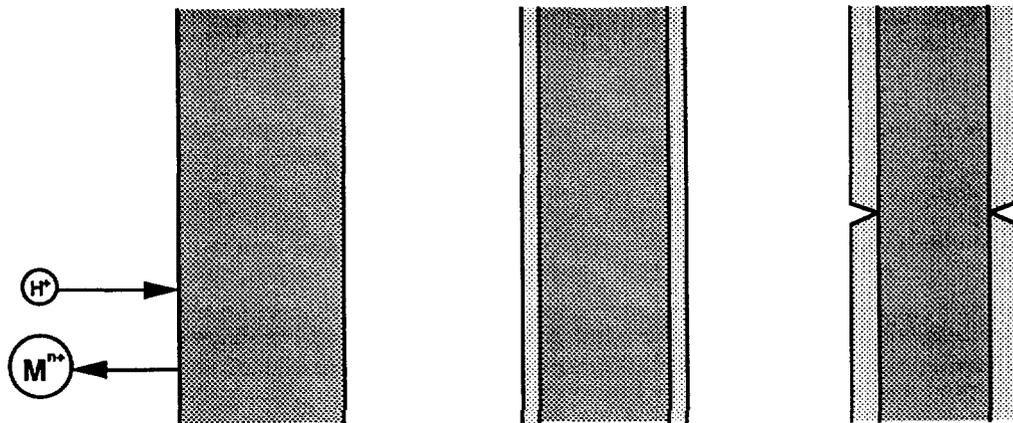
Because of its low silica content, E-glass fiber contains insufficient SiO groups to screen the soluble constituents from the acid, leading to high leachability. Originally, the acid leaching of E-glass fibers was attributed to the ion exchange between alkali ions in the glass and hydrogen ions from the acid, as first proposed by Metcalfe *et al* based on their study of stress corrosion in E glass filaments.⁹² They also suggested that if glass fiber contains less than 5% of alkali ions by weight, surface corrosion cracking can be inhibited. Recently, however, further studies^{52,118-120} have confirmed that the leaching of calcium and aluminum ions, rather than alkali metal ions, is responsible for the acidic corrosion of E-glass fiber. Work by Aveston and Sillwood⁹¹ showed that zirconia glass, which contained almost no calcium and aluminum oxides but 11% of alkali oxides by weight, appeared immune to concentrated sulfuric acid solutions. In fact, all other non-siliceous constituents, in addition to calcium and aluminum, possess a certain leachability in acids^{96,101,118,121,122} However, given their low contents in the glass, the removal of these ions has no significant effect on the acidic corrosion behavior of E-glass fiber.

Figure 1.10 Schematic representation of fiber corrosion in acid: (a) ion exchange of metal ions, M^{n+} , from glass with hydrogen ions, H^+ , from acid; (b) sheath depleted of M^{n+} ions around a intact fiber core, producing a surface shrinkage stress, σ_s ; (c) sheath growth followed by surface cracking when shrinkage stress exceeds sheath fracture strength, σ_{fs} .⁵⁰

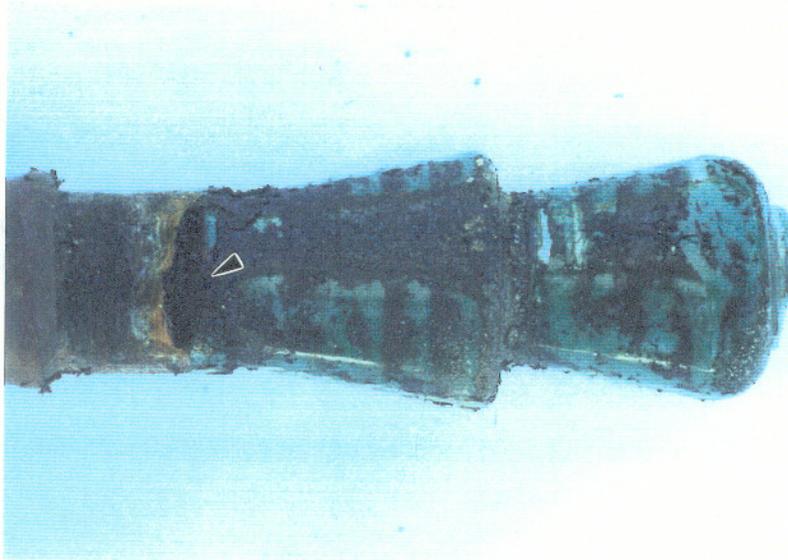
In all the failed and damaged insulators examined in this study, the main fracture occurred in the region from the epoxy/sheath interface to the first weathershed (Figures 1.2 and 2.5). The fracture surfaces in completely failed insulators can be characterized by the morphologies shown in Figures 1.5a and 1.5b. In most cases, the fracture surface exhibited two distinct regions (Figure 1.5a): one region appeared

Figure 2.1 Damage zones found inside the high-voltage end of insulator #3.

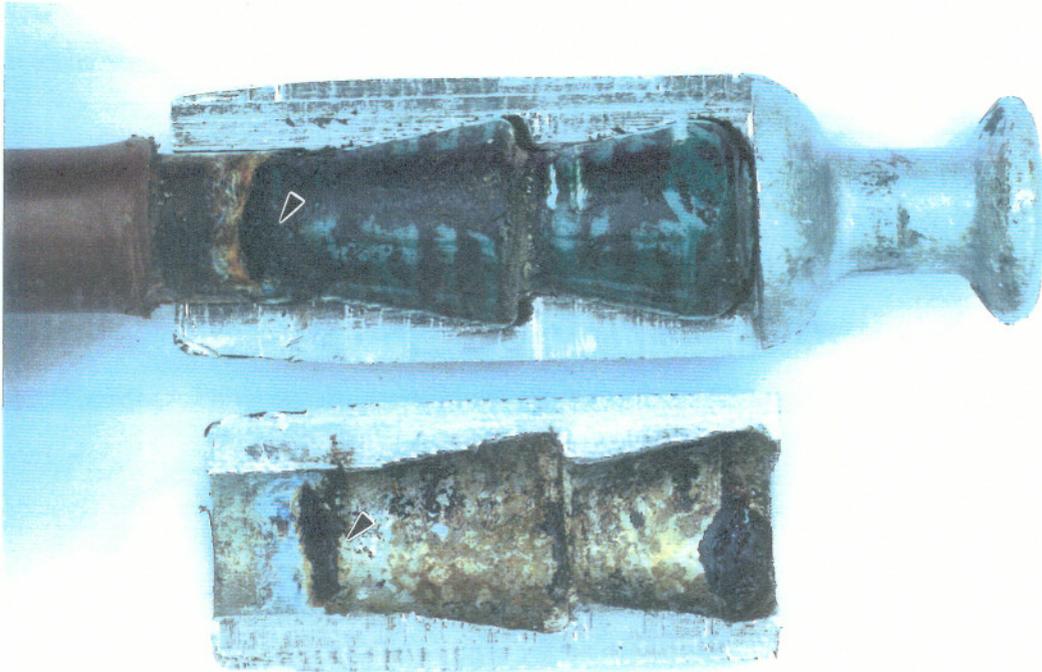
Figure 2.2 Black substance in the damage zone and on the inner surface of the metal casting.

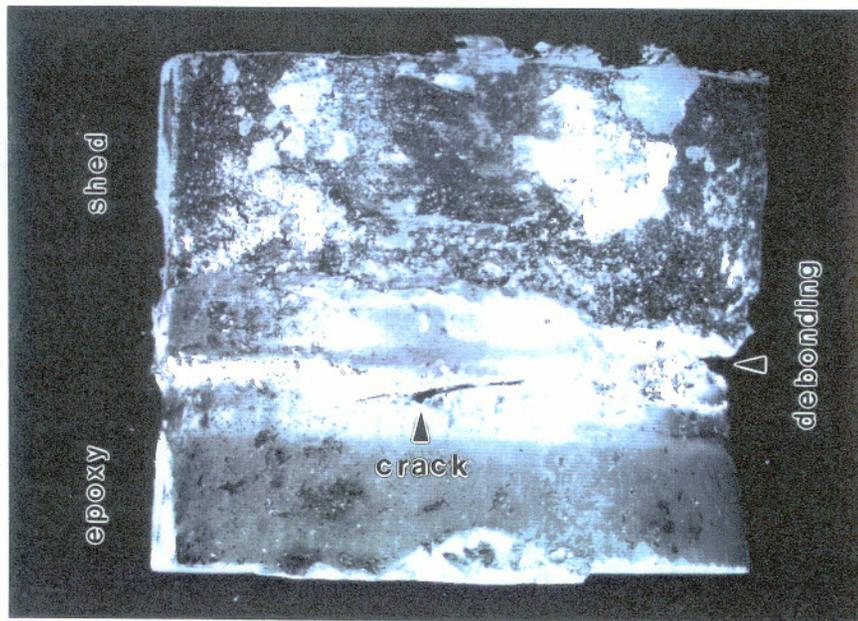
Figure 2.3 Circumferential cracks in the epoxy/sheath interface region.

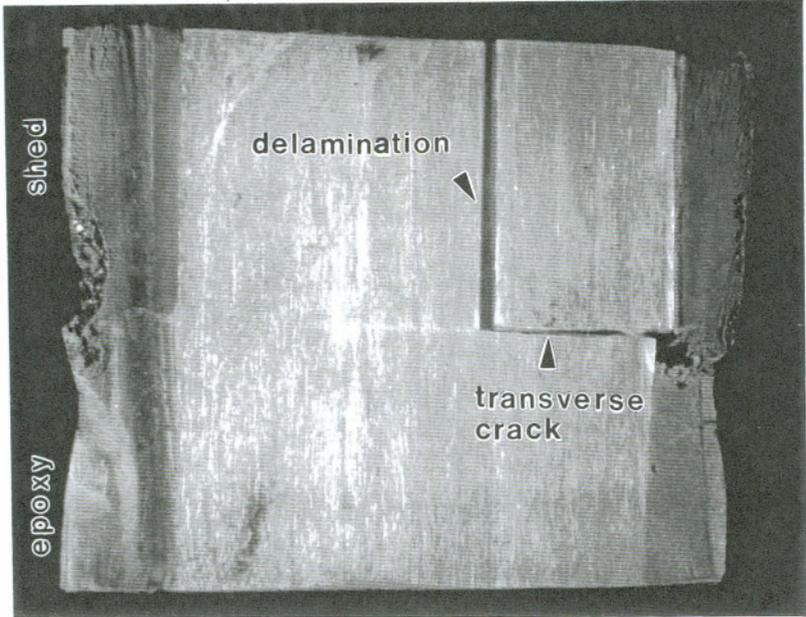
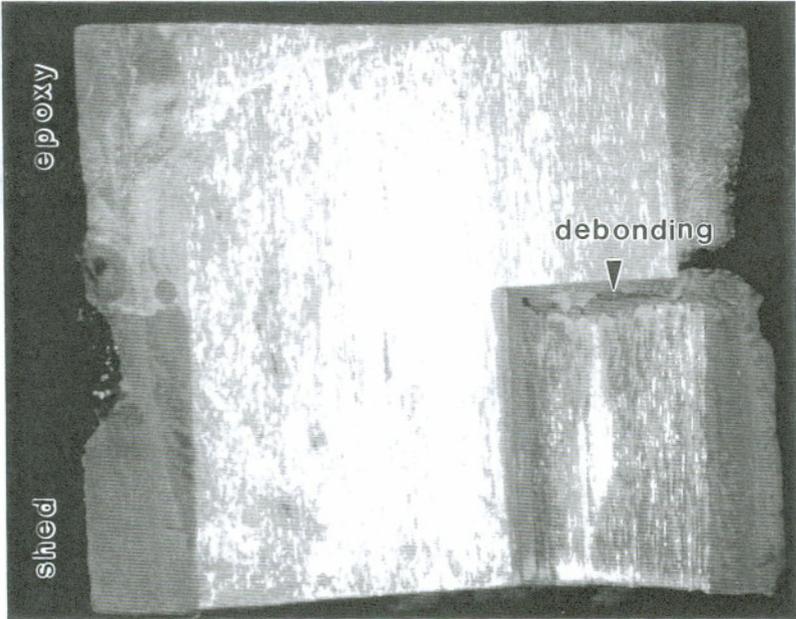
(a) Transverse crack

(b) Epoxy/sheath interface debonding

Figure 2.4 Damaged composite rod found inside the high-voltage end.

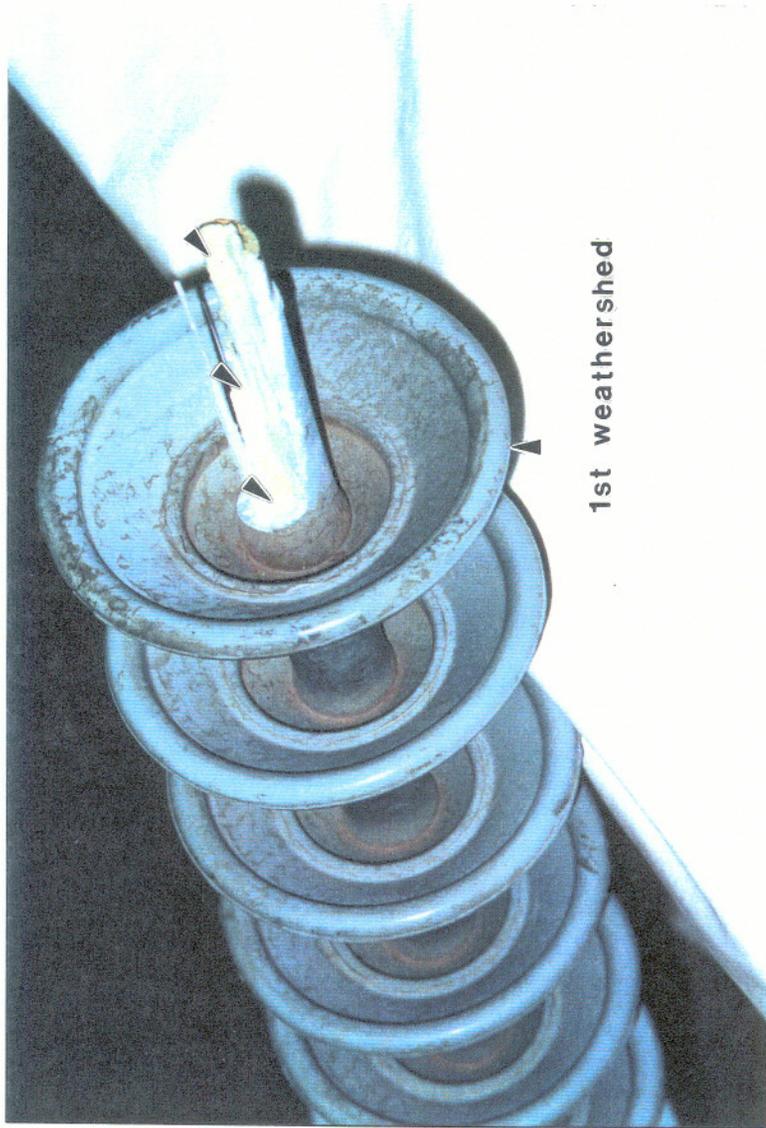
Figure 2.5 Fracture morphology of insulator #6.

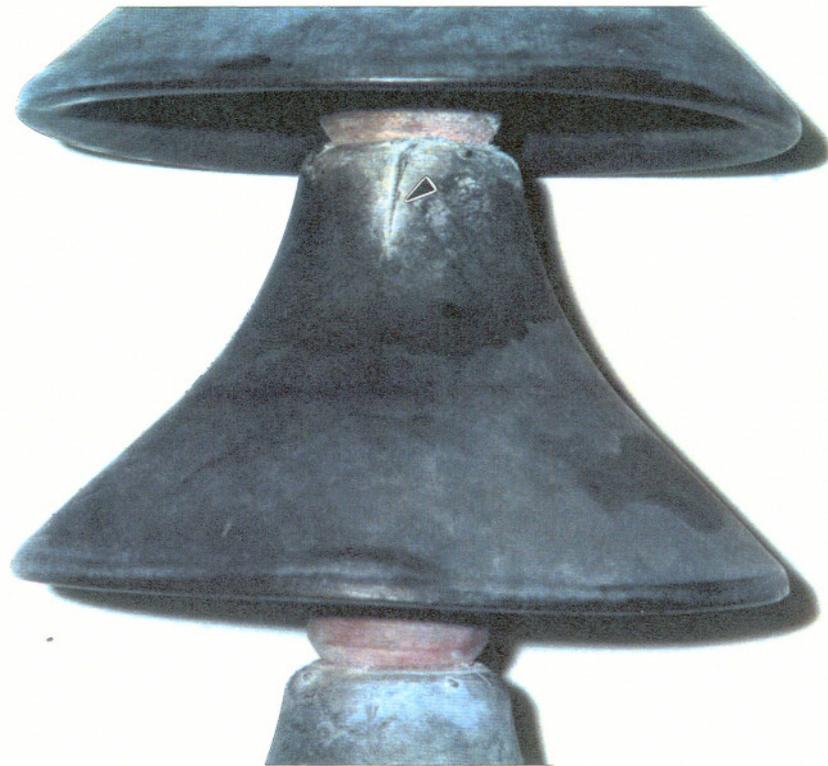
Figure 2.7 Surface cutting on the weathershed.

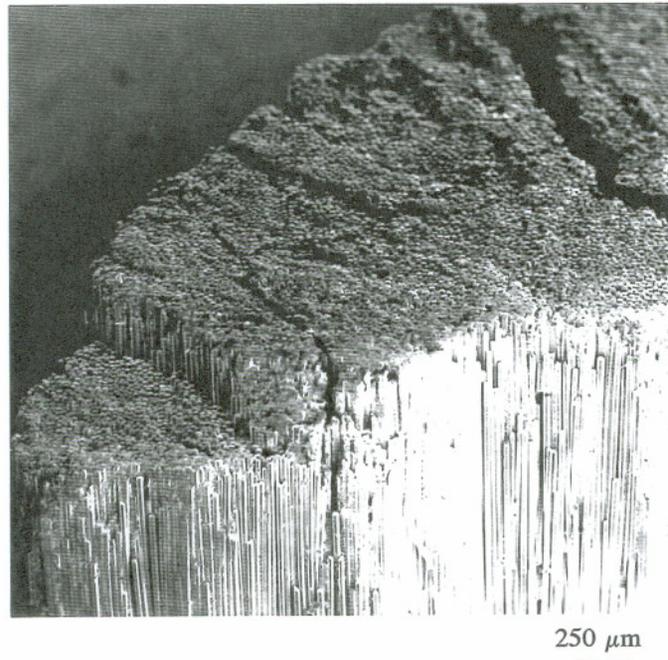
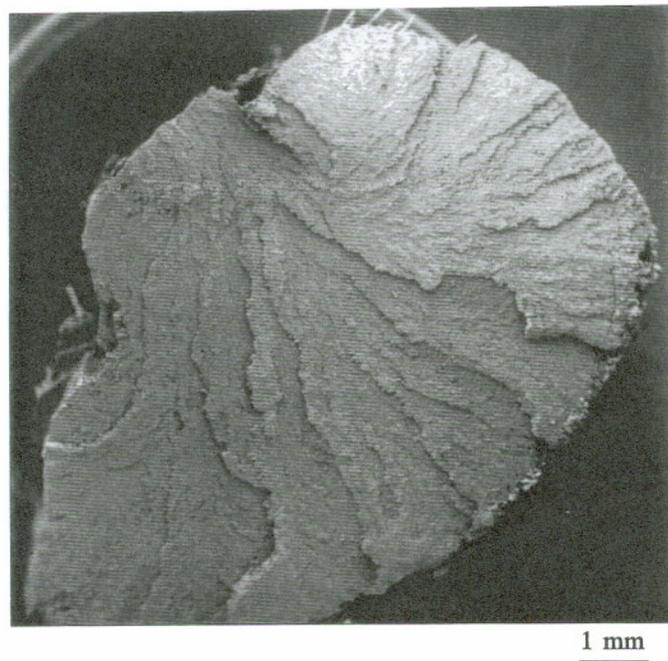
Figure 2.8 Morphology of the insulator fracture surfaces.

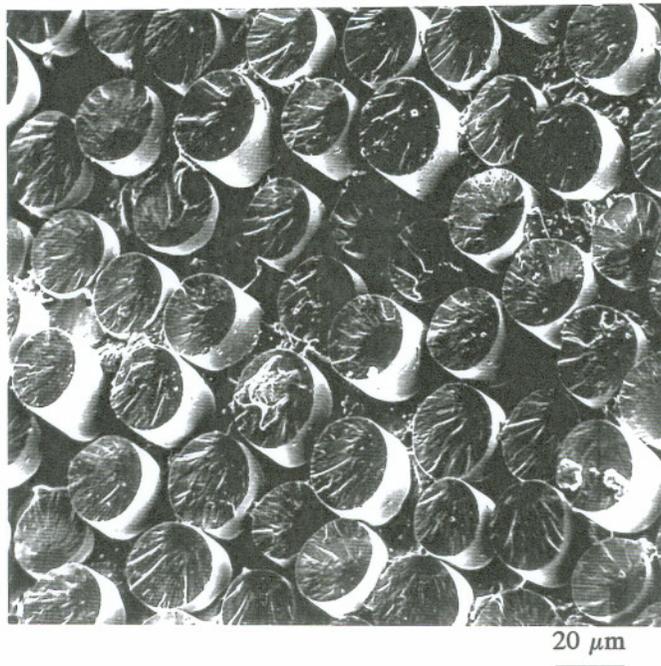
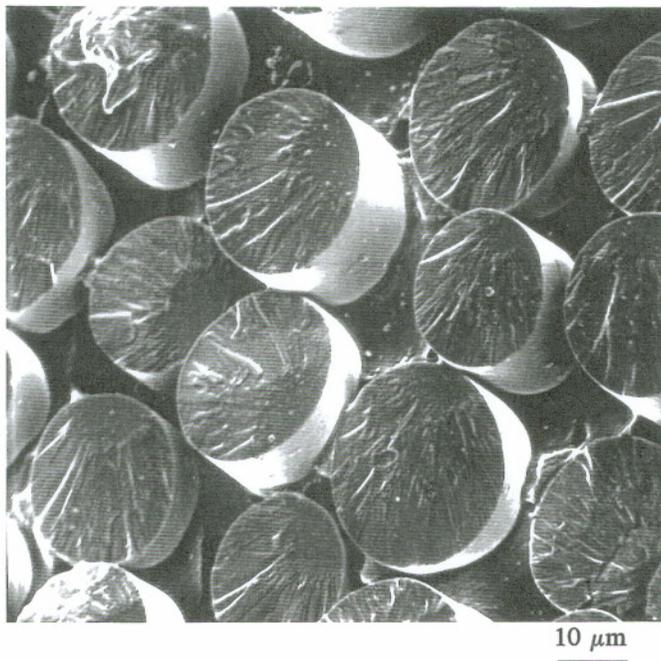
Figure 2.12 Resin decomposition on the fracture surface.

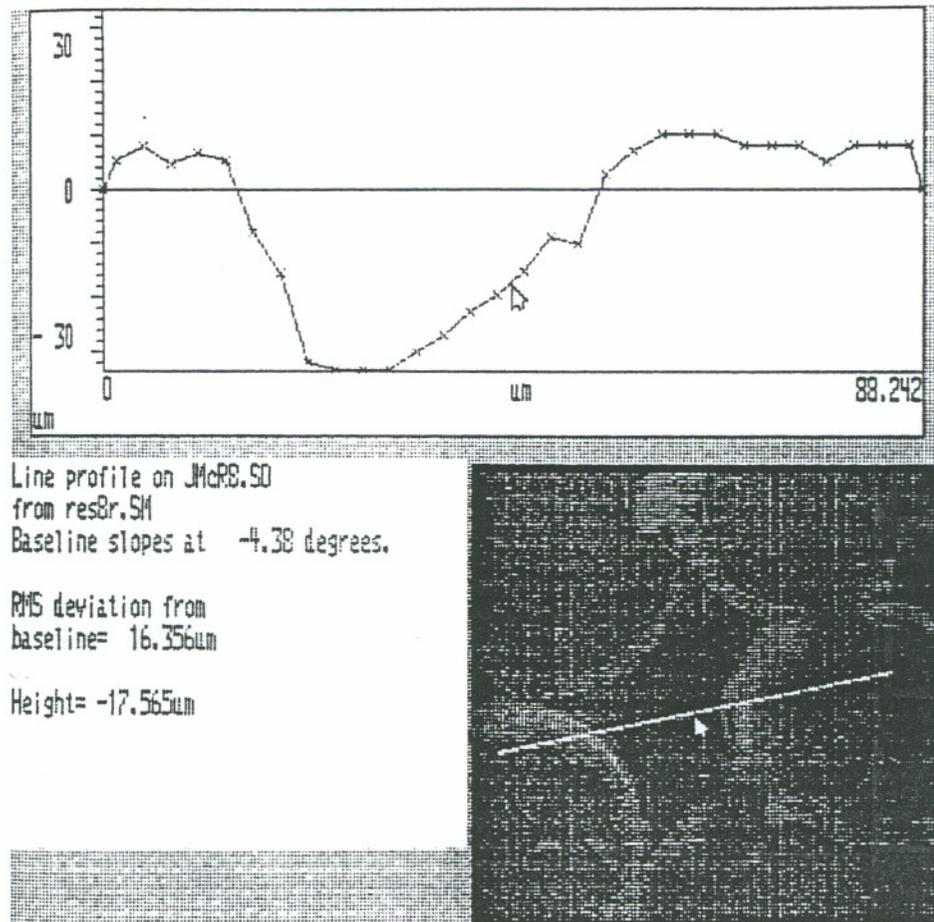
Figure 2.13 Depth profile on the local fracture surface.

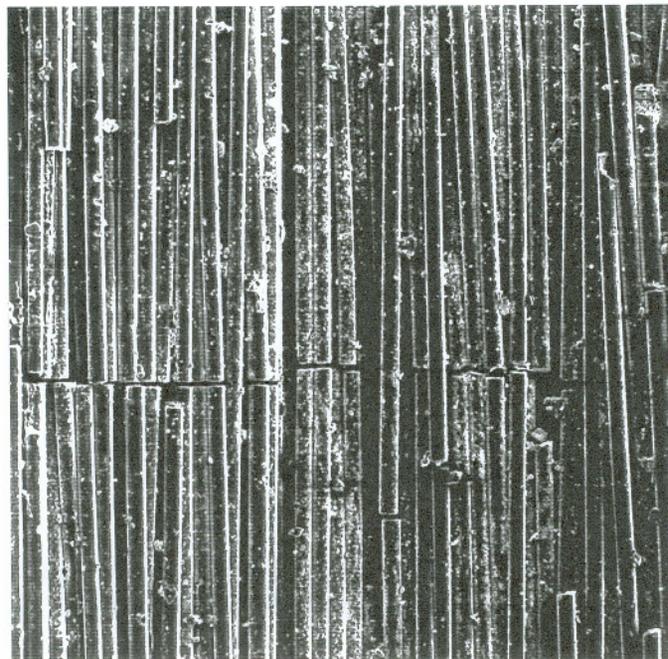
Figure 2.17 Morphology of secondary transverse cracks.

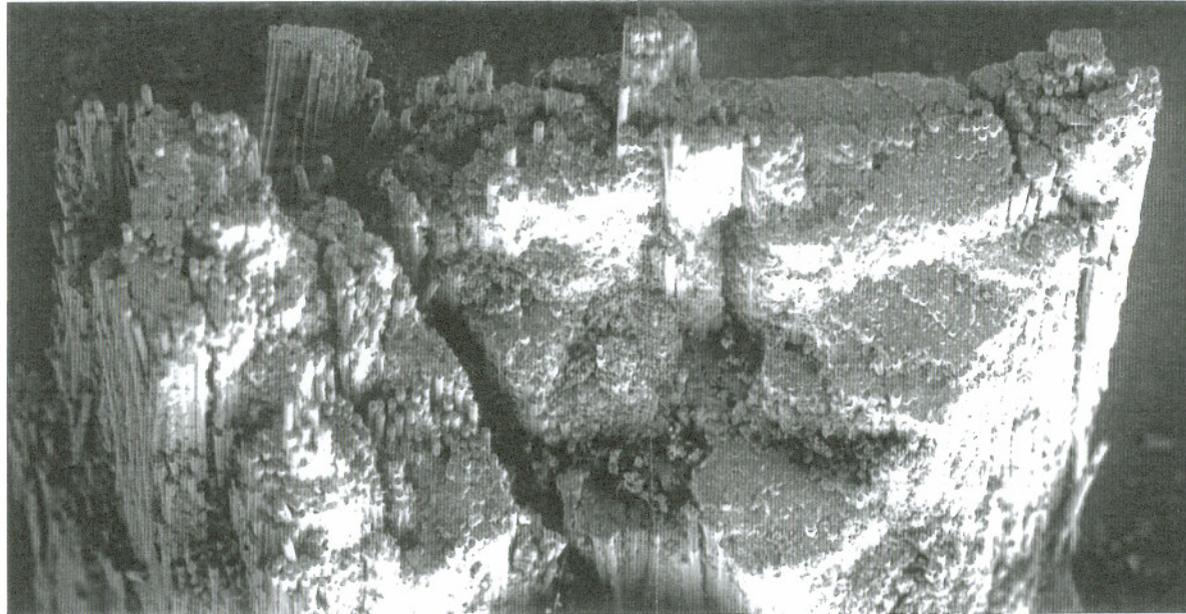
Figure 2.18 Fracture surface taken from the internal crack network.

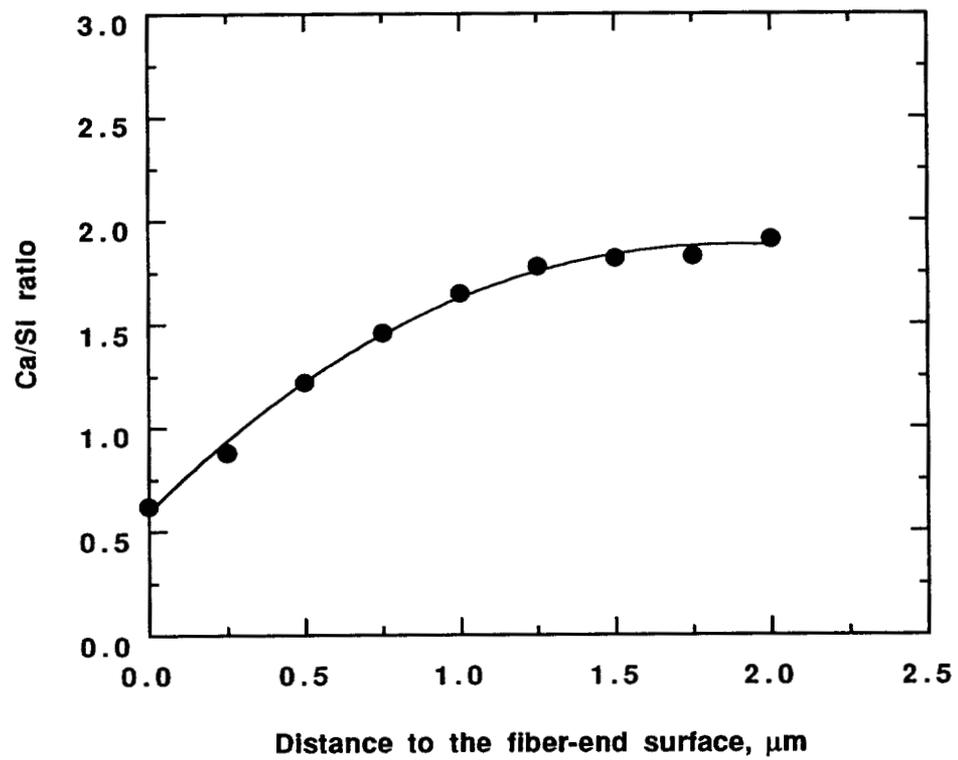
Figure 2.25 Calcium/silicon ratio as a function of the distance to the fractured fiber surface.

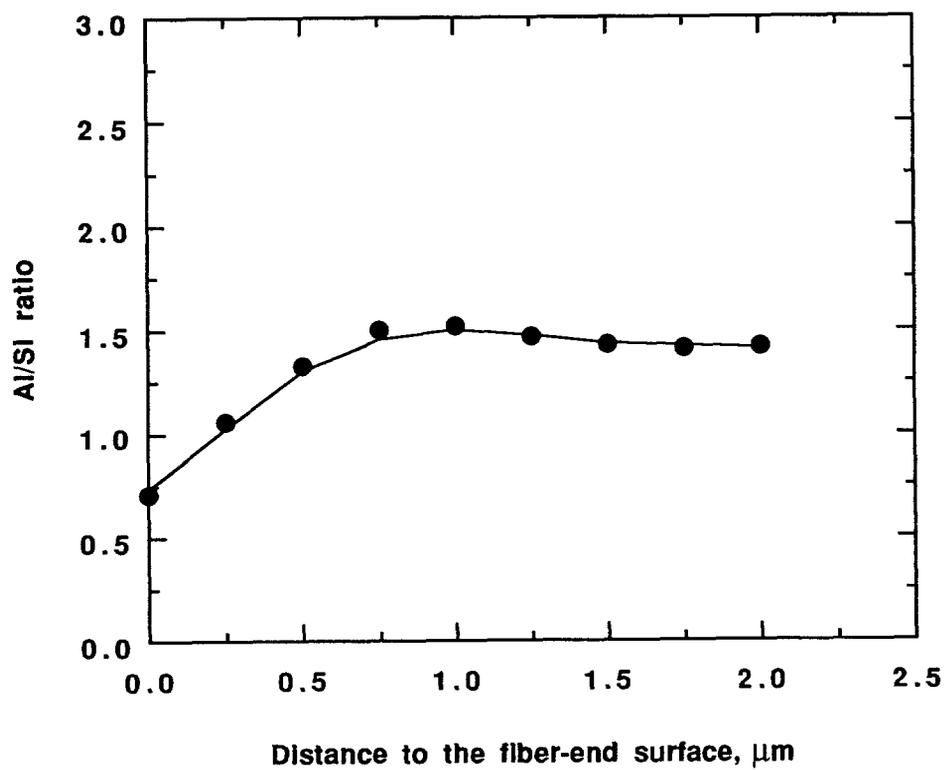
Figure 2.26 Aluminum/silicon ratio as a function of the surface to the fractured fiber surface.

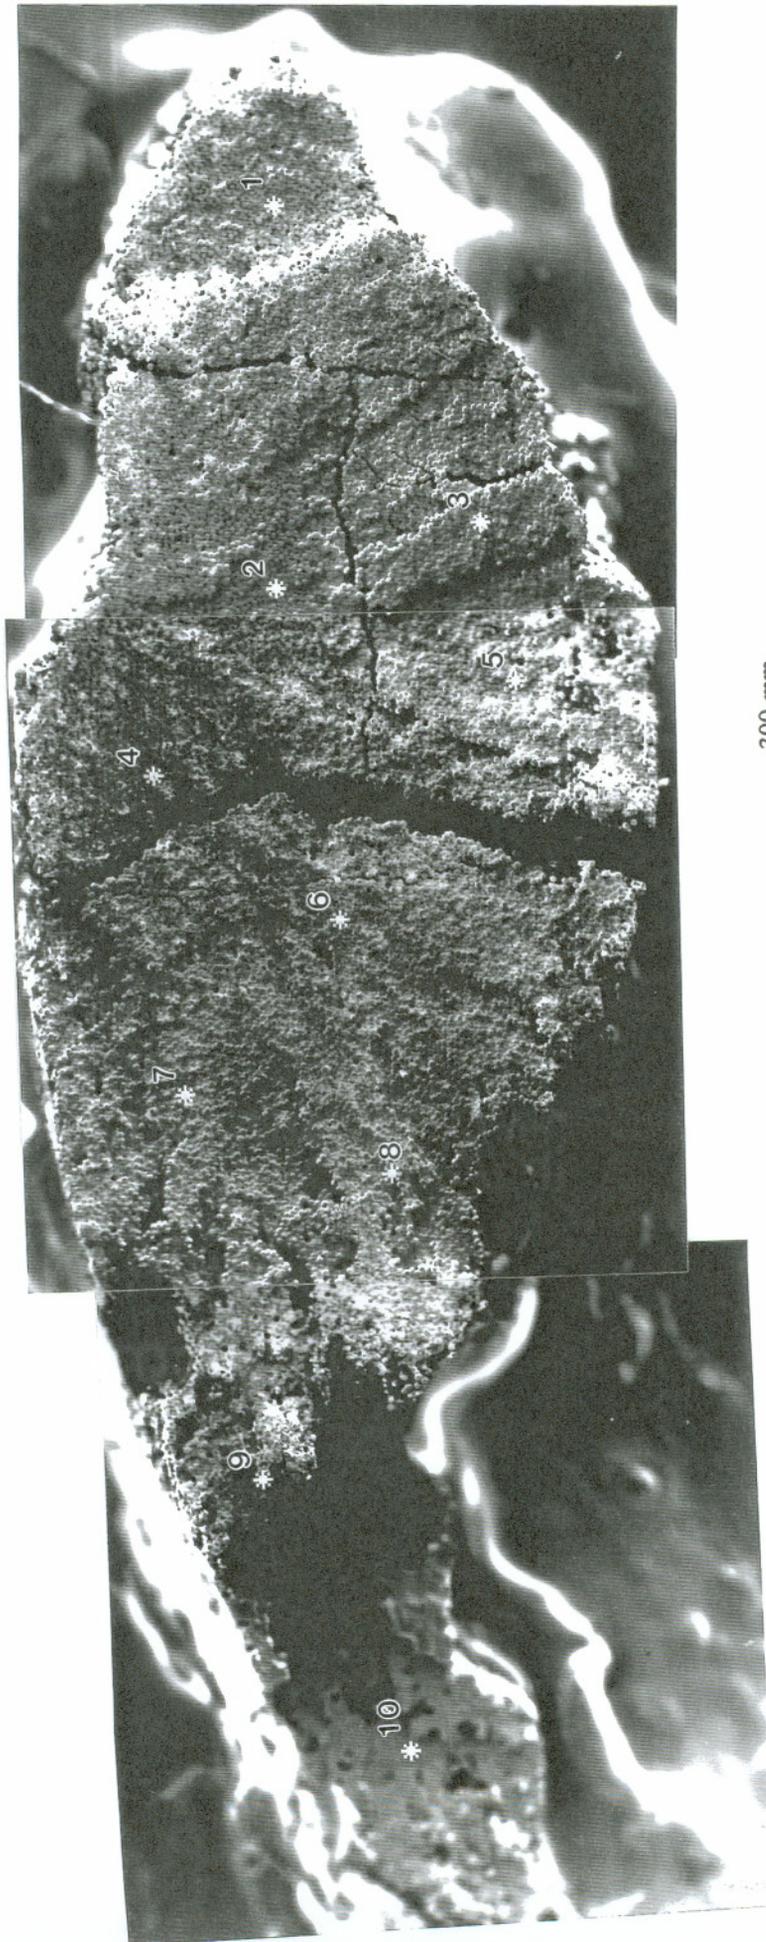
Mirror size and fiber diameter measurements of individual fibers in the selected fields are listed in Table 2.3. The corresponding mirror size and fiber diameter distributions on the basis of 100 fibers are depicted respectively in Figures 2.28 and 2.29. The fiber diameter obeys a Gaussian distribution. If the mirror size distribution is plotted on a semi-logarithmic scale, it can also be described as a Gaussian distribution (Figure 3.29b). The calculated mean value from each distribution appeared to be $23.22 \mu\text{m}$ for the fiber diameter and $6.88 \mu\text{m}$ for the mirror size. Furthermore, the distributions of the average mirror size and the average fiber diameter in each selected field was compared (Figure 2.30). As expected, the average fiber diameter remained nearly constant within the ten fields; however, the average mirror size varied significantly from one field to another, with the smallest value of $4.71 \mu\text{m}$ in field 3 and the largest average value of $14.38 \mu\text{m}$ in field 9.

Figure 2.27 Fracture surface in insulator #5.

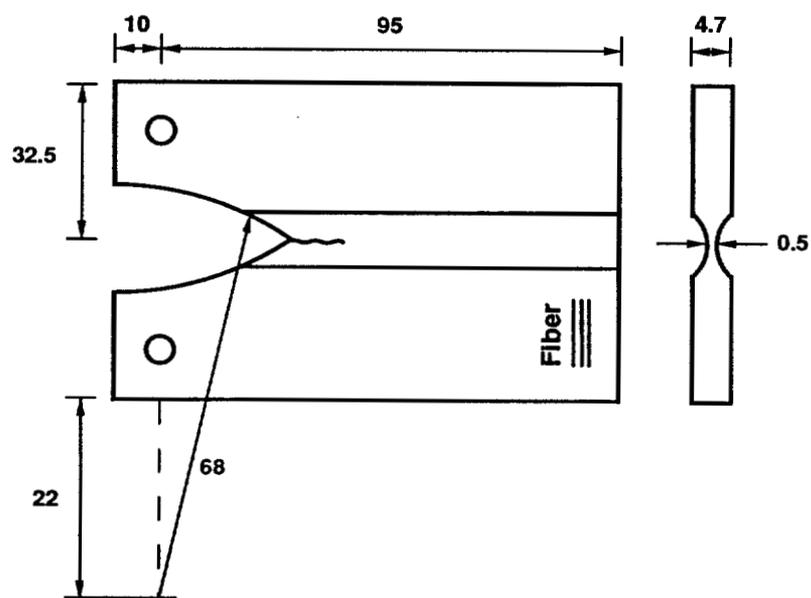
The geometry and dimensions of the specimen used in this study were identical to those employed by Price and Hull,⁶² except for the thickness of the specimen at the grooves, which was reduced from 1.0 mm to 0.5 mm. Further finite element analysis¹³⁸ and a compliance calibration experiment¹³¹ verified that the constant K_I assumption remained valid for the reduced-thickness specimen. Results obtained from the compliance calibration experiment also suggested that the constant K_I region, in this case, was lessened to approximately the first 8 mm of crack growth.

Figure 2.31 Configuration of the constant K_I specimen (all dimensions in mm).

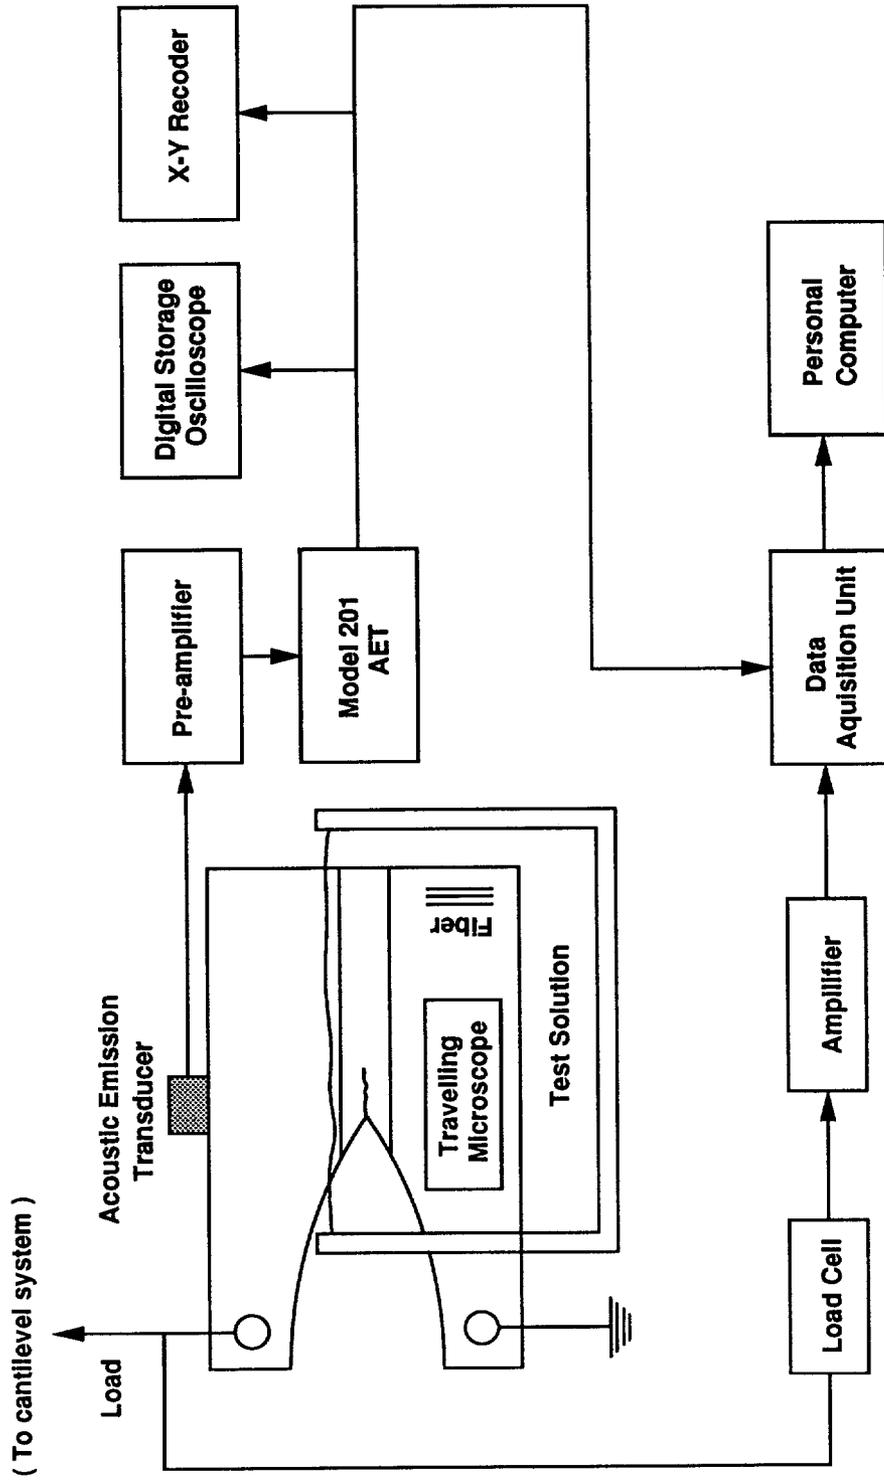
To monitor the stress corrosion process quantitatively, acoustic emission technique was employed in the experiments. An AC 375L piezoelectric transducer was positioned

Figure 2.32 Schematic representation of the stress corrosion experimental arrangement.

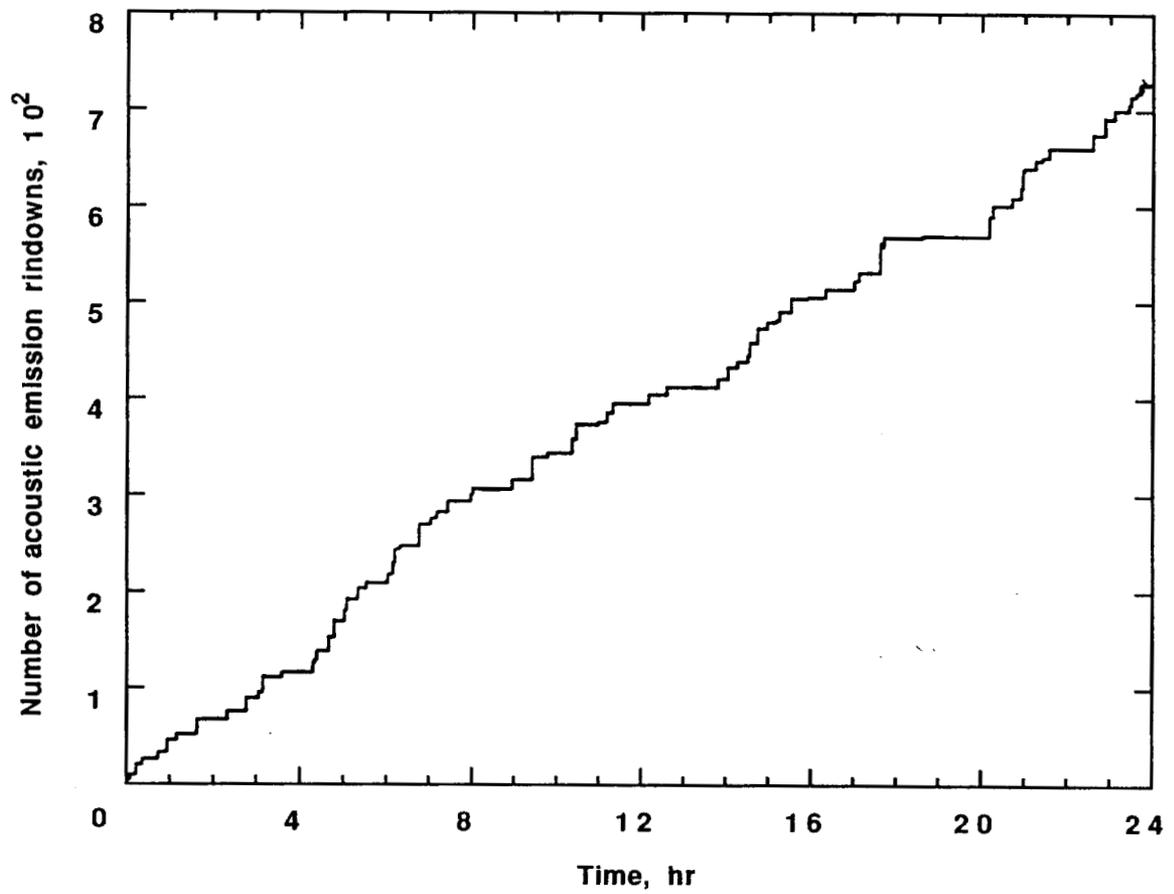
The stress corrosion experiments were performed at room temperature. A fixed tensile load of 9.08 kg (20 Lbs) was employed in all of the experiments, except for the study on mechanical load effect, in which the tensile load was a variable. This particular load was chosen to achieve the possibly highest crack growth rate under conditions of limited fiber/matrix interface debonding at the crack front, thus reducing the test duration. The calibration of the constant K_I specimen used in this experiment¹³⁸ further revealed that the tensile load of 9.08 Kg (20 Lbs) resulted in the stress intensity of approximately 4.3 MPa m^{1/2} at the crack front, which approximated the upper limit suggested by Price and Hull for the formation of a planar stress corrosion crack in acidic environments.^{51,62}

Figure 2.33 Acoustic emission output recorded during the stress corrosion experiments.

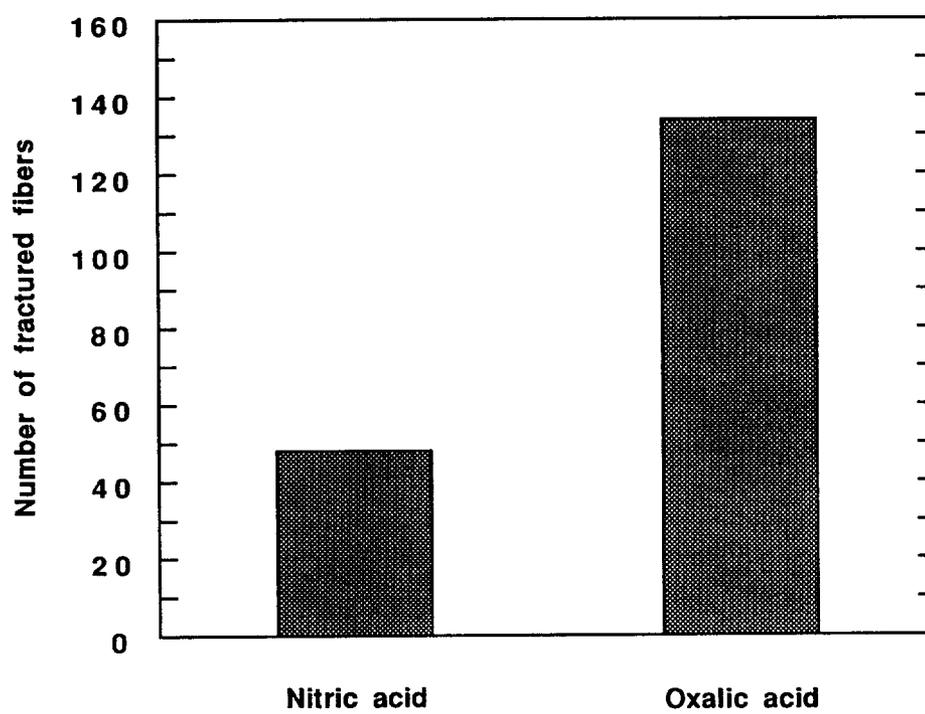
The experimental results are given in Figure 2.34. Within 24 hours, the number of fractured fibers induced by stress corrosion in the oxalic acid solution appeared approximately three times higher than that in the nitric acid solution, suggesting that oxalic acid was more corrosive to E-glass/polyester composite relative to nitric acid at equal pH. These results are consistent with those observed by Chandler *et al* on corrosion behavior of E-glass fiber in nitric and oxalic acids.⁴⁶

Figure 2.34 Number of fractured fibers in the pH 3 nitric and oxalic acids.

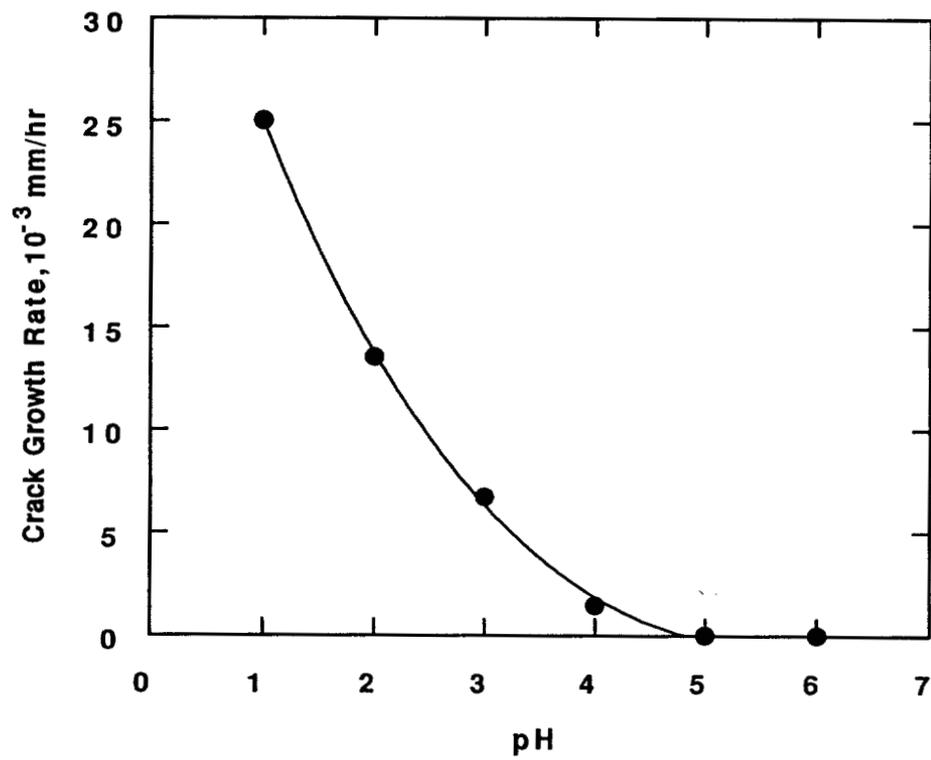
Figure 2.35 Crack growth rate as a function of pH produced by oxalic acid.
