**BRITTLE FRACTURE MECHANISMS OF GLASS-FIBER
REINFORCED POLYMER INSULATORS**

A dissertation submitted to the faculty of the
Oregon Graduate Institute of Science & Technology
in partial fulfillment of the requirements
for the degree Doctor of Philosophy
in
Materials Science and Engineering

October, 1995

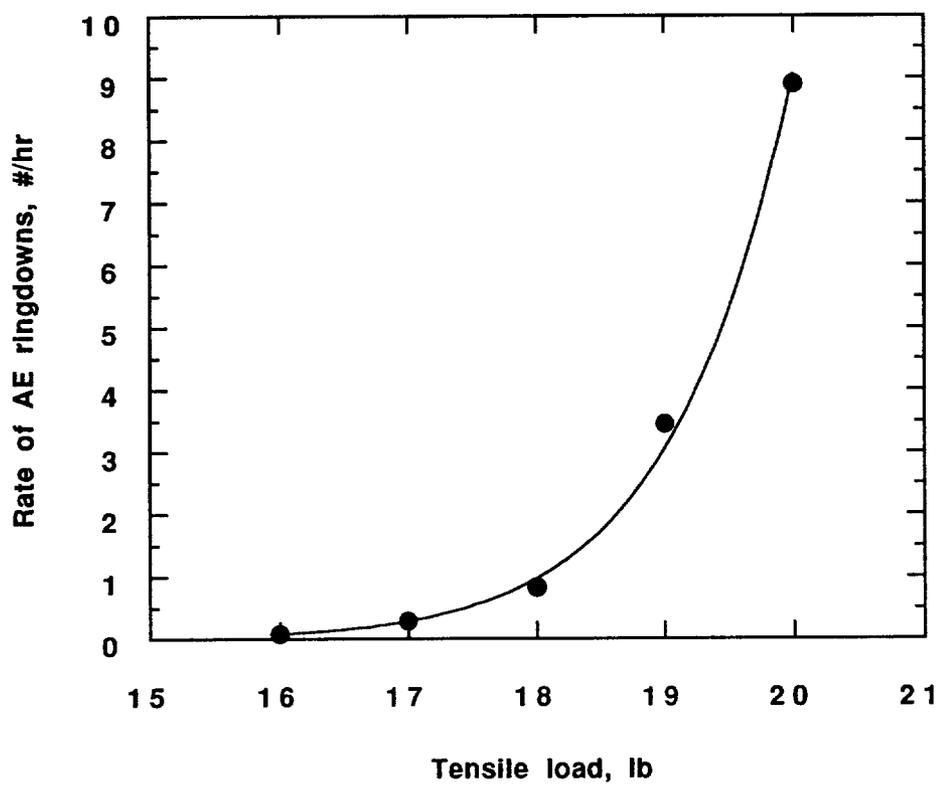
Figure 2.36 Rate of acoustic emission ringdowns as a function of tensile load in the pH 2 oxalic acid solution.

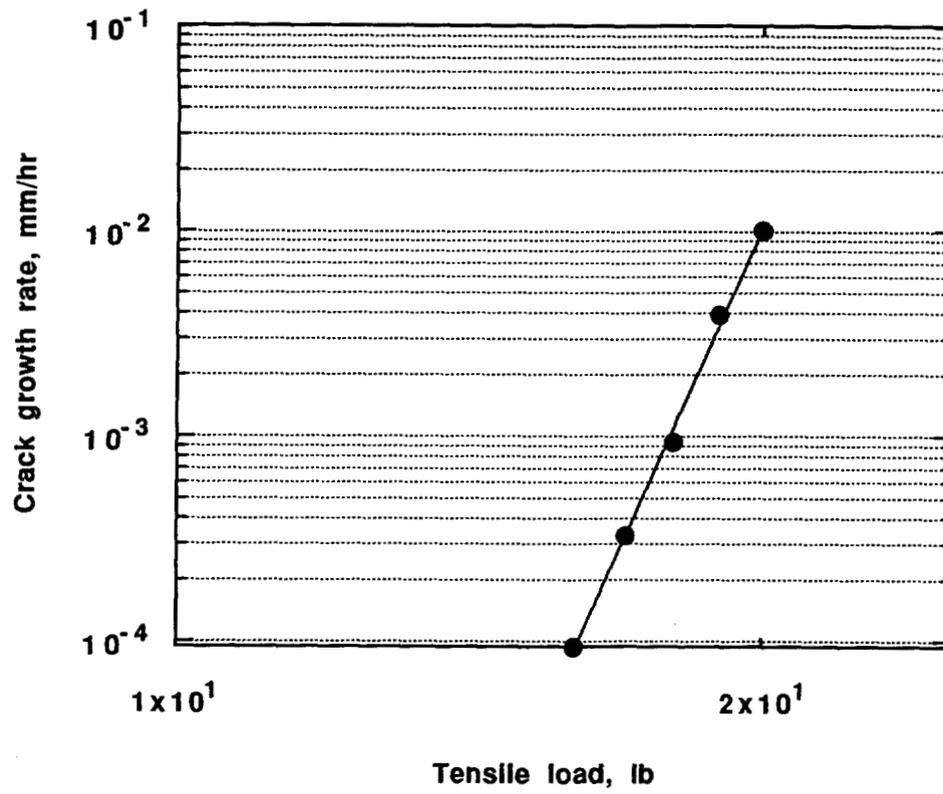
Figure 2.37 Crack growth rate as a function of tensile load in the pH 2 oxalic acid solution.

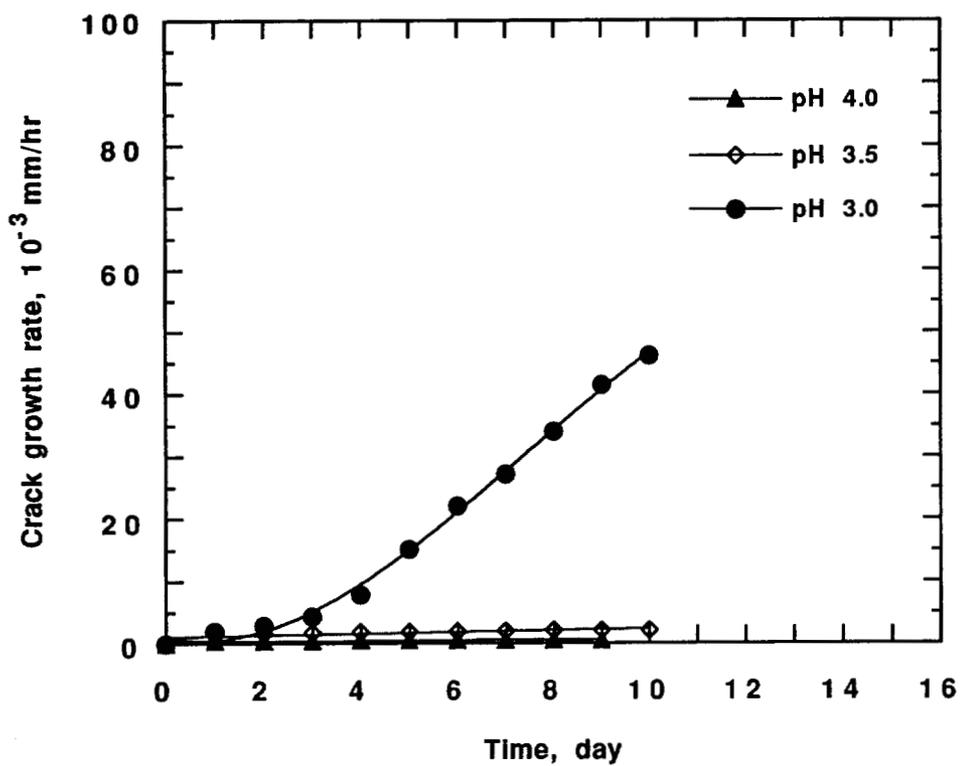
Figure 2.38 Crack growth rate as functions of exposure time and acid solution pH in E-glass fiber/polyester composite.

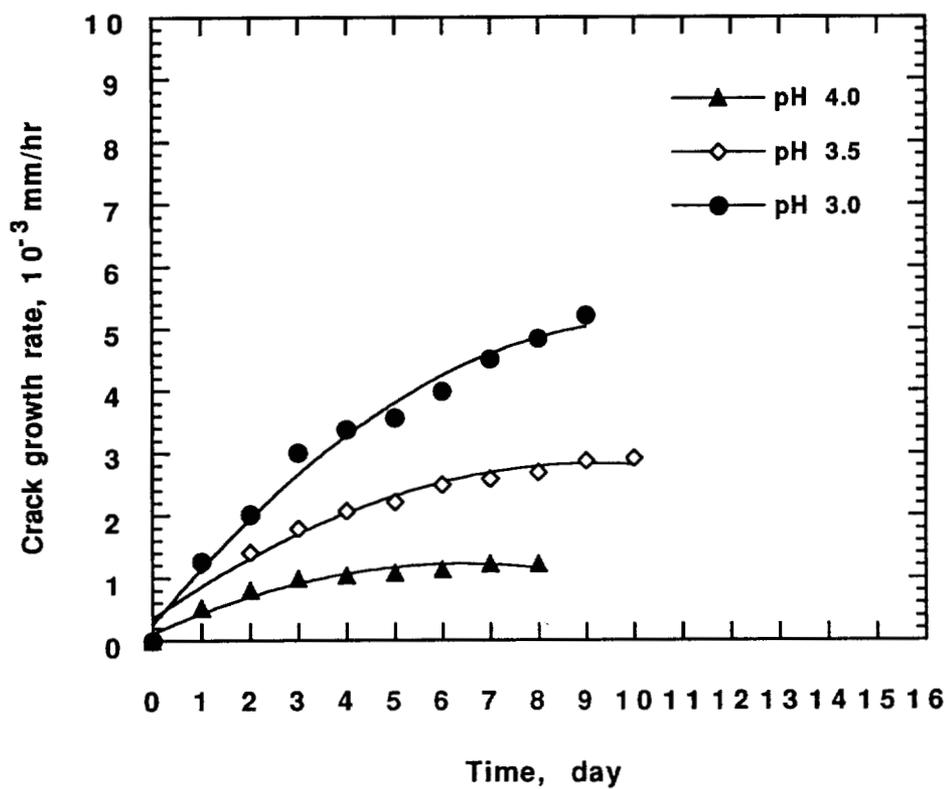
Figure 2.39 Crack growth rate as functions of exposure time and acid solution pH in E-glass fiber/epoxy composite.

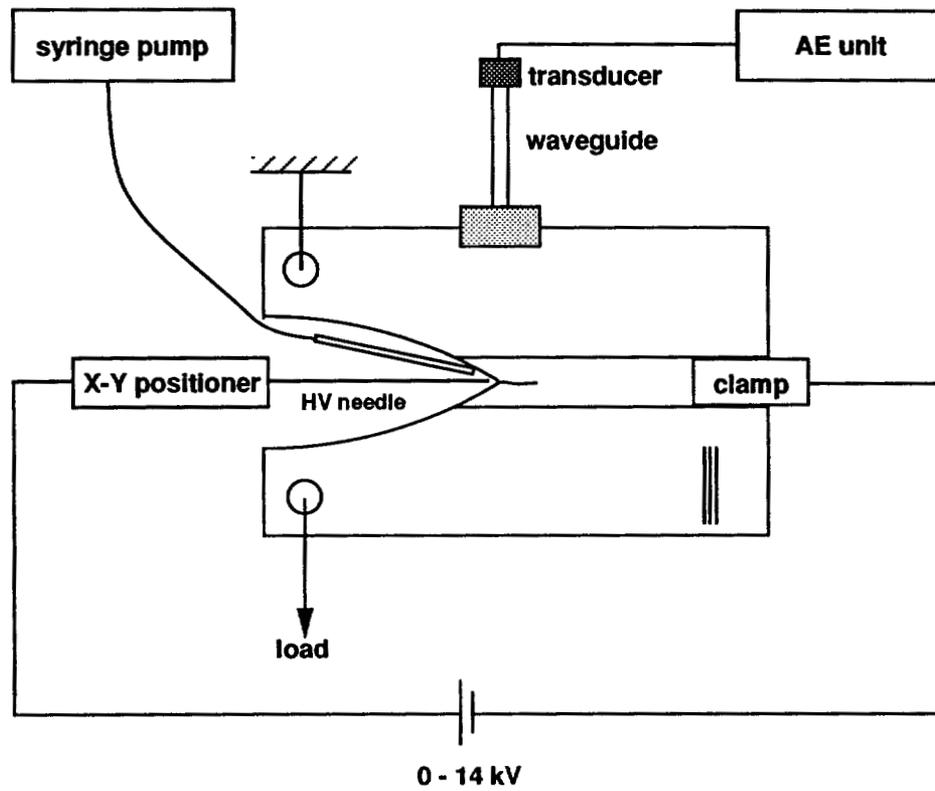
To investigate the influence of electrical discharge on the stress corrosion fracture of composites, a high voltage system was constructed. Designed on the basis of the constant K_I specimen geometry, the system consisted of four basic parts: a loading unit, a syringe pump unit, an electrical control unit, and an AE unit (Figure 2.45). The specimen loading in this system was achieved by applying dead weight. To initiate electrical discharge at the notch root, a positively charged needle, controlled by a X-Y positioner, was placed at a close distance to the notch root, about 0.5 mm, and the opposite side of the specimen was electrically connected to the ground pole. The creepage distance, the distance between the needle tip to the ground, was adjusted by moving the clamp at the ground end along the grooves. Figure 2.46 shows the scheme of the electrical control unit. This electrical layout allowed the system to achieve the maximum voltage capacity of 14 kV. To modify the notch root environment externally, a syringe pump unit was installed, making it possible to transfer test solutions to the notch root at an adjustable rate. Similar to the stress corrosion system, the high voltage system was also equipped with an acoustic emission unit to monitor the fracture process. For insulating purposes, a wave-guide glass bar was employed to bridge the AE transducer to the specimen, eliminating possible electrical discharge on the transducer. More detailed information on the high voltage system can be found elsewhere.¹³⁸

Figure 2.45 Configuration of the high voltage system.

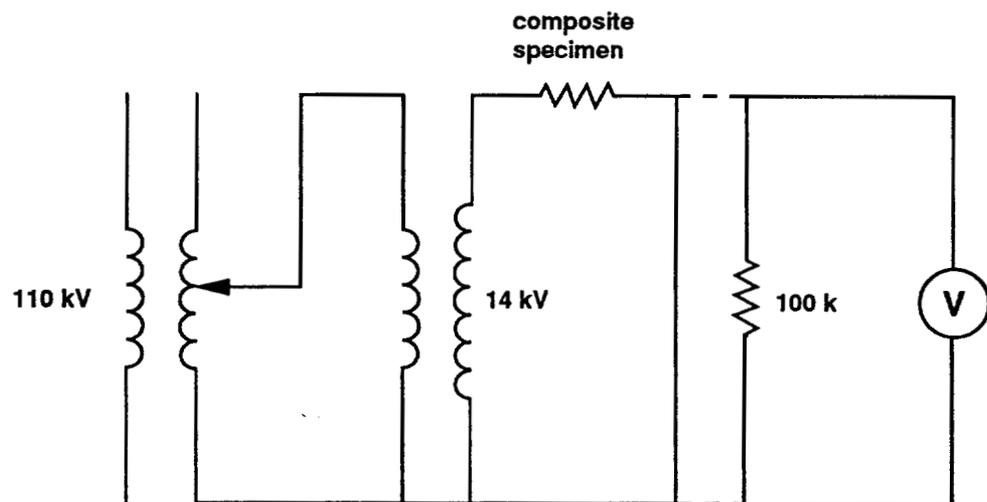
Figure 2.46 Scheme of the electrical control unit.

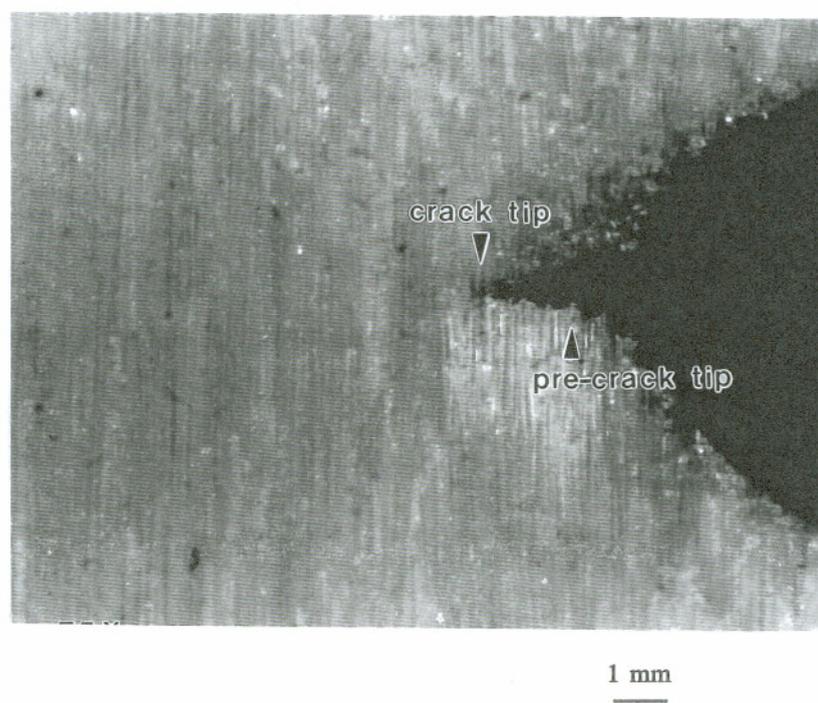
Figure 2.48 Transverse crack developed under wet conditions.

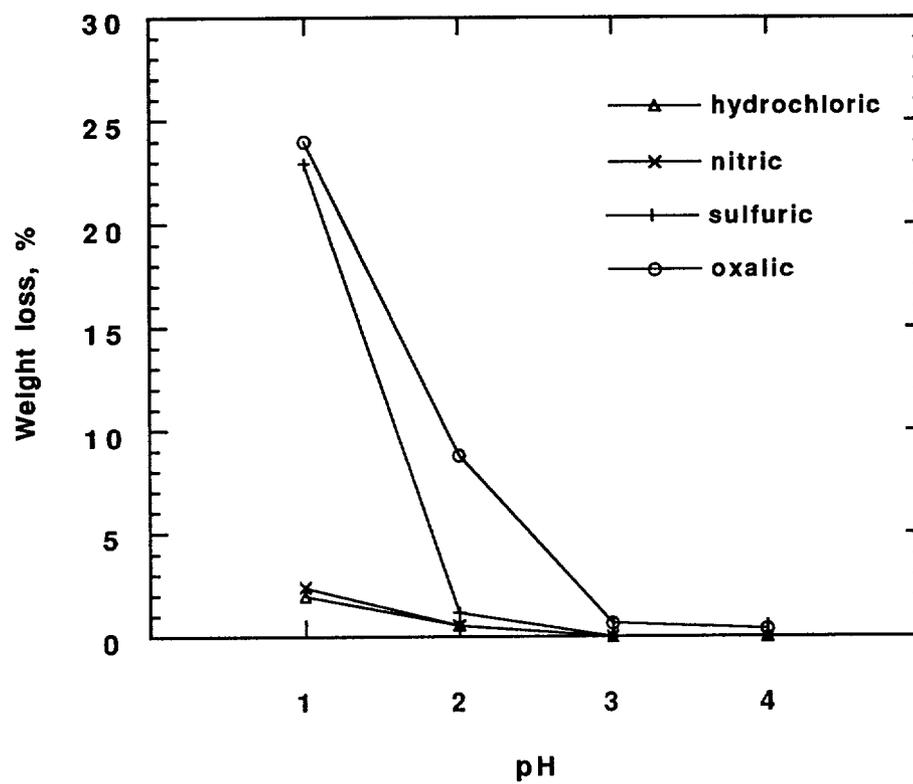
Figure 2.53 Fiber weight loss as functions of acid type and acid solution pH.

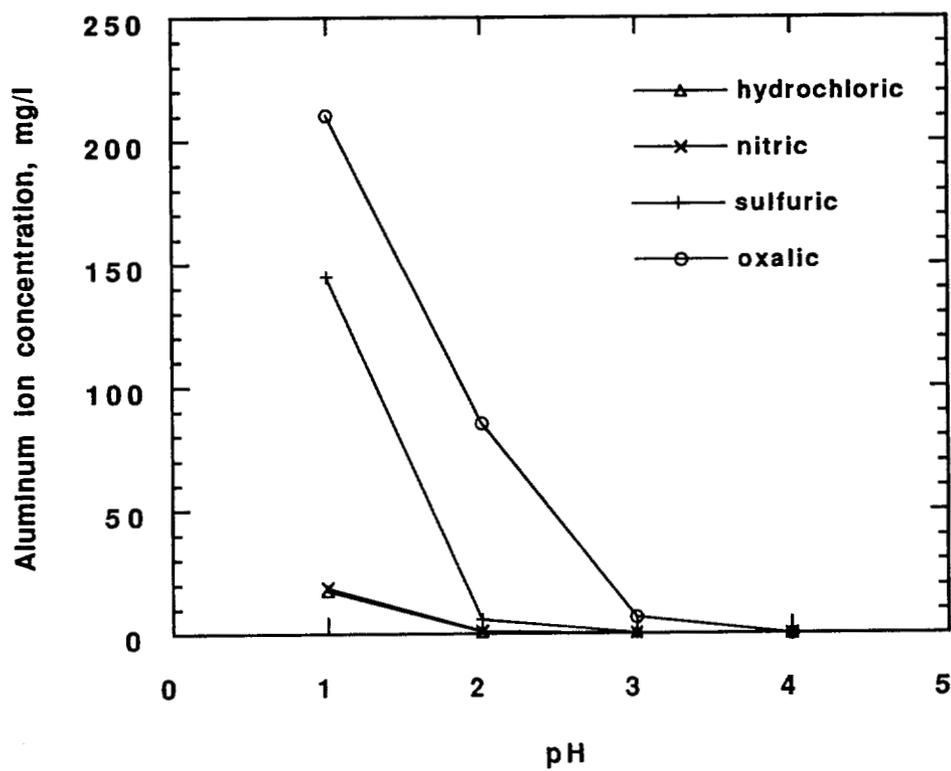
As expected, both calcium and aluminum depletion from E-glass fiber were found in the acid immersion experiments (Figures 2.54 and 2.55). The results further revealed that the leachability of calcium or aluminum ions was highly dependent on both acid type and acid concentration, exhibiting a similar trend to the fiber weight loss (Figure 2.53). For all of the acid concentrations, both calcium and aluminum ion depletion in oxalic and

Figure 2.55 Aluminum ion concentrations in resultant acid solutions.

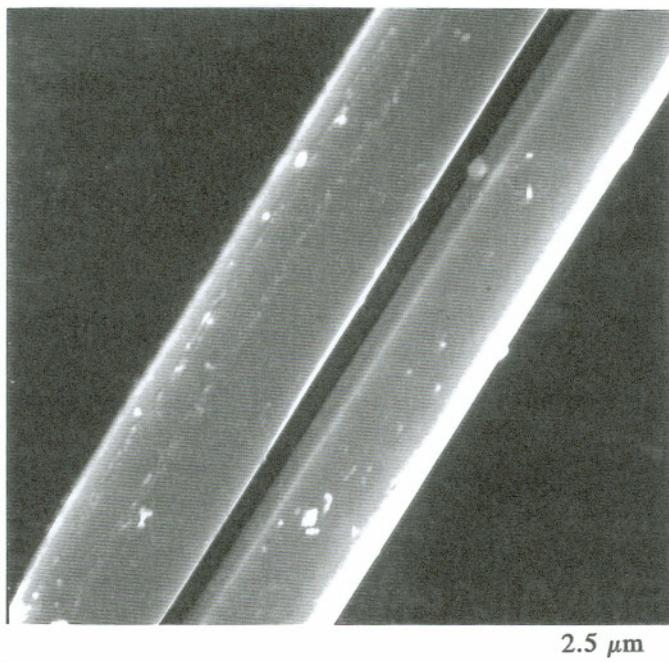
The surface morphology of the fibers immersed in the pH 1 solution was characterized by axial cracks, which ran through the entire fiber length (Figure 2.57). This crack morphology implied that the principal surface stress was axial in nature. Further observation revealed that each axial crack was usually accompanied by an circumferential crack underneath (Figure 2.58). It is likely that during acid immersion the axial crack was initiated on the fiber surface and propagated towards the fiber center. Once the

Figure 2.57 Axial cracks generated in the pH 1 oxalic acid solution.

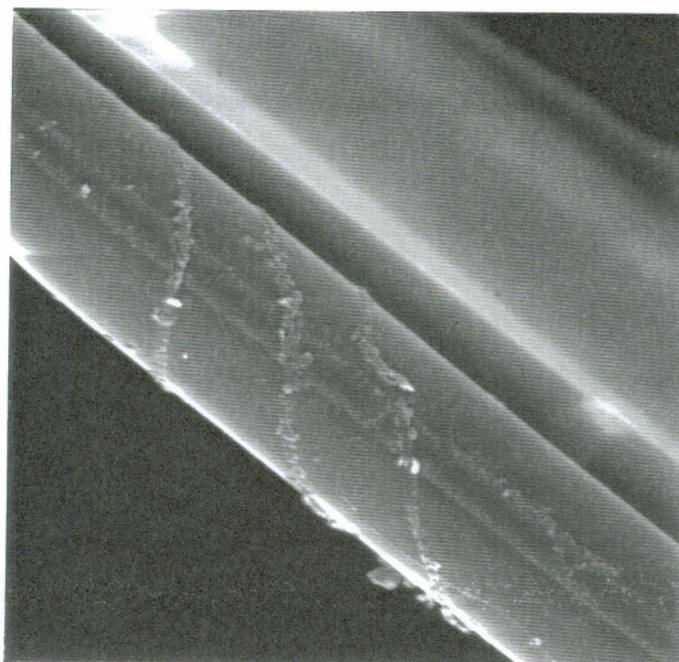
Figure 2.60 Surface damage generated in the pH 3 oxalic acid solution.

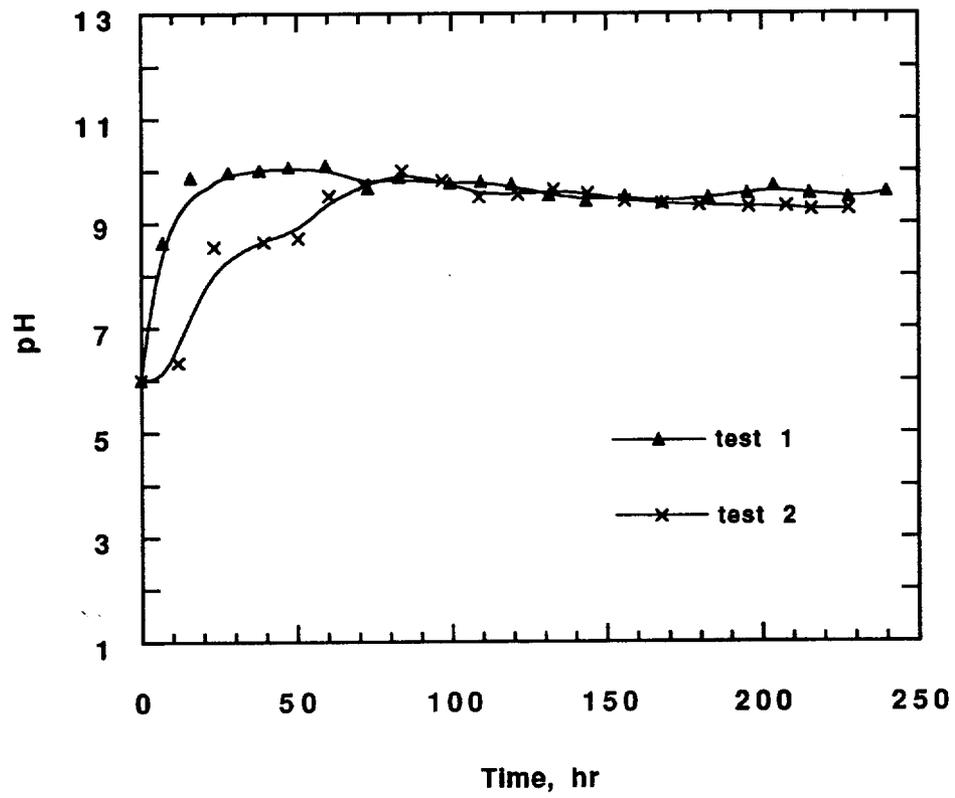
Figure 2.68 pH changes of the extract obtained from the composite with the calcium carbonate filler.

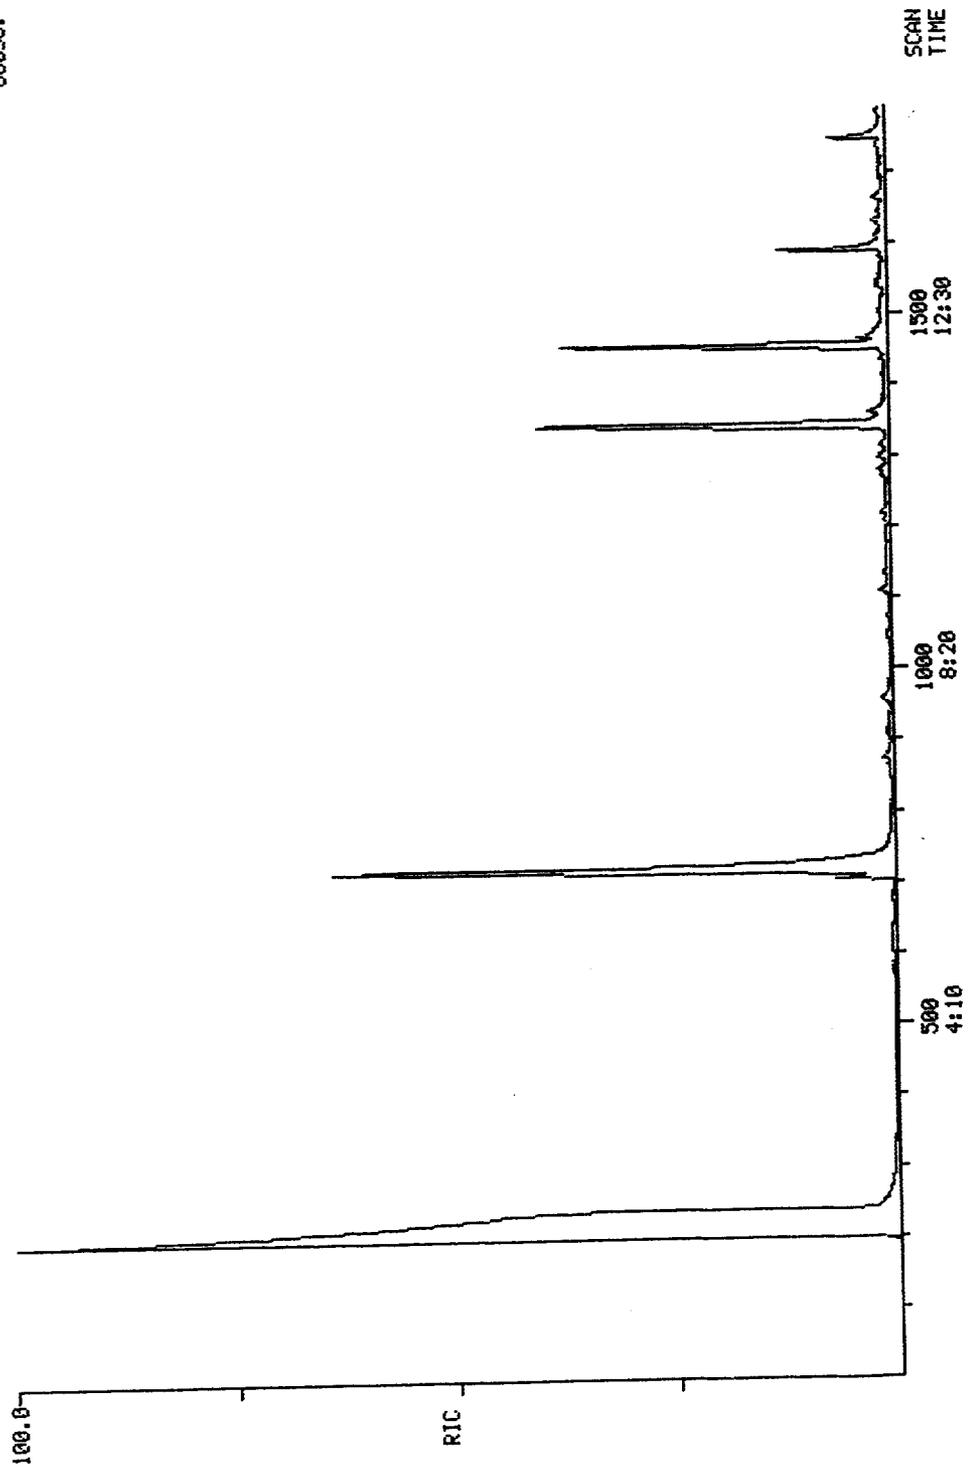
Figure 2.71 Reconstructed ion chromatogram for the deposits.

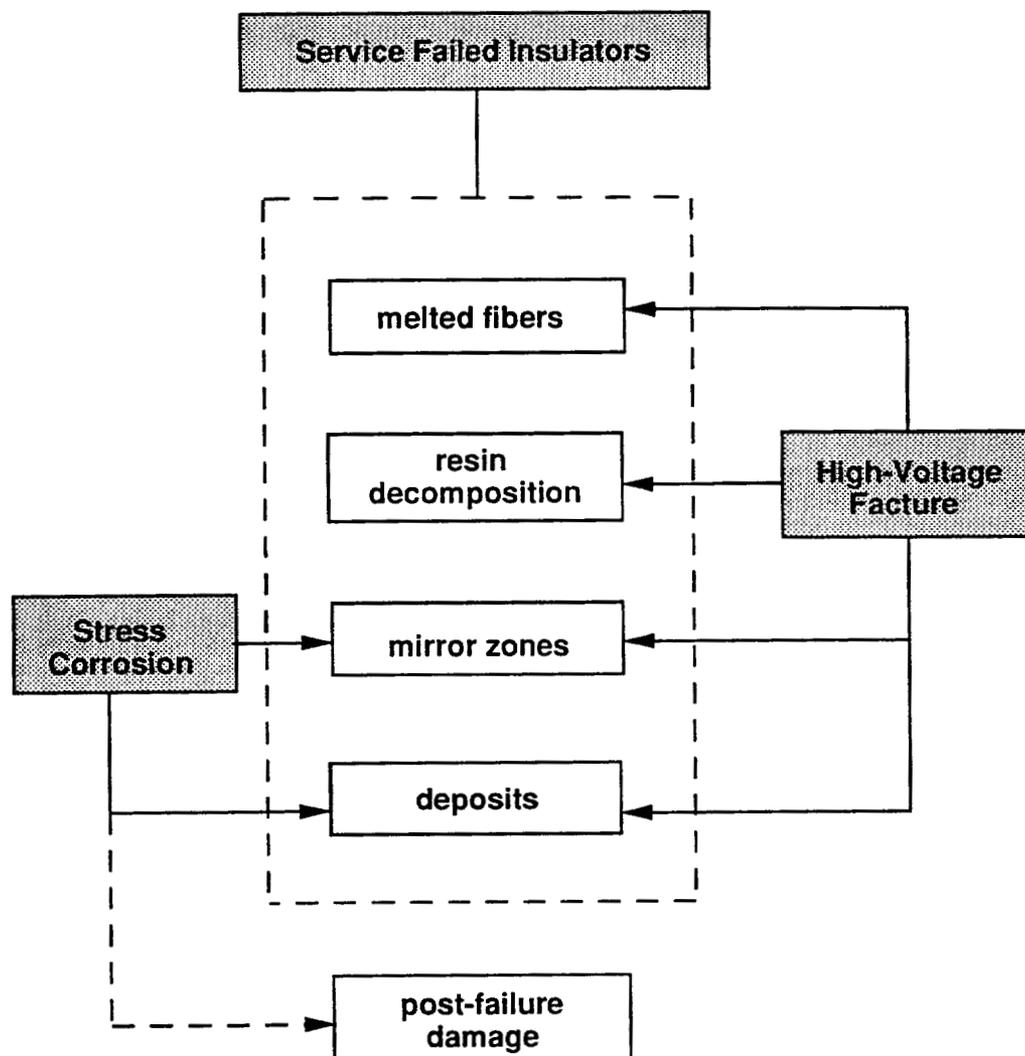
Figure 3.1 Fracture morphology comparison.

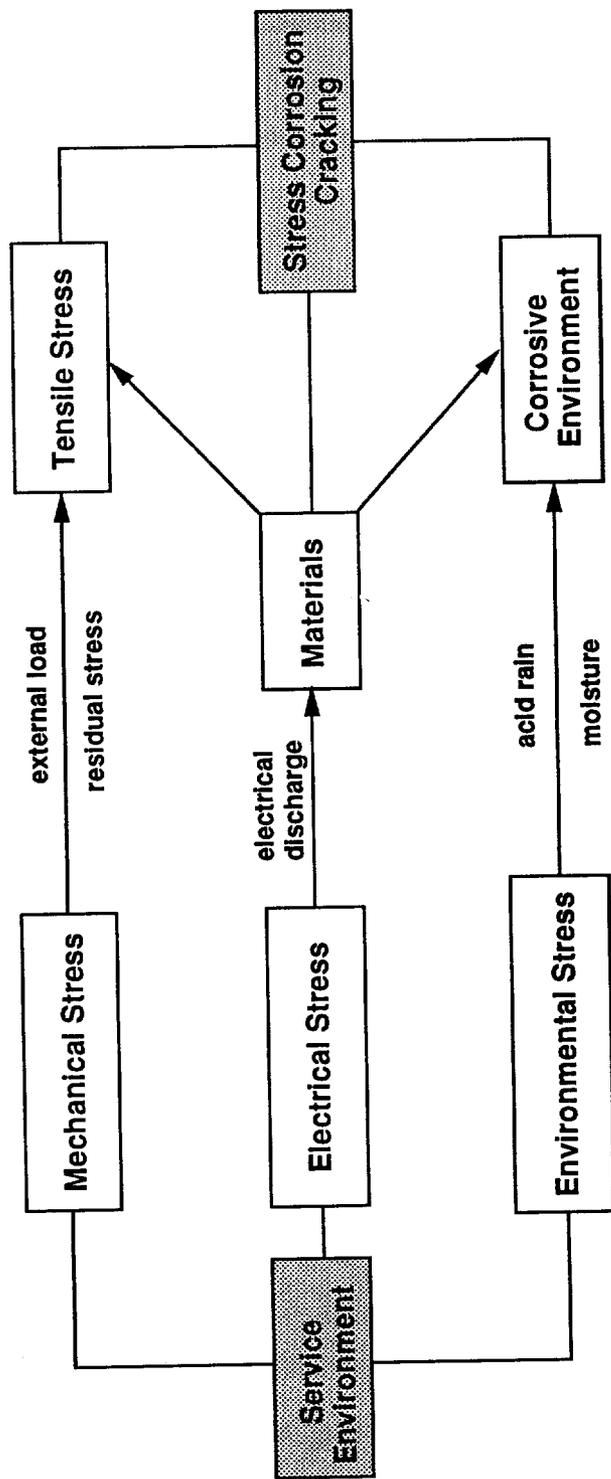
Figure 3.2 Complex stress corrosion environments in insulator service.

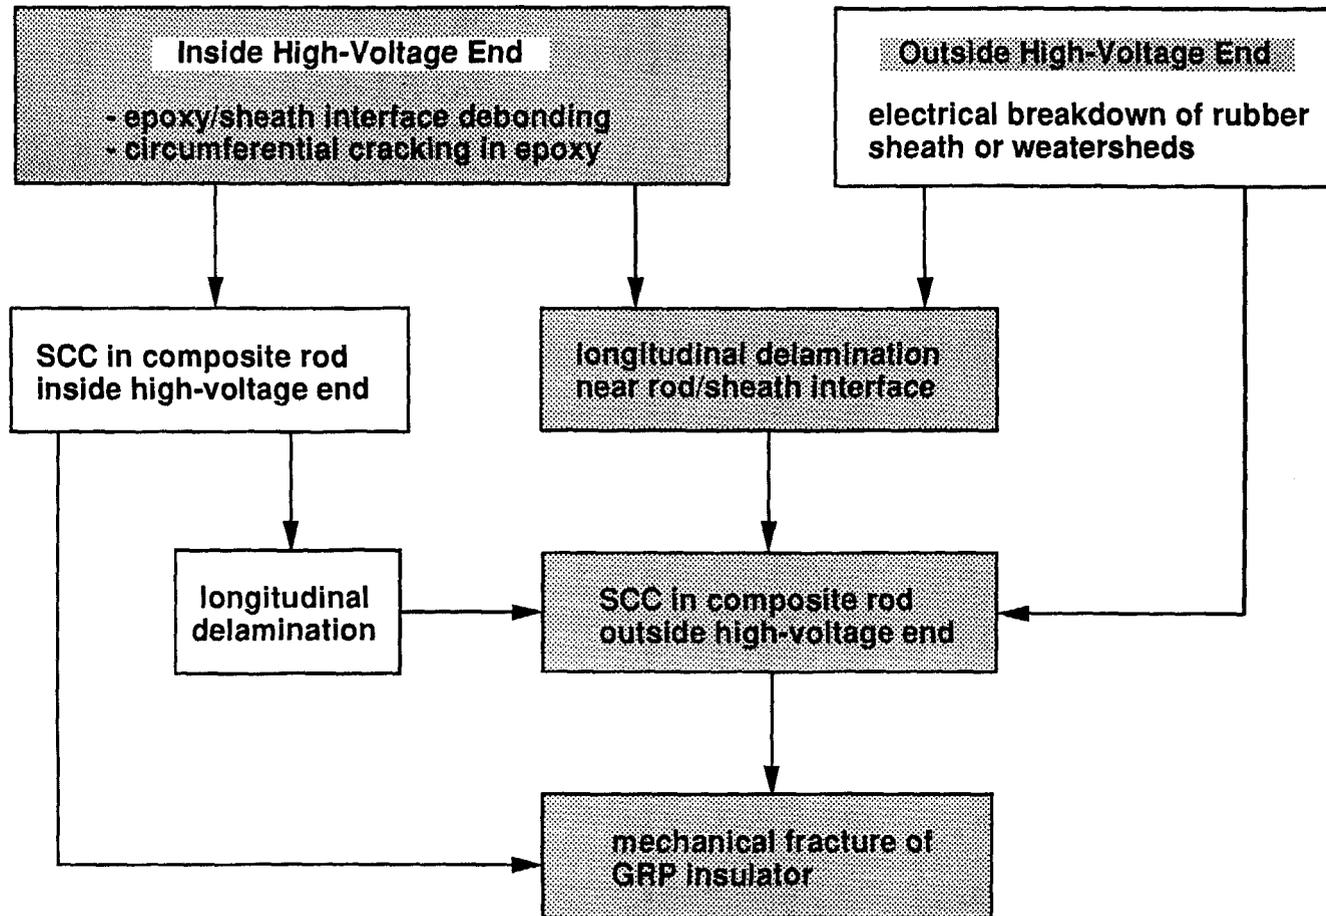
Figure 3.3 Failure model proposed for insulator brittle fracture.

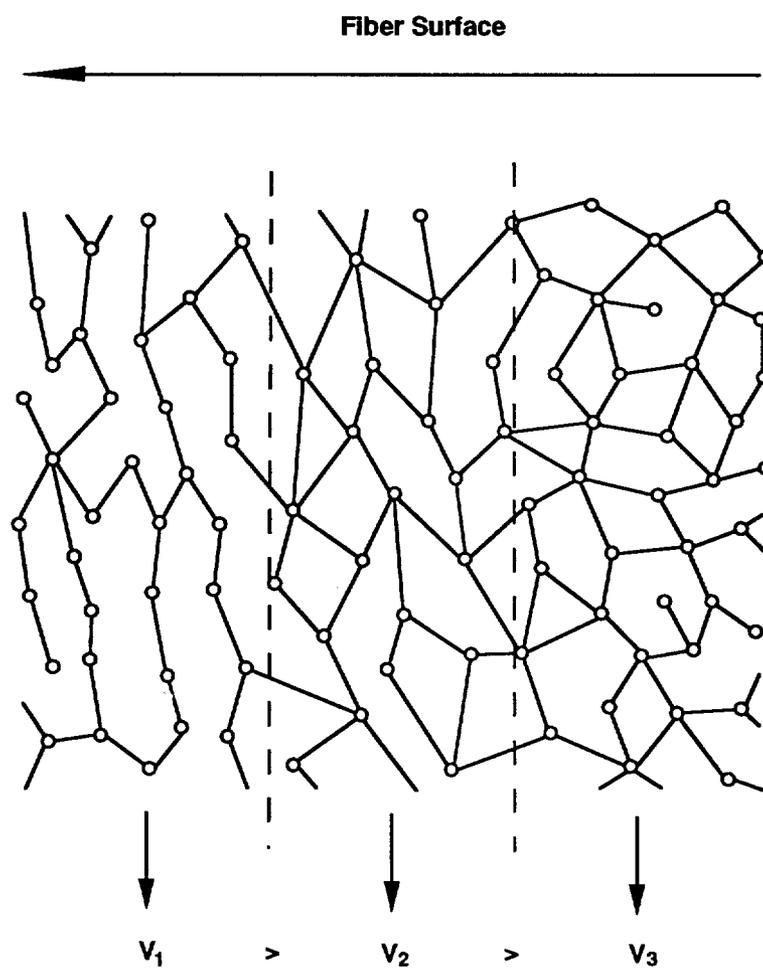
Figure 3.4 Fiber structure change in the radial direction.

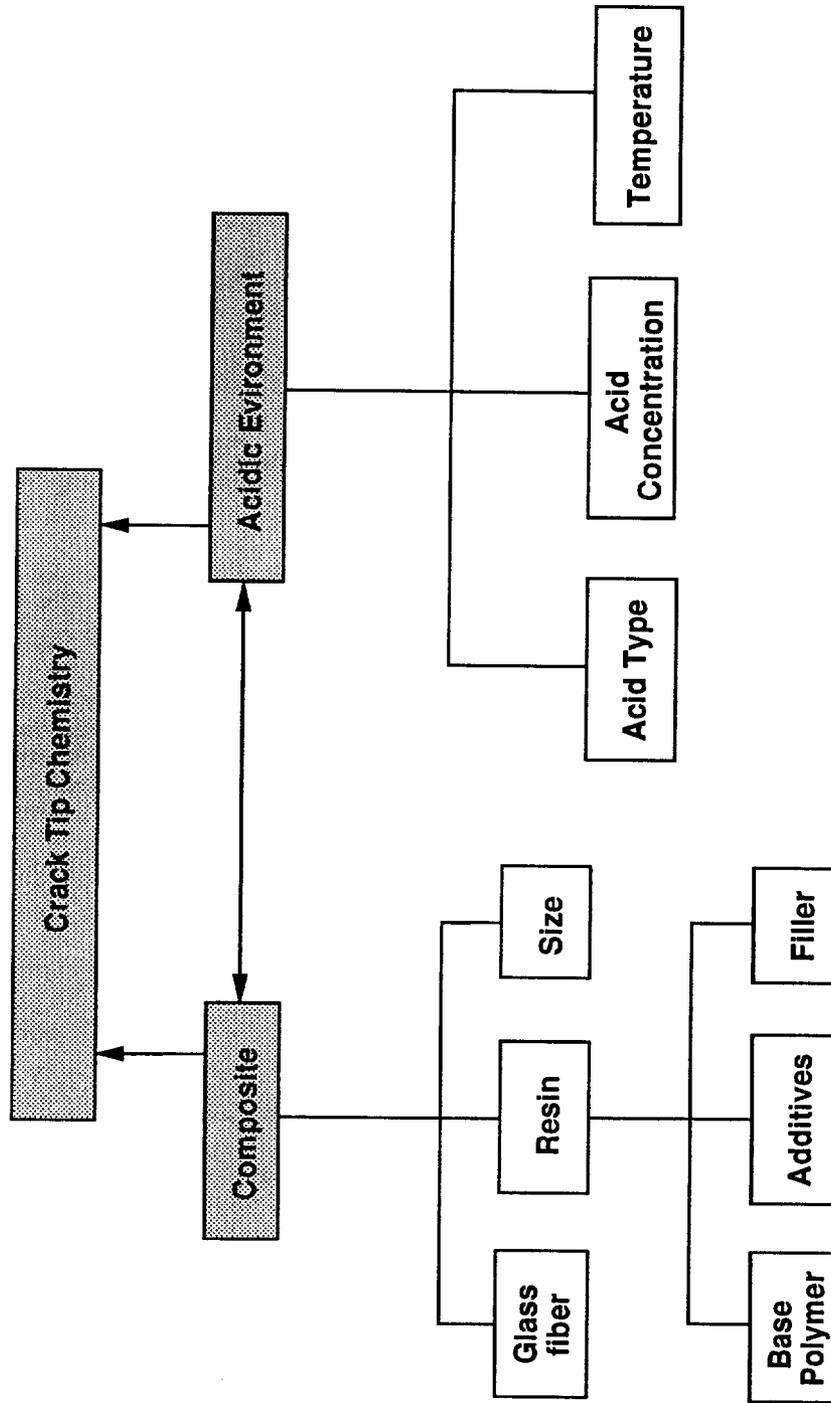
Figure 3.5 Crack tip chemistry in acid corrosion of composites.
