Field Welding of Rails:  
Failure Investigation of Thermite Welds  
and Property Study of Electroslag Welds

Lisa Marie Cobb  
B.Sc., Clarkson University  
Potsdam, NY, 1987

Master of Science  
in  
Materials Science

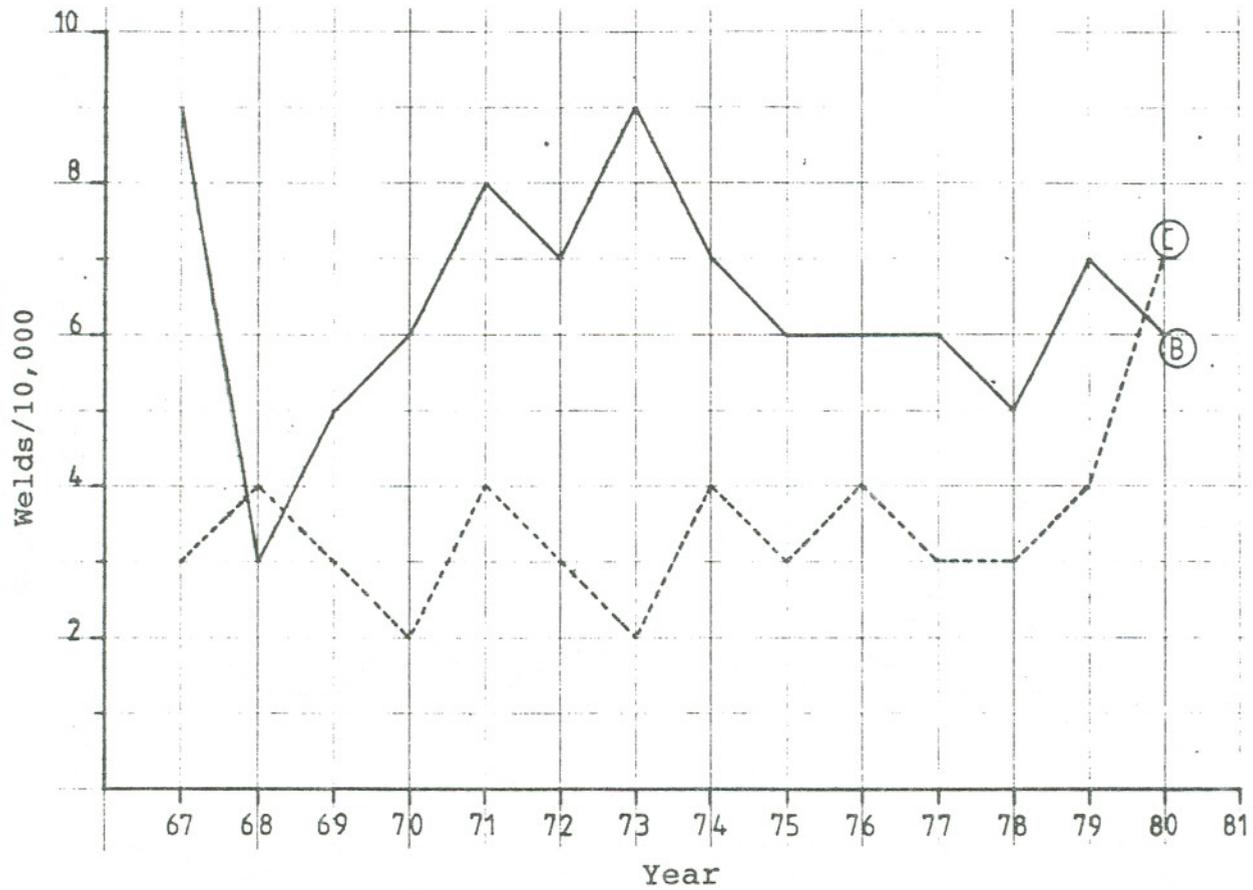
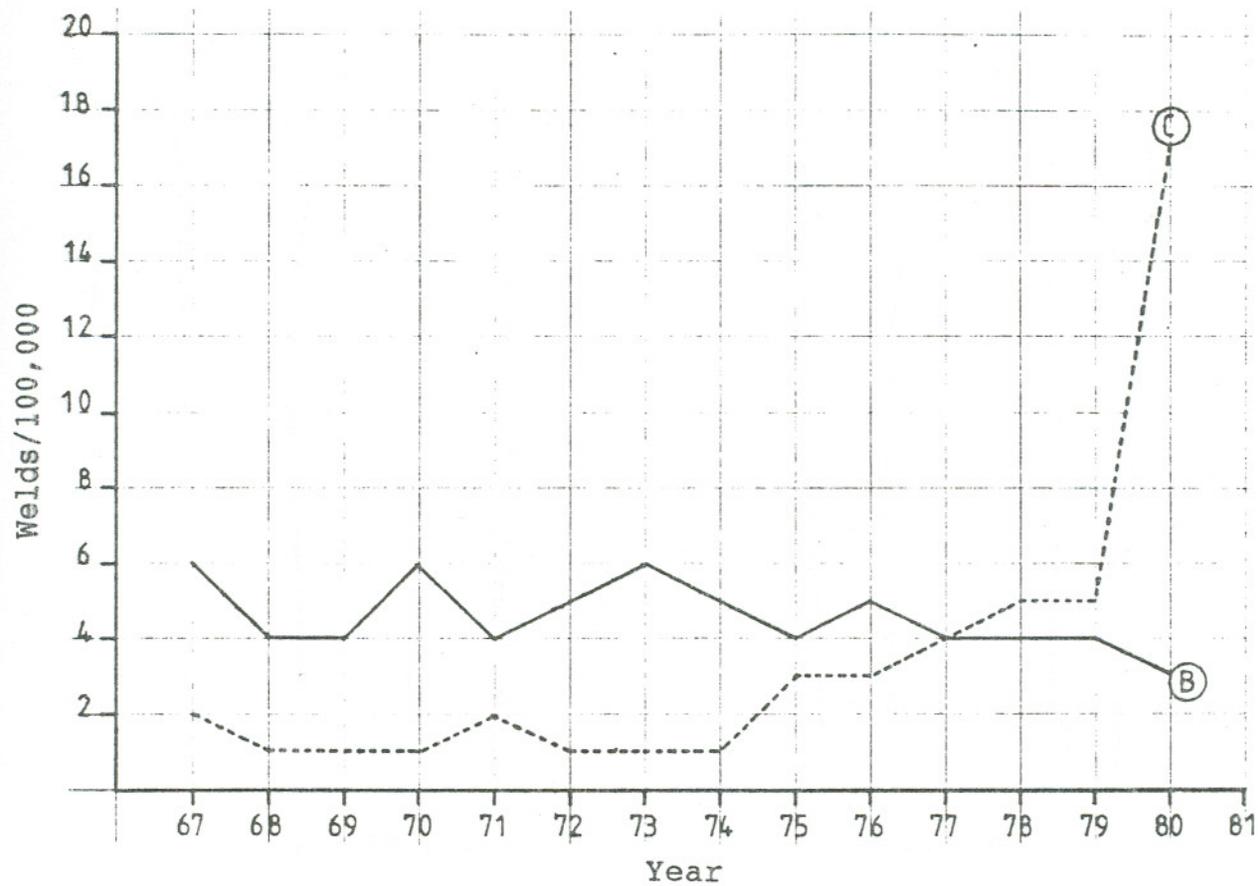
British Rail statistics [22] show that thermite welds fail approximately 10 times more often than EFB's, as seen in Figures 7a and 7b. The BR analysis did not, however, take into account the age of the failed welds, so they may not be directly compared to the U.S. data. They do show, however, that thermite weld failure rates are significantly higher than factory weld failure rates in Britain as well. The peak in the EFB curve in 1980 was attributed to chiseling the weld upset, a practice that was discontinued when automatic weld trimmers were introduced.

Figure 7a. British Rail Weld Failure Statistics  
for Thermite Welds [22]

Figure 7b. British Rail Weld Failure Statistics for Flash Welds [22]

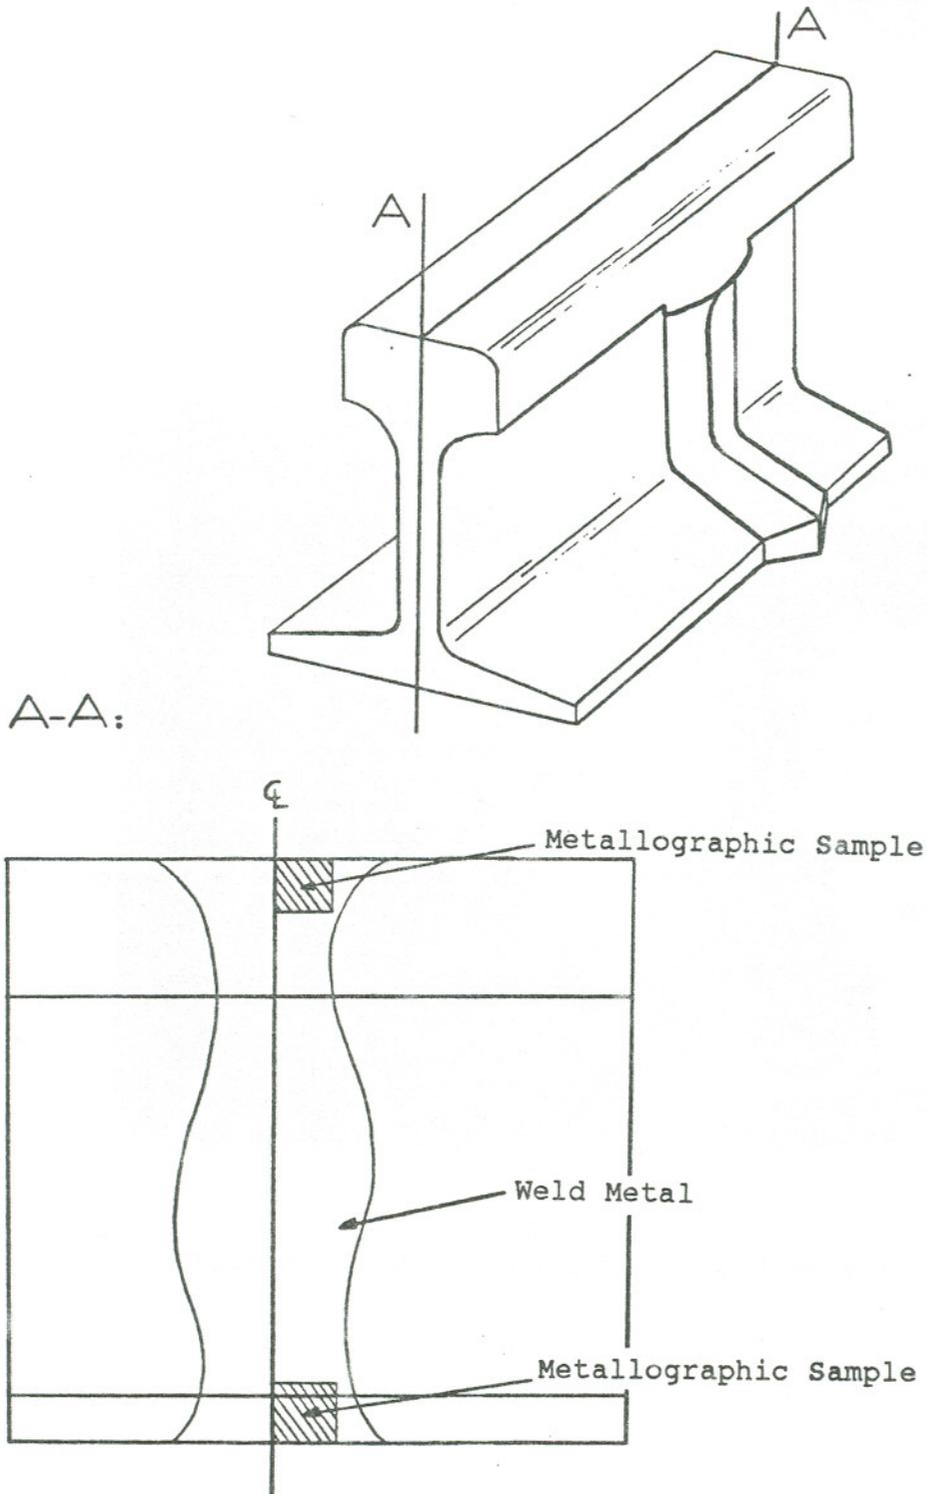
Figure 9. Thermite Weld Metallographic Sample Locations

The thermite welds examined were provided by Amtrak via the Federal Railway Administration (FRA). The information received on the six thermite welds is given in Table II. Three of the welds passed ultrasonic evaluation and three failed. After visual inspection, all six welds were band-sawed down the vertical longitudinal axis. The shape of the heat-affected zones were examined by etching sections with 10% nital (10 mL nitric acid in 100 mL ethanol) and tracing the resulting outline, as shown in Figures 8a-8c. The longitudinal section was then cut in half, transverse to the rail axis and sections were taken in the weld zone at the head and foot of the rail for metallographic examination, Figure 9.

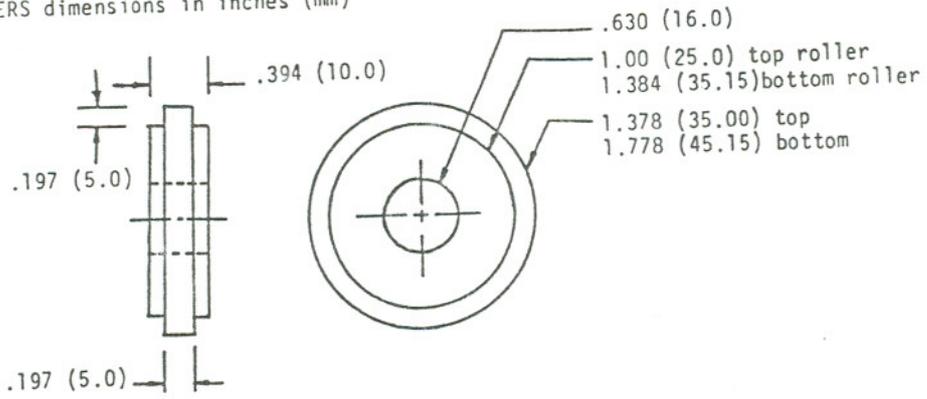
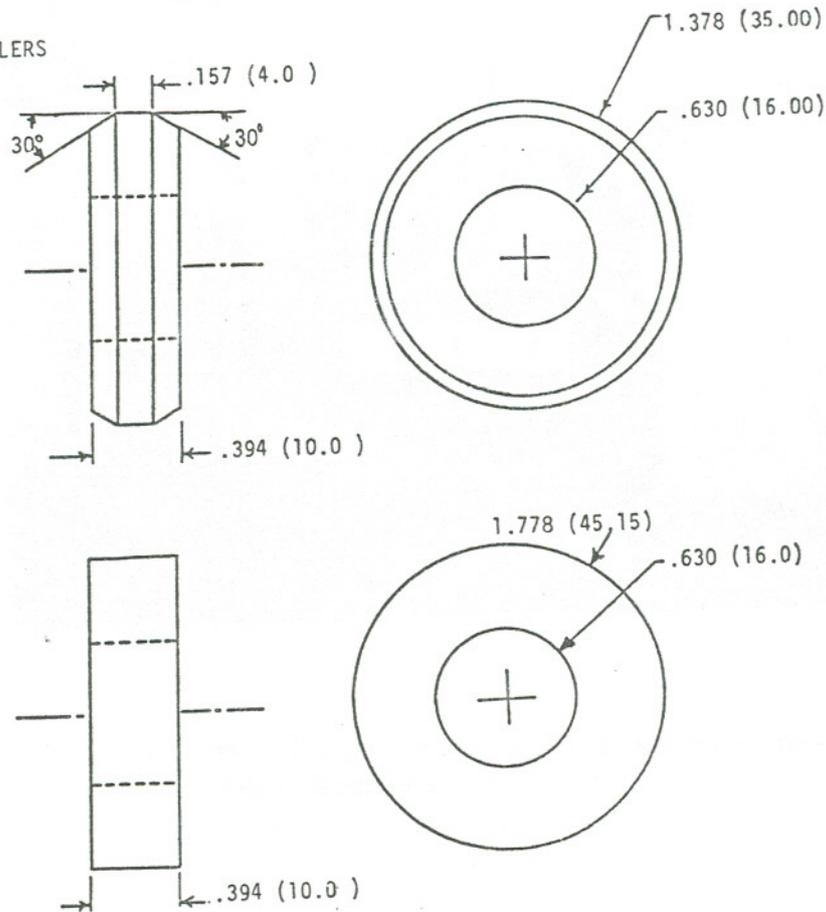
Figure 17. Machine Drawings of Amsler Rollers

Special care was taken in the machining of all specimens to ensure proper orientation. Standard one inch gage length, 1/4"-inch diameter tensile bars and standard sized CVN specimens were machined. To obtain weld metal properties, the failure of the tensile bars had to occur in the weld metal. This was achieved by polishing the bars to an hour-glass shape four- to six-thousandths thinner in the center of the gage length. The Charpy V-notches were broached into the specimens so that the notch ran along the weld centerline, and the crack was driven in the direction of grain growth, as shown in Figure 16. It has been found that driving the impact fracture parallel to the growth direction of the grains in the electroslag weld metal gives the most conservative test results [14]. Rollers for wear and RCF tests were machined as shown in Figure 17.

WEAR ROLLERS dimensions in inches (mm)

RCF ROLLERS

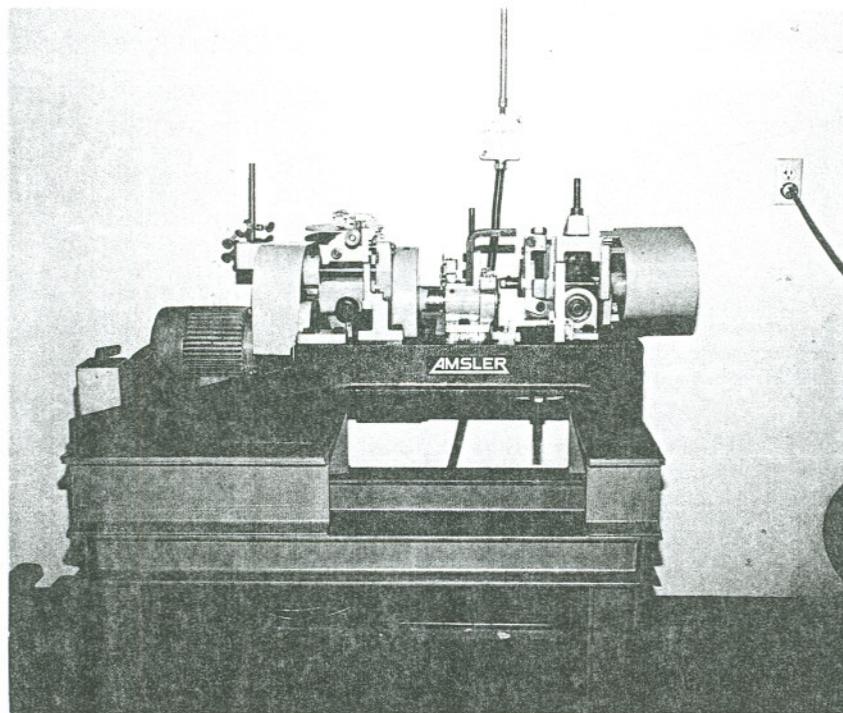
Figure 18. The Amsler Twin-Disk Rolling Contact  
Test Machine

Wear and rolling contact fatigue (RCF) tests were performed on an Amsler twin roller machine, Figure 18, employing specimen geometries shown in Figure 17. Wear tests were performed at contact pressures of 1220, 900, 700 and 500 N/sq.mm with a 35% slide/roll ratio. The latter represents the differences in velocities of the two rollers and was determined from the following equation [33]:

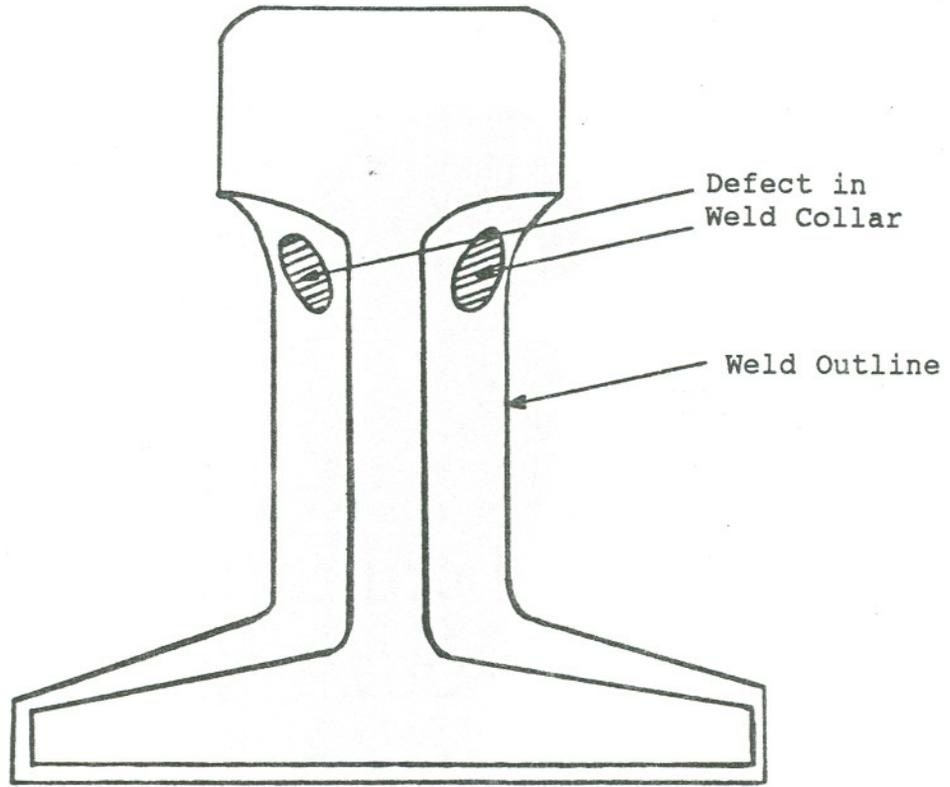
Figure 22. Locations of Defects in Thermite Weld TW-2

Complete information on the thermite welds received can be found in Table II. Three welds, TW-1, TW-2, and TW-6, were judged defective by Sperry Rail Service. All of the thermite welds were in track for some period of time; the time between installation, inspection and removal from track is unknown. Only weld TW-6 had visual defects, three holes approximately 1/4" in diameter on the rail running surface, and was presumably removed immediately after manufacture. All of the welds had a coating about 1/8" to 1/4" inch thick of refractory material from the thermite molds on the web area, which obscured possible defects, Figure 20. Of the three rejected welds, defects were found in welds TW-2 and TW-6 by sectioning. Weld TW-6, Figure 21, was found to have large voids due to shrinkage or gas porosity (approximately 1/4" by 1/2" by 1") spaced approximately 1/4" apart and found throughout the weld metal. Weld TW-2 had a 1" by 1/4" by 1/2" defect positioned on the centerline of the weld

toward the outside of the collar area. The orientation of the defect is shown schematically in Figure 22; a photograph of the actual defect is shown in Figure 23.

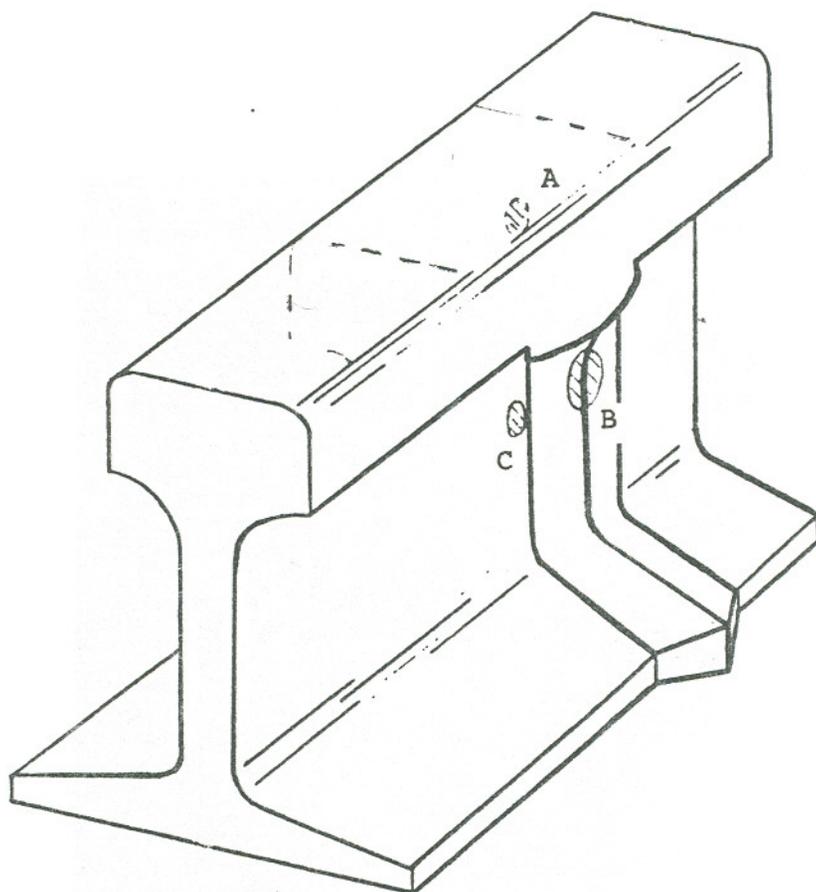
Radiography was carried out first on Weld TW-1 to find the source of the ultrasonic indications. A defect was found on sectioning consisting of a hole approximately 1/8" across in the weld head area, shown as "A" in Figure 24. It was considered to be too small to have been detected ultrasonically. Radiography revealed indications in three other areas, also shown schematically in Figure 24. Defects "B" and "C" were uncovered by sectioning after radiography indicated the location for band-sawing. Defect "B" was found in the collar of the weld, just under the head (similar to the defect found in weld TW-2 on initial sectioning). It was approximately one inch long and 3/8" wide and deep, consisting of a cluster of roughly shaped voids. Defect "C" was found close to the centerline of the weld and was similar in nature to defect "B". It measured approximately one-half inch in diameter. A fourth defect, "D", which was not evident on the radiographs, was found by chance during later sectioning. It was also similar to the defect in weld TW-2 and the defects "C" and "D" of weld TW-1.

D (analogous to B on  
hidden side of weld)

Figure 24. Locations of Defects in Thermite Weld TW-1

accepted and rejected welds. Weld TW-6 was not extensively sectioned or radiographed since it was obviously defective. All of the welds exhibited the defect initially found in weld TW-2, and later in weld TW-1 (defect "B") in the collar. It typically appeared as a cluster of voids, 1/8" to 1/4" wide and ranging in length from 1/2" to 3/4". Dendrites were observed in the voids when examined in the scanning electron microscope. Figures 25 through 29 show the dendrites in these voids and clearly illustrate that all are of the same type. This defect shall be referred to as a "collar defect", since it appears in the collar area of the welds. Collar defects were found in welds TW-1, TW-2, TW-3, TW-4 and TW-5.

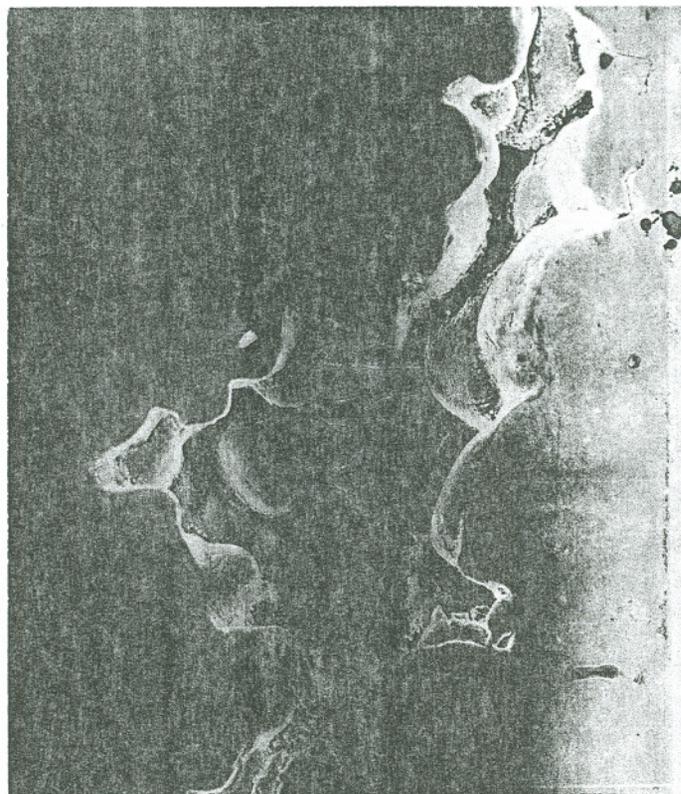
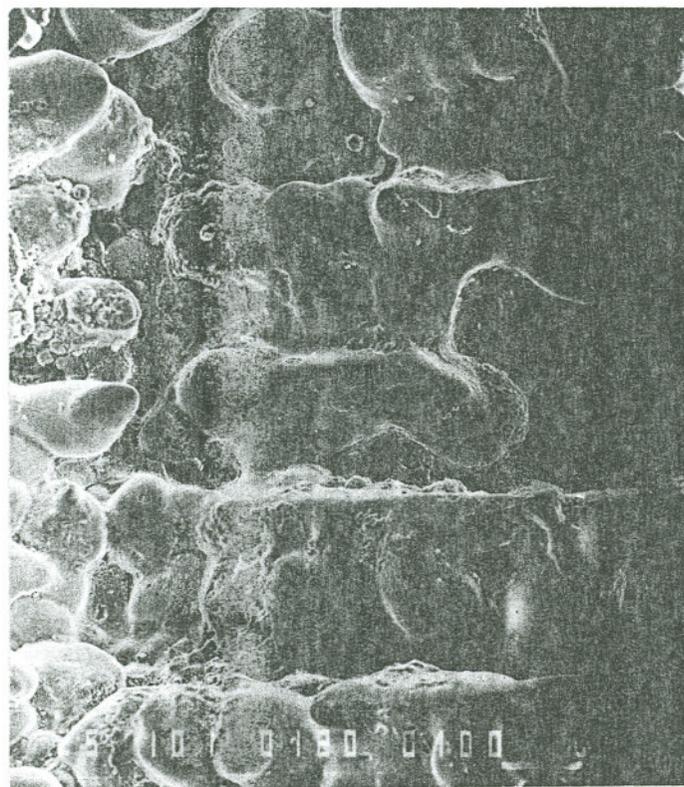
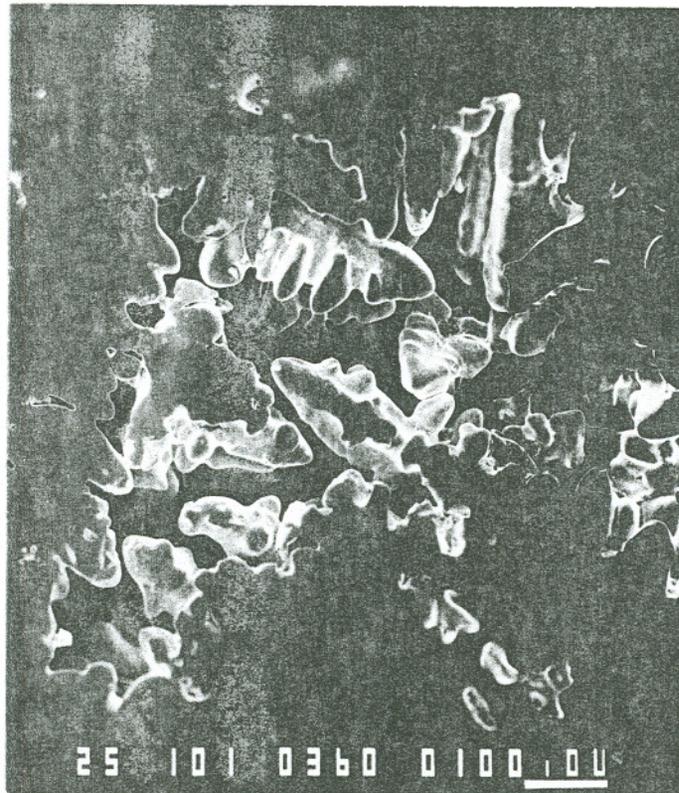
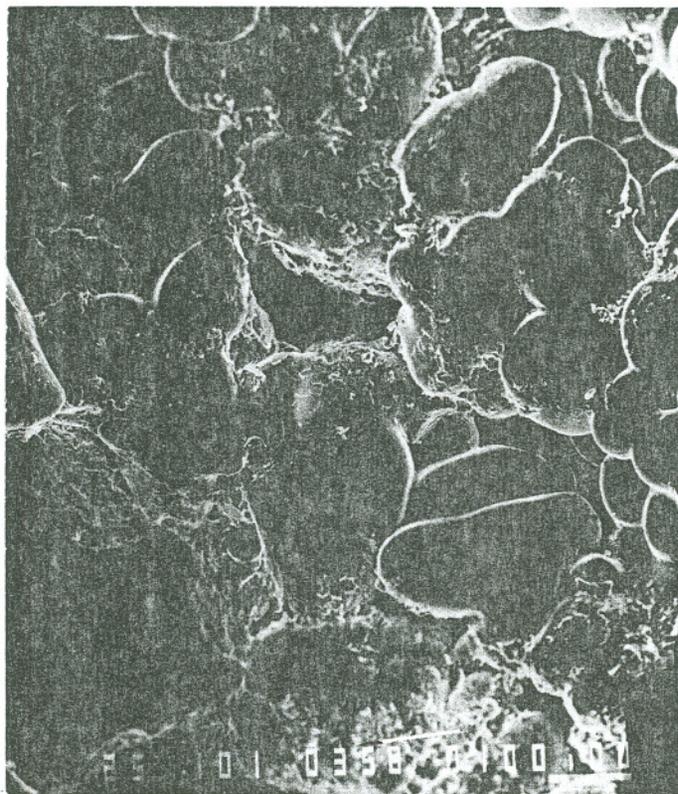
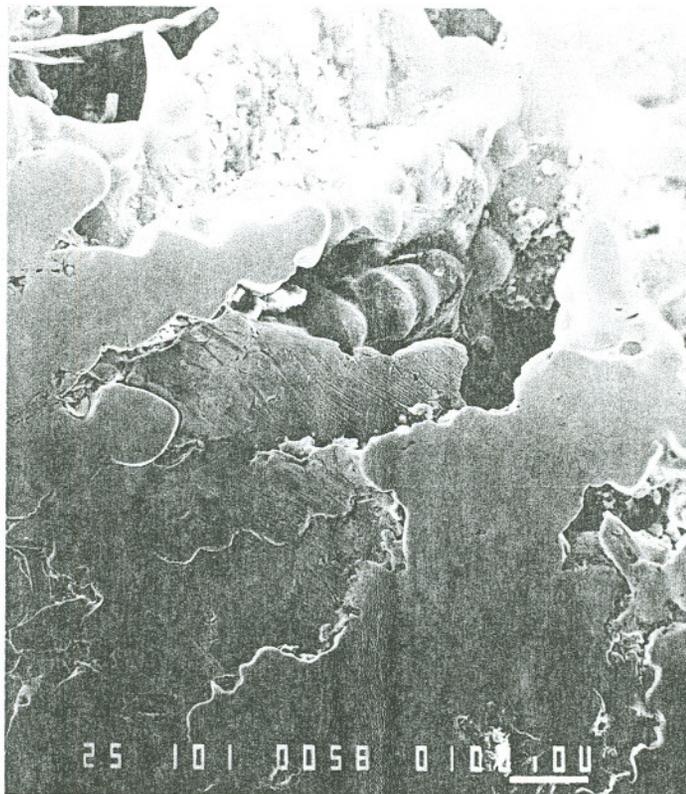
Figure 25. Dendrites in Collar Defect of  
Thermite Weld TW-1 (220X)

Figure 26. Dendrites in Collar Defect of  
Thermite Weld TW-2 (100X)

Figure 27. Dendrites in Collar Defect of Thermite Weld TW-3 (100X)

Figure 28. Dendrites in Collar Defect of Thermite Weld TW-4 (100X)

Figure 29. Dendrites in Collar Defect of  
Thermite Weld TW-5 (100X)

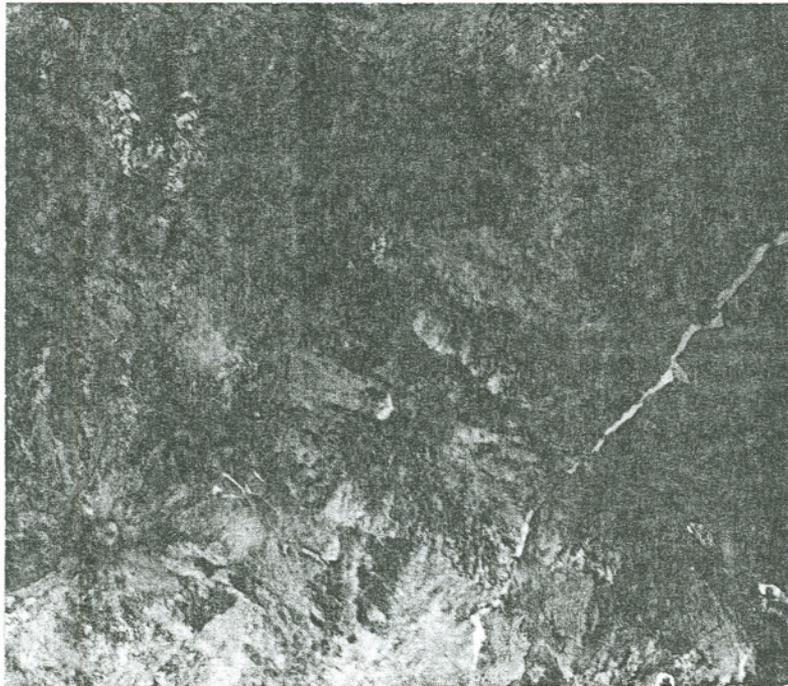
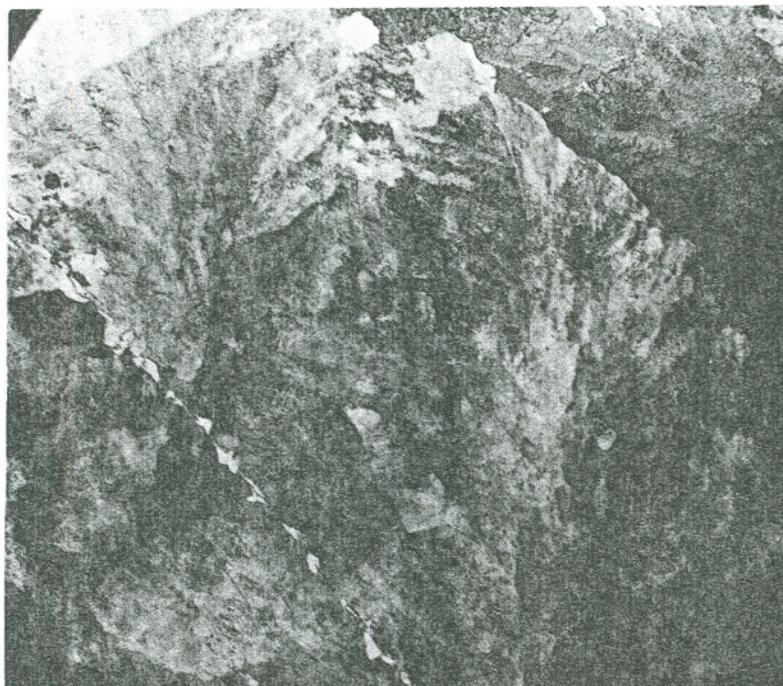
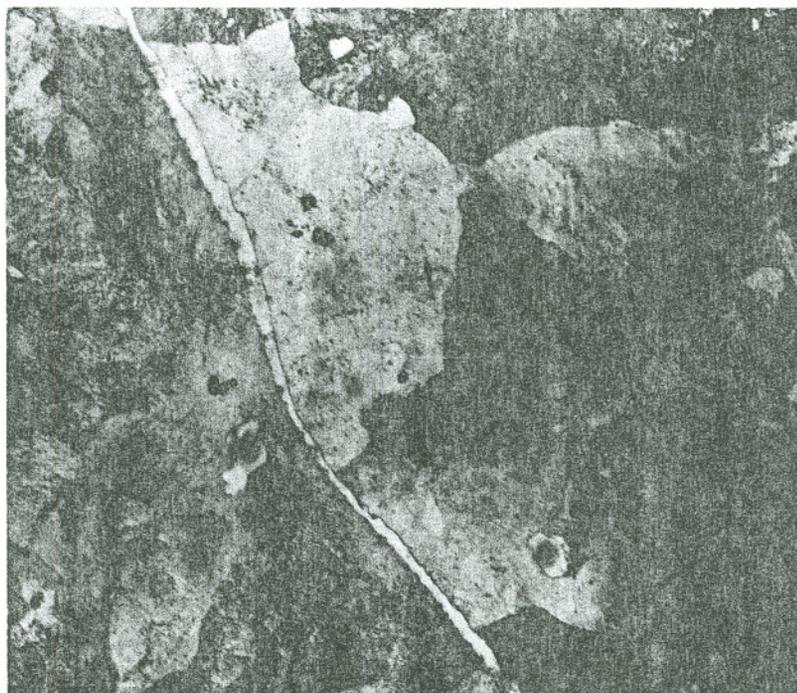
Typical microstructures of thermite welds are shown in Figures 30 through 35. All thermite weld microstructures observed were nearly fully pearlitic with a small amount of proeutectoid ferrite in the prior austenite grain boundaries and around inclusions. The inclusions in the weld metal were spherical. The inclusion volume fraction measurements of the thermite welds are shown in Table V. The lowest value obtained for thermite weld inclusion volume fraction percentage was .11 +/- .03 (%), while the highest was .21 +/- .07 (%). When the 95% confidence limits are applied to all of the data, a ranking of the specimens on the basis of inclusion levels could not be made.

Figure 30. Typical Micrograph of  
Thermite Weld TW-1 (400X)

Figure 31. Typical Micrograph of  
Thermite Weld TW-2 (400)

Figure 32. Typical Micrograph of  
Thermite Weld TW-3 (400X)

Figure 33. Typical Micrograph of  
Thermite Weld TW-4 (400X)

Figure 34. Typical Micrograph of  
of Thermite Weld TW-5 (400X)

Figure 35. Typical Micrograph of  
Thermite Weld TW-6 (400X)

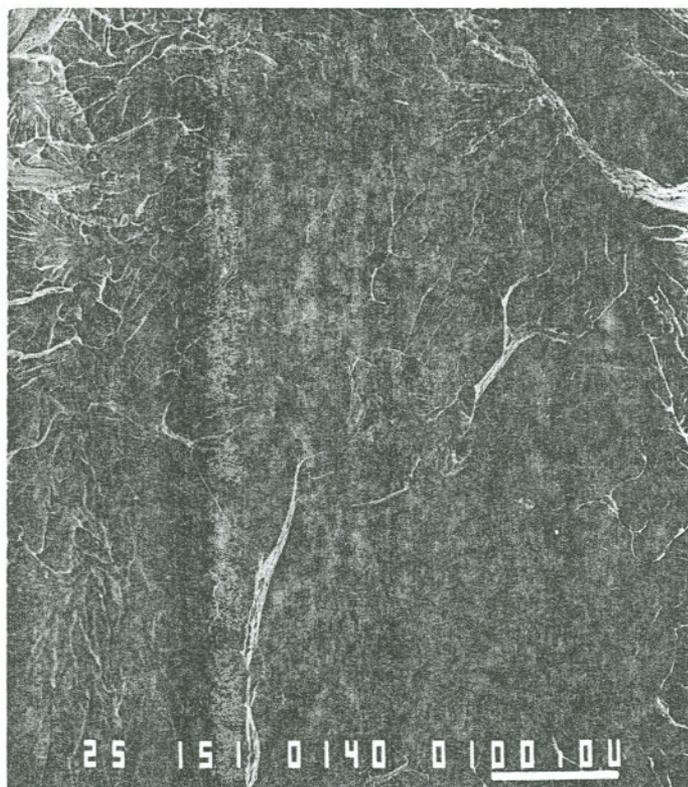
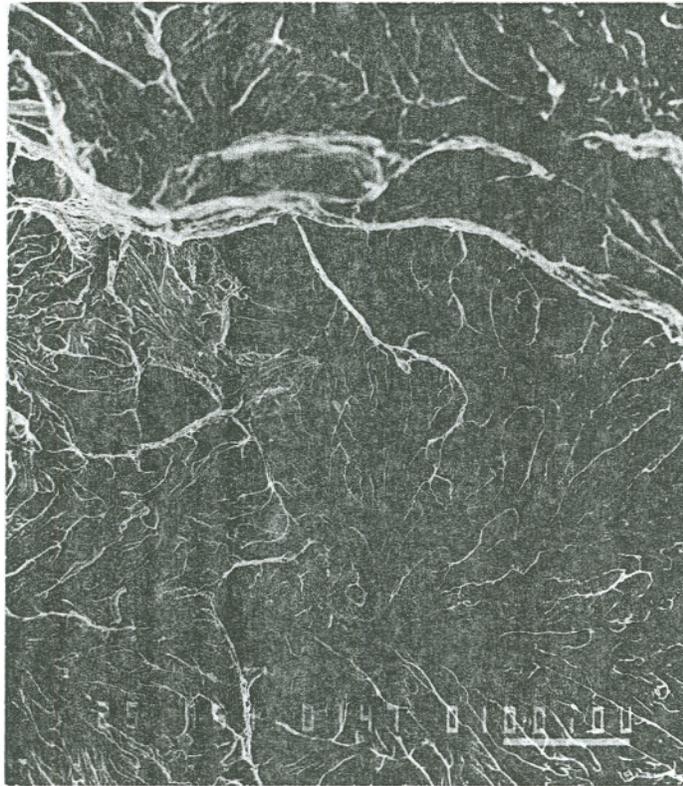
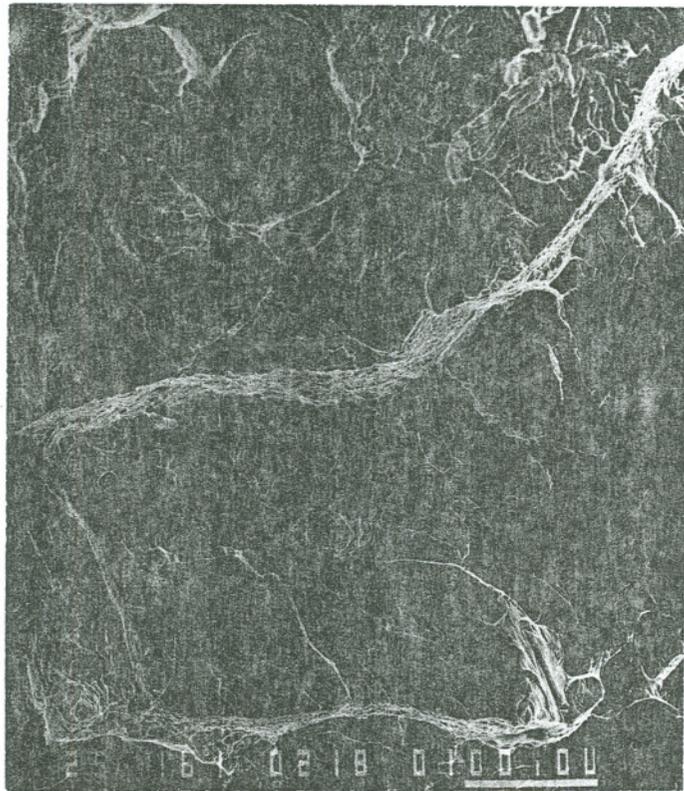
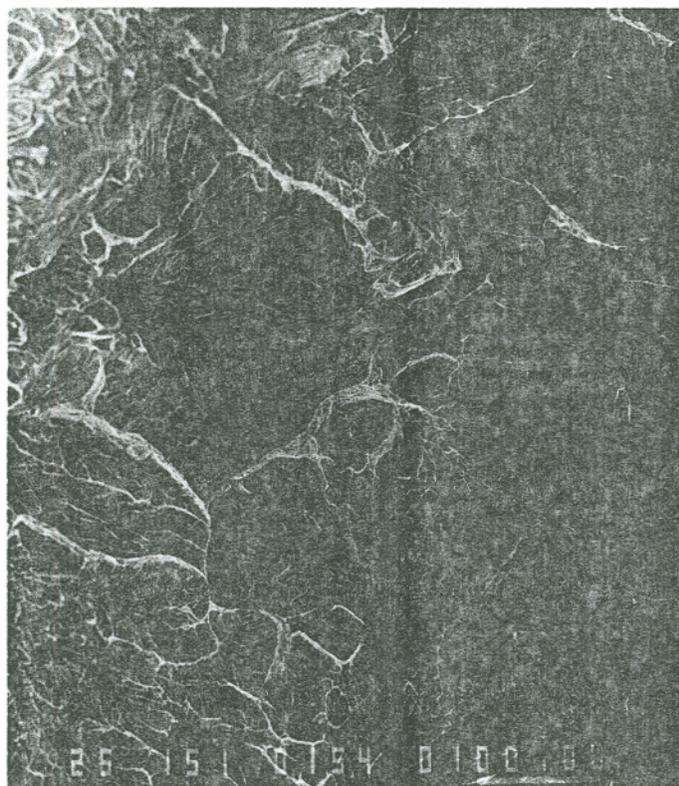
The CVN dial energies for electroslag weld specimens are shown in Table VIII. Dial energies ranged from 1.5 to 3.5 ft-lb. Scanning electron microscopy of the broken specimens revealed brittle cleavage fracture with a small amount of ductile dimple fracture along grain boundaries, as shown in Figures 36 to 39. Some possible fracture initiation sites were found at inclusions, as seen in Figure 40. Energy Dispersive X-Ray analysis was used to determine the composition of these inclusions. Traces of copper, aluminum, and silicon were found, but manganese and sulphur yielded strong peaks relative to the others, Figure 41. It was concluded that at least some of the inclusions were

Figure 36. Electroslag Rail Weld ES-1  
Charpy Fracture Surface (150X)

Figure 37. Electroslag Rail Weld ES-2  
Charpy Fracture Surface (150X)

Figure 38. Electroslag Rail Weld ES-4  
Charpy Fracture Surface (160X)

Figure 39. Electroslag Rail Weld ES-5  
Charpy Fracture Surface (150X)

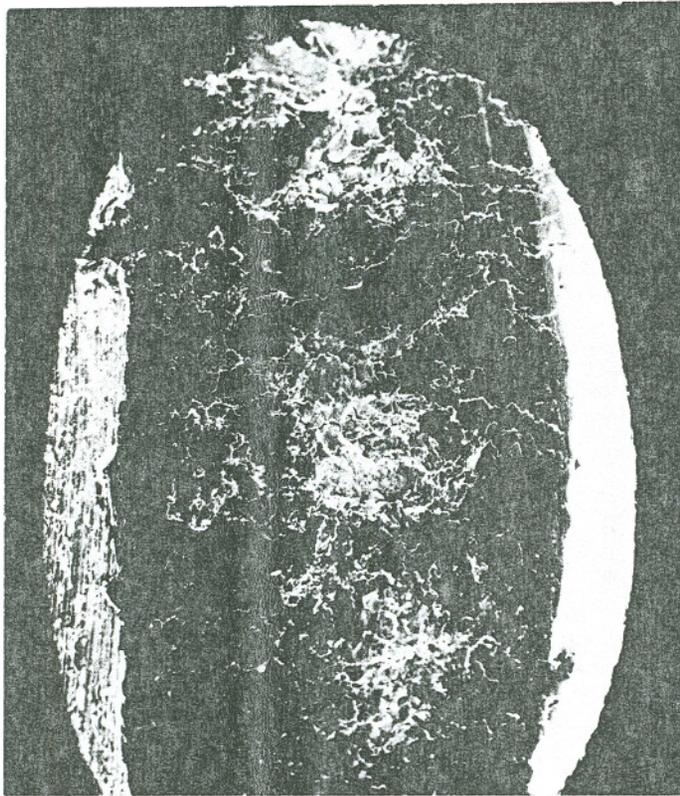
Figure 59. Rolling Contact Fatigue  
Failure (10X)

The RCF test results are shown in Table XIV. Gross failure, typified by angular cracks in the rolling direction, and spalling, is shown in Figure 59. The results are plotted as life
