Thermal Pulp Insult from Laser Debonding Ceramic Brackets

Frederick J.D. Schwendeman

OHSU School of Dentistry
Department of Orthodontics

May 1995

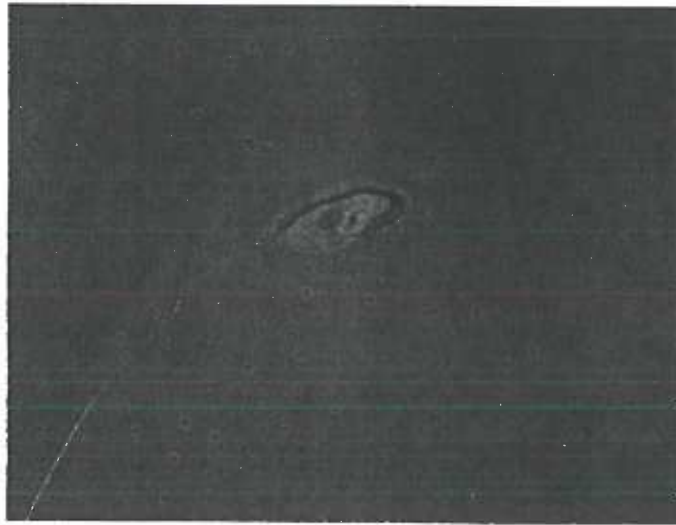
Photograph #10: Enamel damage seen in sample #7 of the laser debonded, Starfire bracket group.

The results of the evaluation of the enamel after debonding are shown in tables XI - XV. Enamel damage was not detected under light microscopy for either one of the mechanical debonding groups or the electrothermal debonding group. However, enamel damage, ranging from mild to severe, was seen in all but two of the laser debonded brackets. In general, the damage was less severe in the teeth bonded with the Allure brackets. This damage was seen as small cracks and chips in the enamel, and also included some pitted areas (see photographs #7 and 8). The teeth bonded with the Starfire brackets were seen to have extensive cracking and cratering of the enamel surface (see photographs #9, 10, and 11). The two teeth that didn't exhibit evidence of enamel damage were in the Allure bracket group (see photograph #12). SEM evaluation of one of the more severely damaged teeth is displayed in photos #13 - 16.

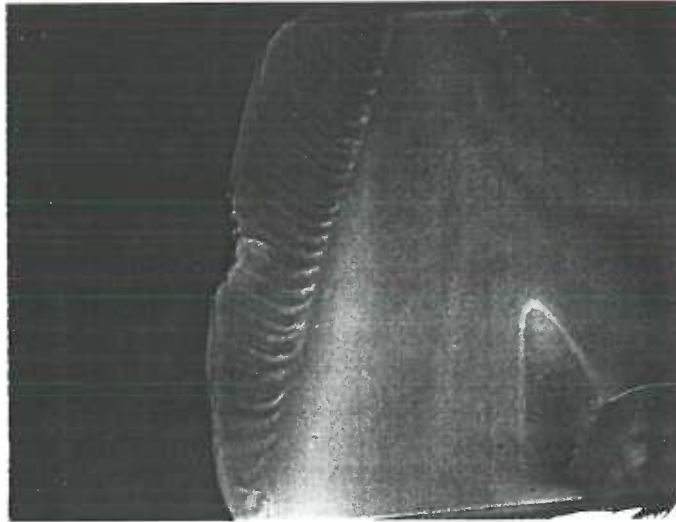
Photograph #11: Enamel damage seen in sample #6 of the laser debonded, Starfire bracket group.
