# **Evaluation of the Load to Failure of Fiber Reinforced Composite Orthodontic Bracket Tie Wings**

A thesis submitted to the Department of Orthodontics, Oregon Health and Sciences University,  
School of Dentistry in partial fulfillment of the requirements for the M.S. degree

March 2006

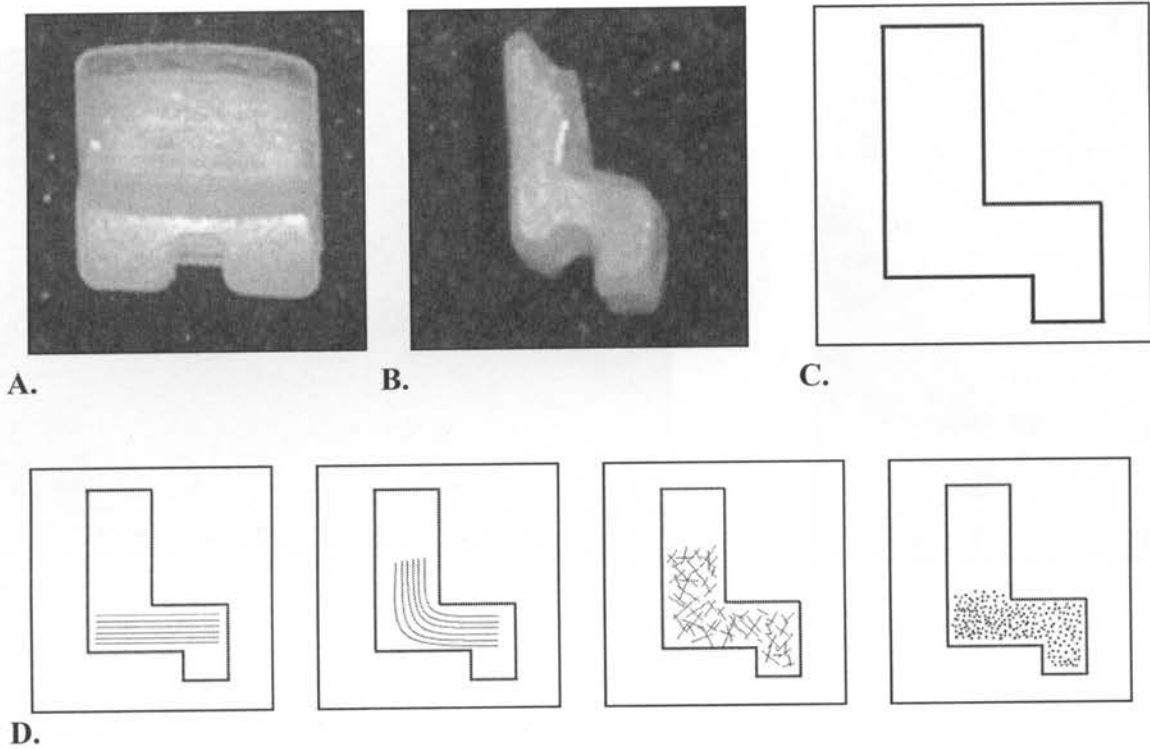
**Figure 2.** Photograph of modified commercial polycrystalline bracket (Mystique- GAC Intl, Islandia, NY). A.) frontal view of the modified bracket, B.) cross-sectional view of the modified bracket, C.) pictogram of the cross-sectional view of the modified bracket, D.) pictograms of the four different patterns of E-glass fibers tested

An upper right central ceramic (polycrystalline) bracket without a metal slot (Mystique-GAC Intl, Islandia, NY) was chosen as the design pattern for the fabrication of the test brackets. The configuration of the bracket was semi-twin with a slot size of .022". The gingival tie wing complexes of the ceramic brackets were removed using a 30 micron coarse high speed diamond bur (Brassler). A 0.012 inch stainless steel wire (Ligature Tie, GAC Intl, Islandia, NY) was placed in the arch wire slot to protect against scratching during tie wing removal (Figure 1). The modified bracket was inspected with 10X magnification (Nikon Microscope Model) to confirm the absence of any surface damage close to the incisal tie wings. A single bracket free of any defect was then selected from a sample of five cut brackets to be used as a model for the fabrication of the prototype brackets. The modified ceramic bracket was placed on a glass slab with the mesh pad down. An impression was made using a clear, transparent vinyl polysiloxane impression material (Memosil-2®). Once the impression material was set (2 minutes), it was cut down to a 1 cm X 1" X 1" pad. A total of ten molds were fabricated. Each mold was inspected using 10X magnification (Nikon Microscope Model). The most accurate impressions of the modified ceramic bracket were used as the negative mold for the fabrication of the prototype brackets.

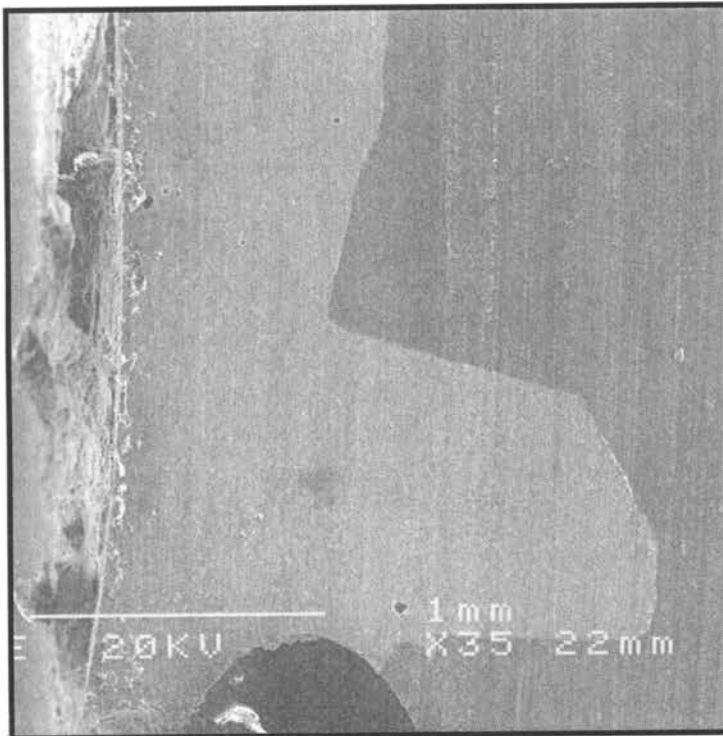
**Figure 6.** Homogenous mixture of particulate (80% strontium) with resin (X35).

All fabricated brackets were constructed without major visible voids or surface flaws. SEM images revealed that: 1) There was a uniform distribution of material within the brackets made from the Z100™ commercial restorative (3M ESPE) composite (Figure 5), 2) The laboratory prepared particulate (80% strontium) filled resin brackets consisted of a homogenous mixture of particulate with resin (Figure 6), and 3) The E-glass fibers were able to be manipulated into various shapes for incorporation within the tie wing complex (Figure 7).

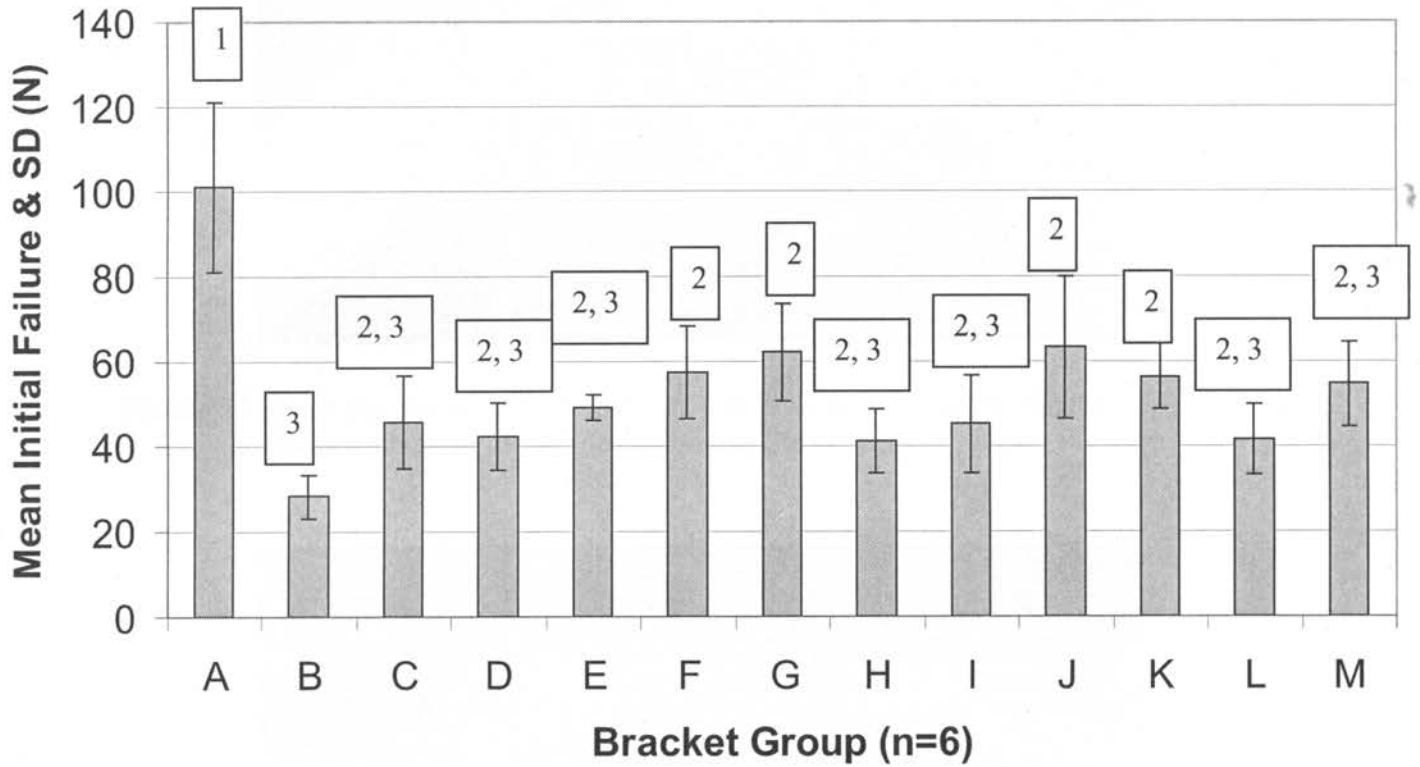
## Mean Initial Failure of the Bracket Tie-Wing

**Figure 10.** Bar Graph of Mean Initial Failure of the Bracket Tie-Wing. Statistical ANOVA with Post-hoc Tukey test at  $p < 0.05$ . Y-bars designate Standard Deviation. The numbers above the Y-bars signify statistical groups. Statistically, the bracket groups with the same number are not significantly different.

All of the samples remained in the UDMA block during the static load testing. None of the samples pulled out of the block or exhibited any movement in the block. The mean initial failure values for each bracket type are listed in Table IV and presented in Figure 10. There was no statistically significant difference between the mean initial failures of the FRC groups at  $p < 0.05$ . The Group A brackets (commercial polycrystalline bracket; Mystique-GAC Intl, Islandia, NY) had the highest mean initial failure value of all the groups tested. The Group B brackets (commercial polycarbonate (filled with 35% alumina) Vogue-GAC Intl, Islandia, NY) had the lowest mean initial failure value of all the groups and was found to be significantly different with Group A, F, G, J, and K. Groups F ( $W_f = 13.75\%$ ) and J ( $W_f = 25.82\%$ ) consisted of straight fibers placed perpendicular to the bracket base extending out into the tie wing. Groups G ( $W_f = 13.75\%$ ) and K ( $W_f = 25.82\%$ ) consisted of curved E-fibers running from the center of the bracket extending out into the tie wing. Only the FRC prototype brackets in the experimental groups H and L (random oriented fibers) had mean load to initial failure values (41.15 N and 41.52 N respectively) that were less than the pure resin control group D (42.26 N).

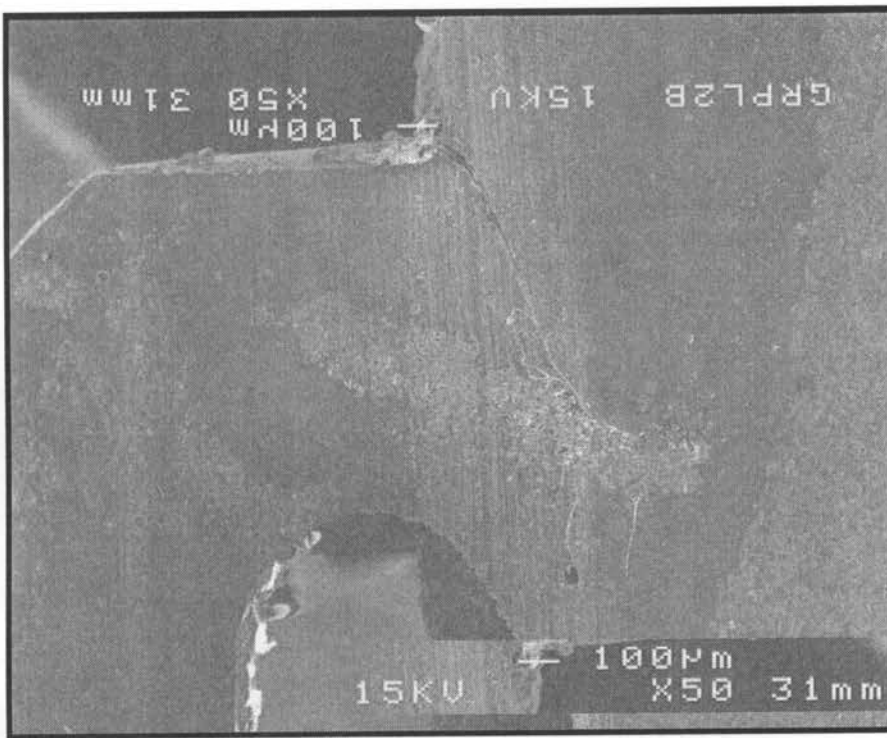
**Figure 11.** Poor placement of E-glass fibers within tie-wing complex; fibers located far from initial site of fracture (X50).

The slightly lower mean initial load to failure values in the FRC prototype brackets (groups H and L) may be due to the fact that the random oriented fibers were not incorporated in the most optimal areas within the tie wing complex (Figure 11). All of the other FRC prototype groups had higher mean load to initial failure values compared to the pure resin control group (D). The E-glass fibers were able to reinforce the polymer matrix increasing the load to initial failure of the tie wing complex. Among the FRC groups, one of the brackets in group J (straight fibers running perpendicular from the bracket base) had the highest load to initial failure value (92.30N) perhaps due to the fibers being located closer to the initial site of fracture.

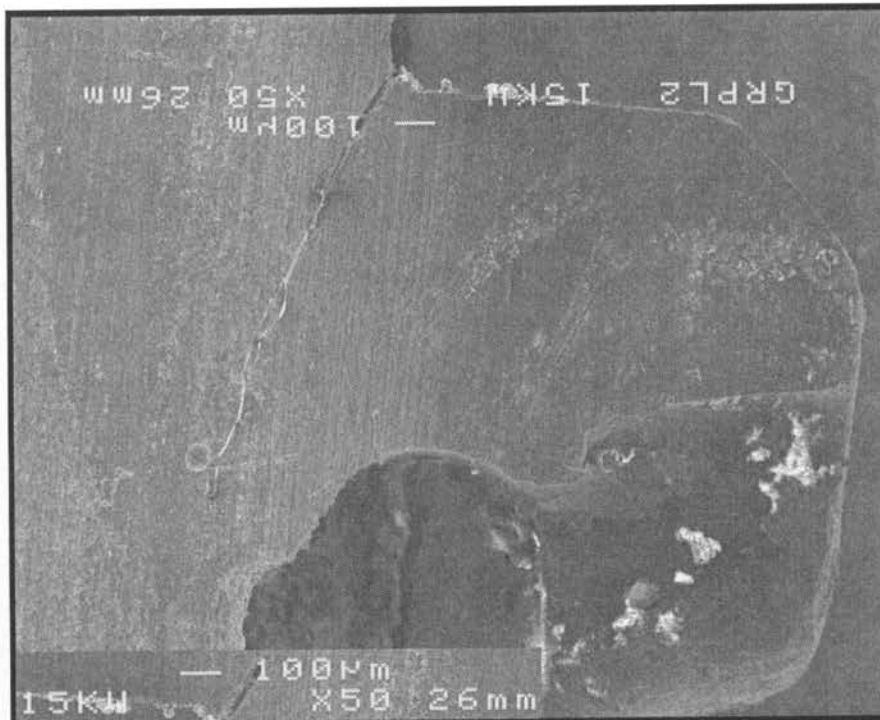
**Figure 12.** Random orientation of E-glass fibers. Di-methacrylate resin-rich areas present (X50).

low weight fraction of fiber within the tie wing complex resulted in areas that were only enriched with resin (i.e., resin zone; Figure 12). The areas of pure resin seemed to be the most at risk for fracture.
