Assessment of Plasma Sprayed Coatings to Modify Surface Friction for Railroad Applications

A dissertation submitted to the faculty of the
OGI School of Science & Engineering
Oregon Health & Science University
in partial fulfillment of the
requirements for the degree
Doctor of Philosophy
in
Materials Science and Engineering

June 2002

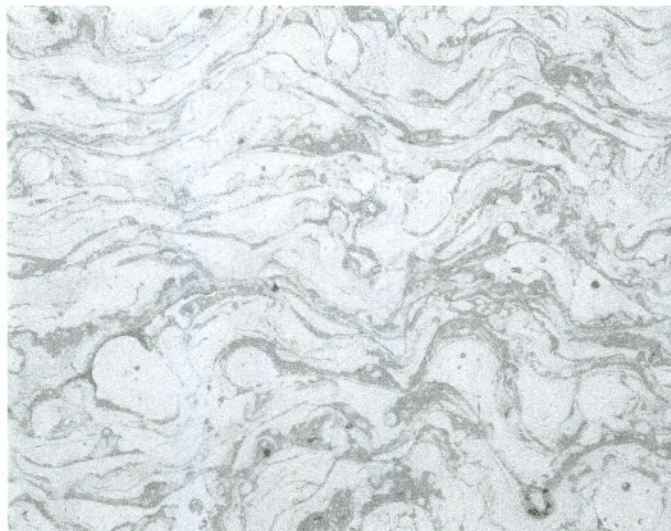
Figure 3.1.1.2. Microstructure of the stainless steel coating sprayed using the parameters optimized by single splat analysis. 400x, optical micrograph.

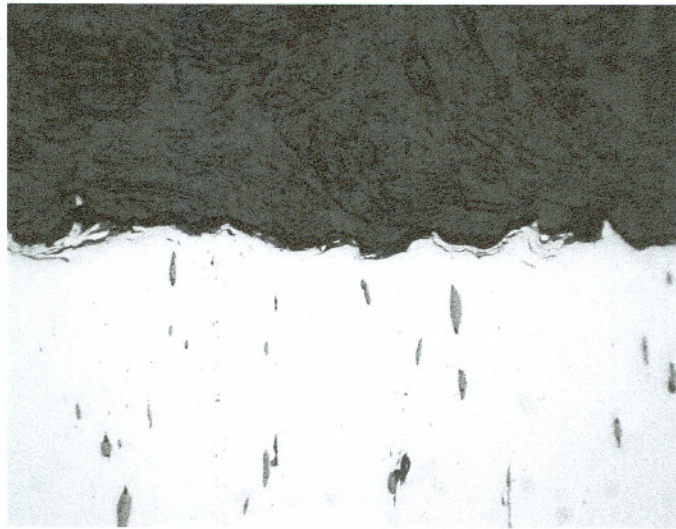
Figure 3.1.3.1. Photomicrographs of tested tensile bars showing adhesive failures occurring at the coating/substrate interface, (a) coating and 3M epoxy on one side of specimen and (b) bare substrate on other side of specimen. 100x, optical micrographs.

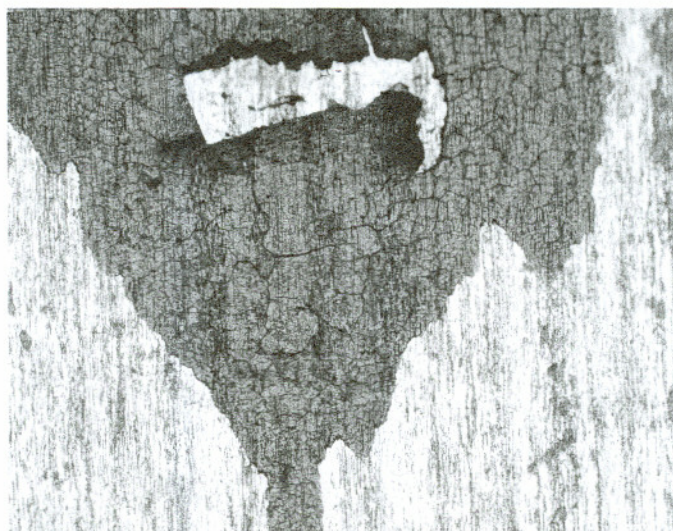
Figure 3.3.1.1. Black oxide film on a stainless steel roller surface.
100x, optical micrograph.

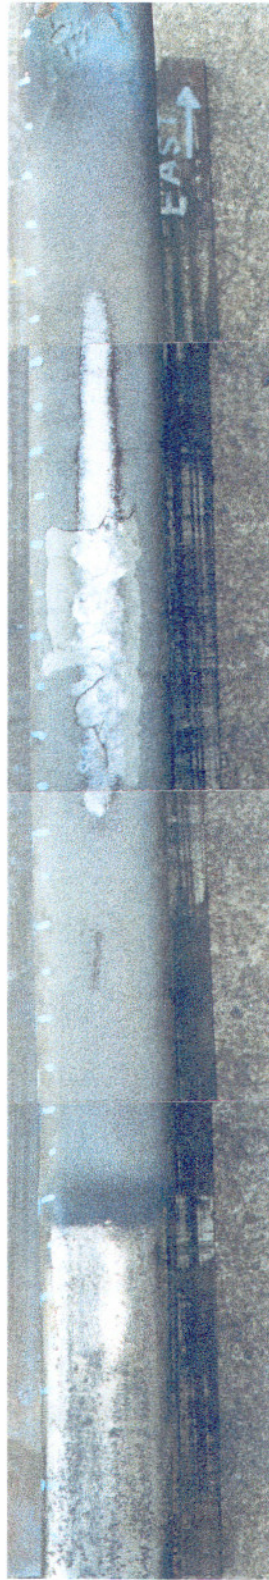
Figure 3.4.1. As-received Rolling Load Specimen 1 (RL1).

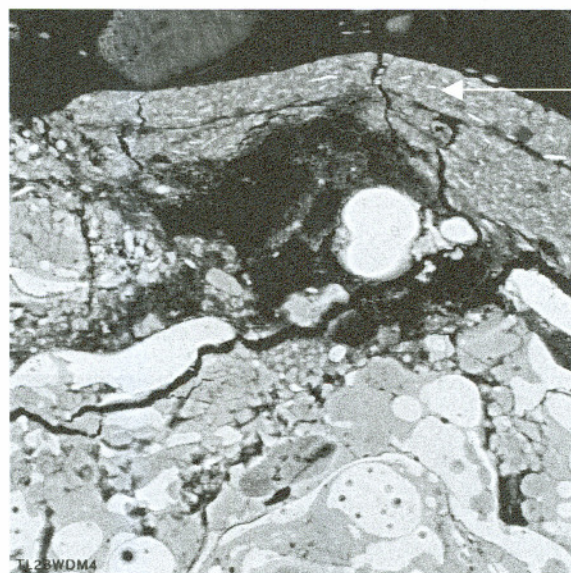
**Wear
product**

Figure 3.4.6.19. Fractured wear surface of TL2 coating. 1000x, backscattered electron image.

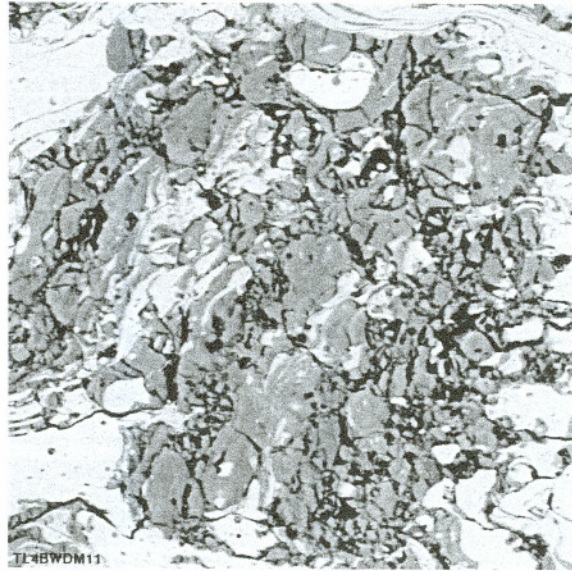
Figure 3.4.8.17. Cracking of oxide rich region in TL4 coating.
1000x, backscattered electron image.

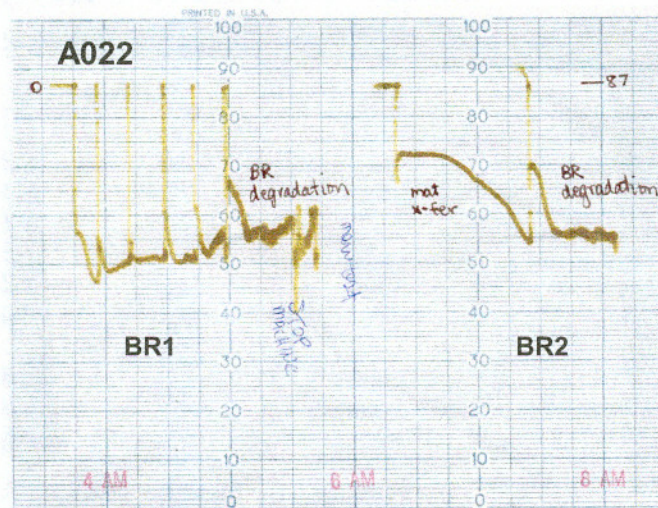
Figure 4.3.1. Amsler test friction trace for plasma sprayed stainless steel, test number A022.
