ROLLING CONTACT FATIGUE BEHAVIOR OF THREE  
EUTECTOID RAIL STEELS

A thesis submitted to the faculty  
of the Oregon Graduate Center  
in partial fulfillment of the  
requirements for the degree  
Master of Science  
in  
Materials Science and Engineering

November, 1987

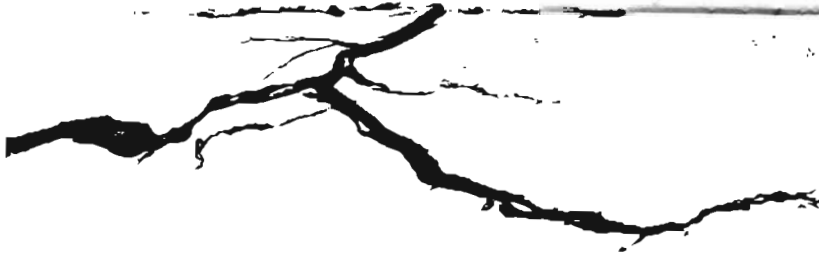
FIGURE 1. CRACK APPEARANCE IN A LONGITUDINAL SECTION OF HH RAIL USED IN SERVICE

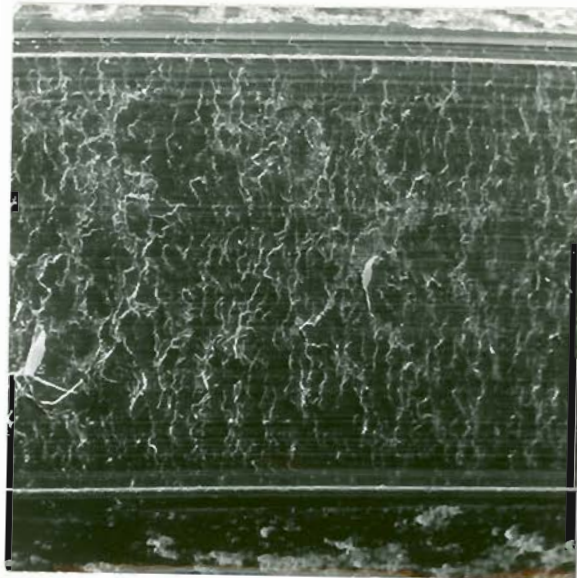
FIGURE 38. SCANNING ELECTRON MICROGRAPHS SHOWING THE SURFACE APPEARANCE OF THE FAILED ROLLER FOR HH RAIL STEEL (a) MAG 15x (b) MAG 150x

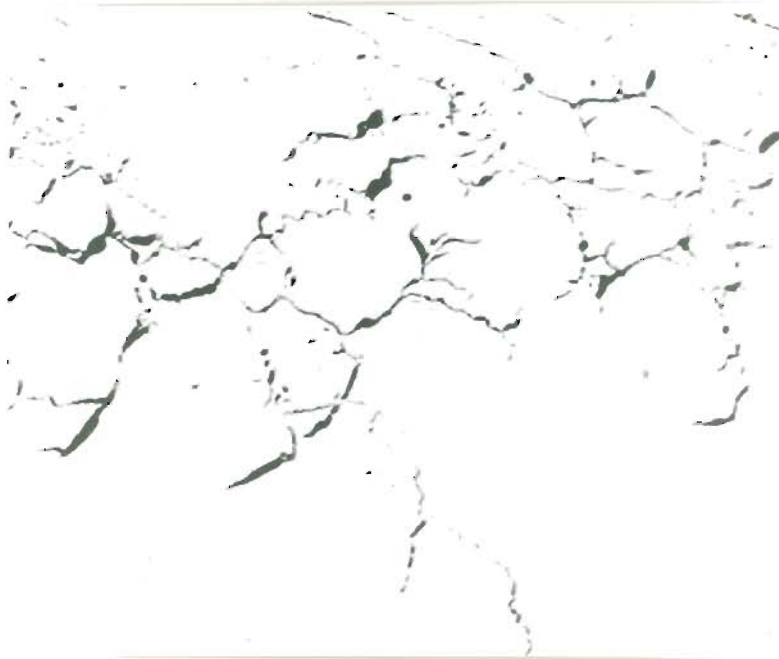
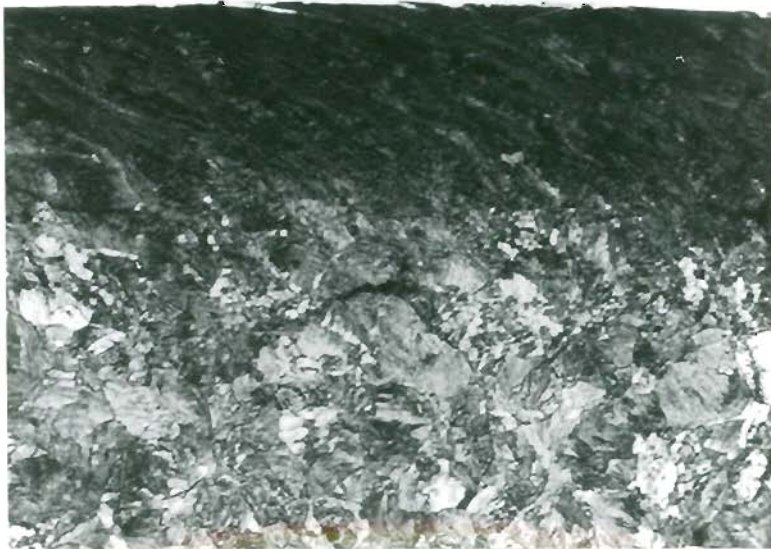
FIGURE 39. OPTICAL MICROGRAPHS SHOWING CRACK APPEARANCE OF THE FAILED ROLLER (c) AND SUBSURFACE PLASTIC FLOW (d) FOR STD RAIL STEEL AT CONTACT PRESSURE 1354 N/mm<sup>2</sup>, TRACTION FORCE FROM RIGHT TO LEFT  
MAGNIFICATION 100X

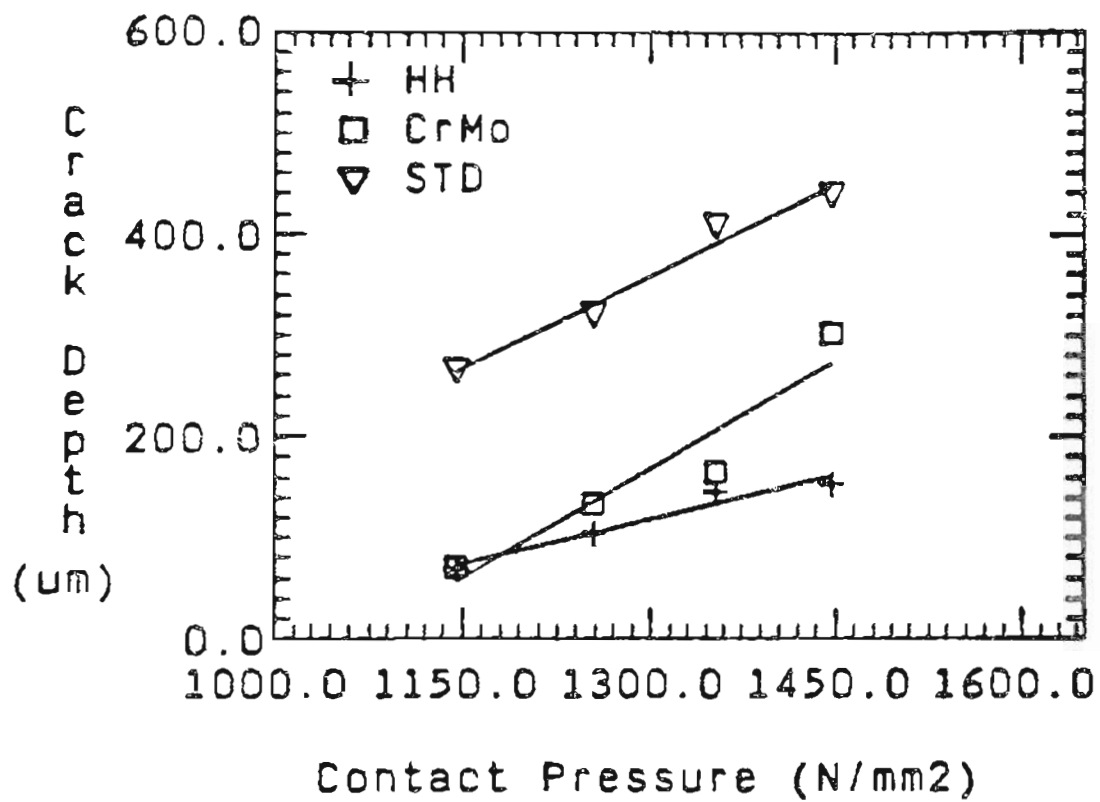
FIGURE 43. EFFECT OF DIFFERENT RAIL STEEL AND CONTACT PRESSURE ON DEPTH OF NETWORK CRACKS

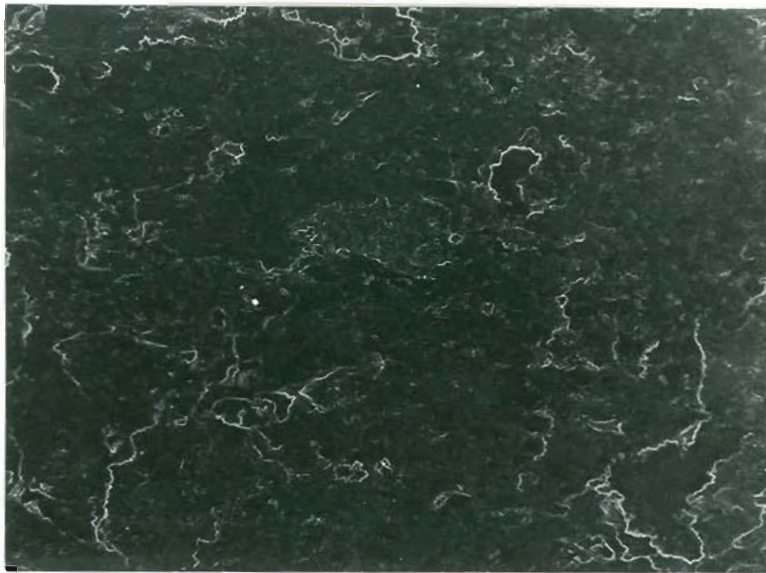
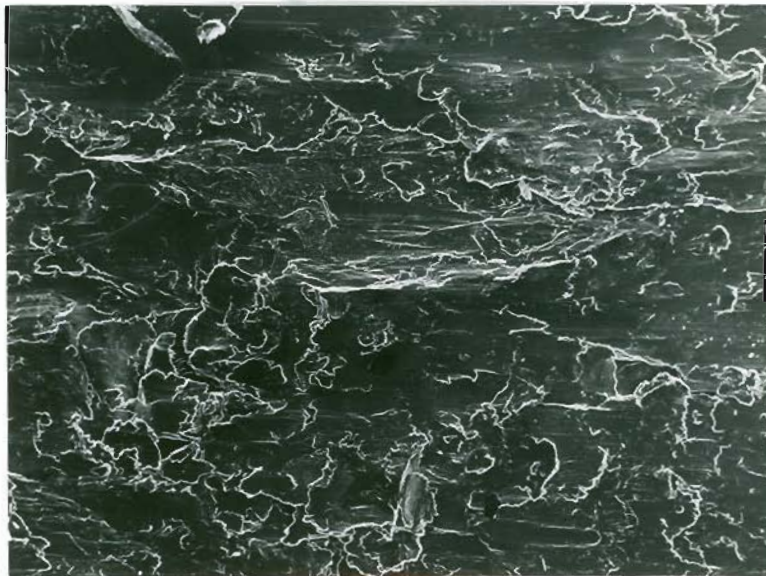
FIGURE 46. SCANNING ELECTRON MICROGRAPHS SHOWING WEAR SURFACE APPEARANCE OF ROLLER FOR HH RAIL STEEL, MAGNIFICATION X100  
(a) WITH A BLACK FILM,  $P_o=900N/mm^2$   
(b) WITHOUT A BLACK FILM,  $P_o=1220N/mm^2$

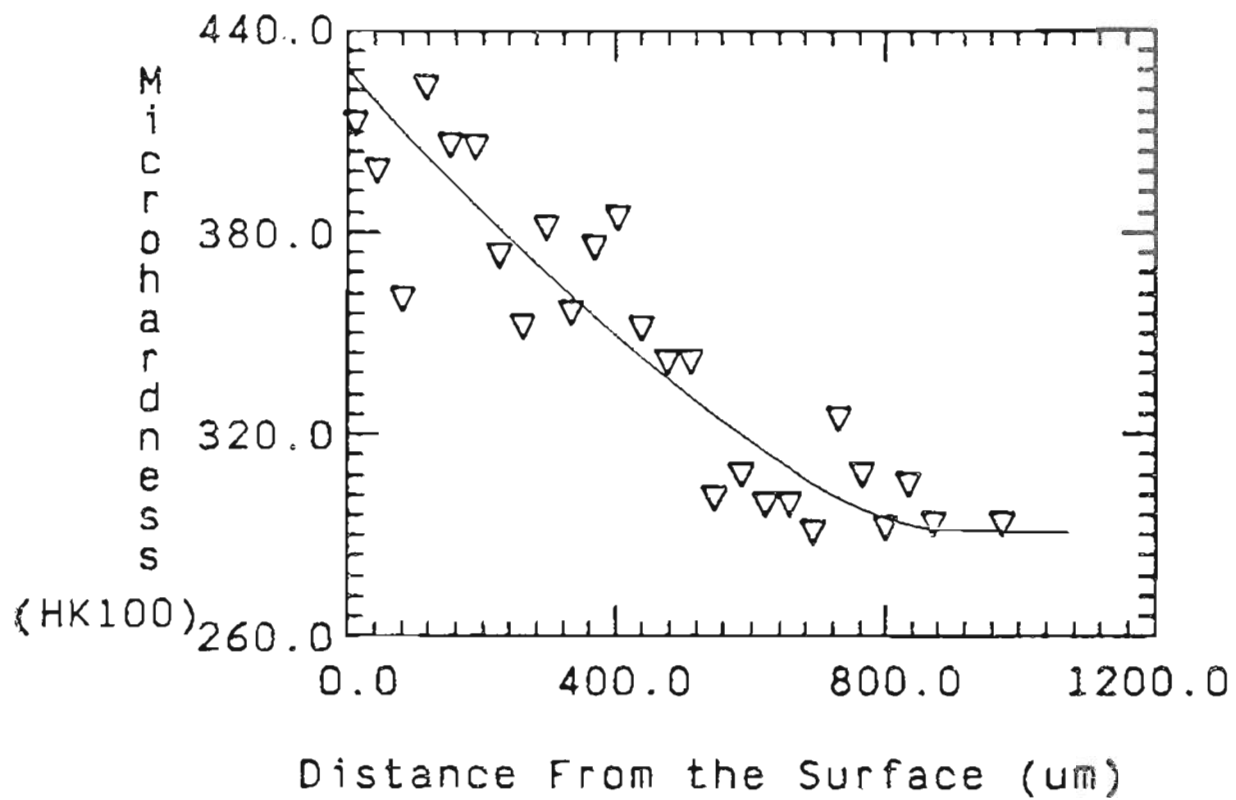
FIGURE 50. HARDNESS PROFILE IN FAILED ROLLER OF STD RAIL STEEL,  $P_0=1354N/mm^2$

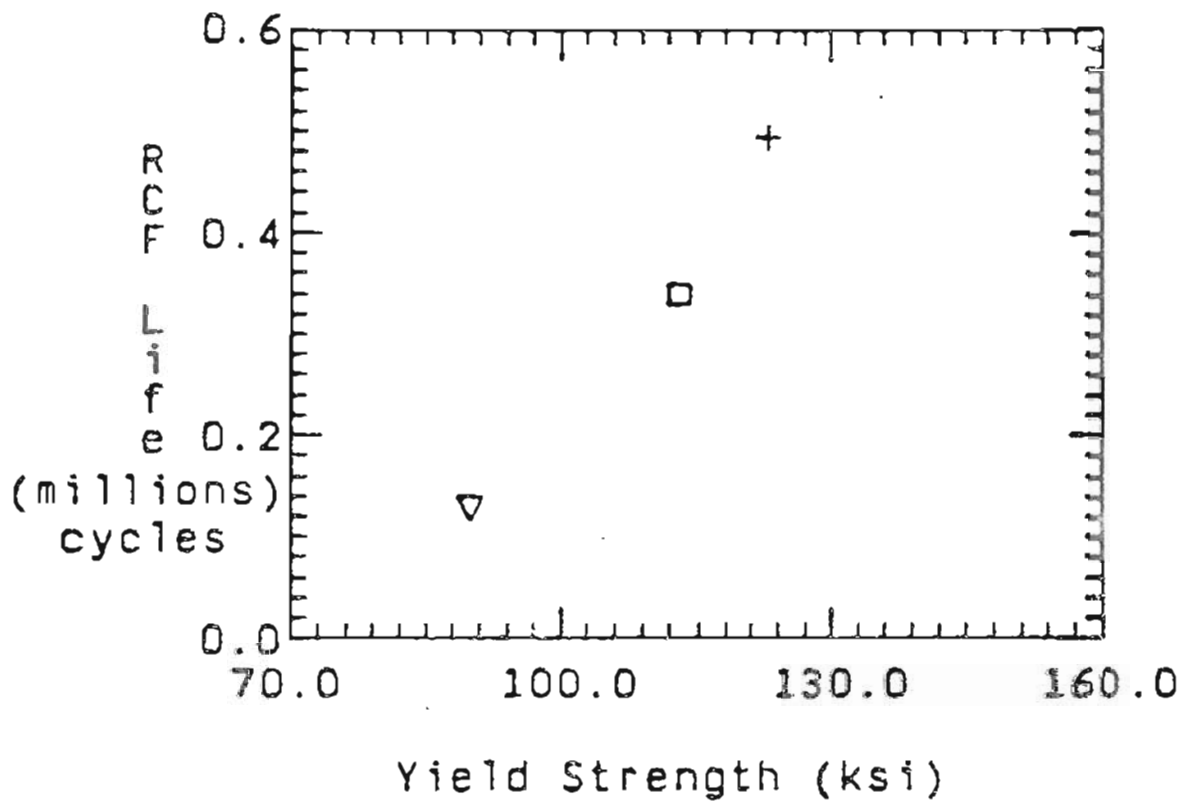
FIGURE 54. EFFECT OF YIELD STRENGTH ON RCF
