TEST METHOD FOR EVALUATING THERMAL-SPRAYED
COATINGS UNDER UNIFORM STRAIN CONDITIONS

A thesis submitted to the faculty of the
Oregon Graduate Institute of Science & Technology
in partial fulfillment of the
requirements for the degree
Master of Science
in
Material Science and Engineering

October, 1994

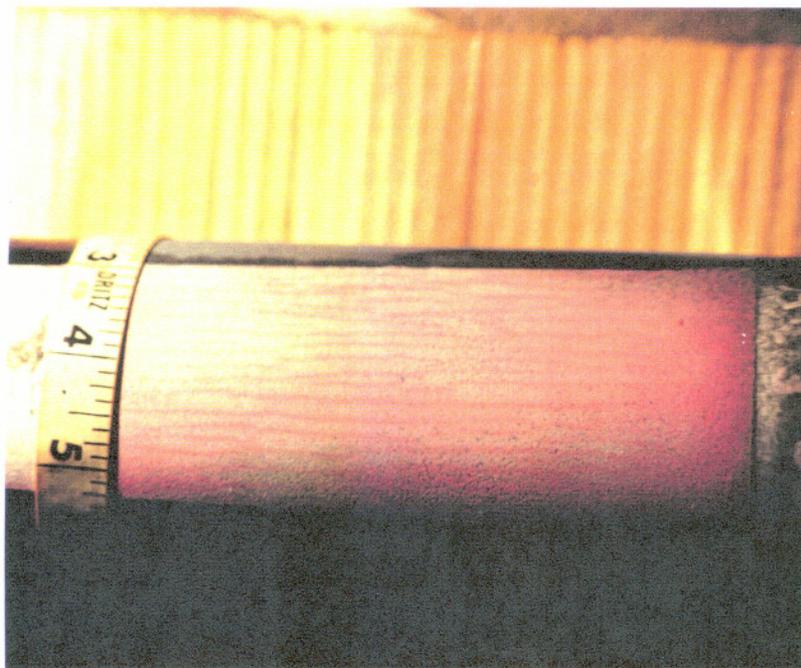
Figure 13 – DYE PENETRANT TEST FOR .015" THICK Al_2O_3 COATING
MAXIMUM STRAIN CONDITION

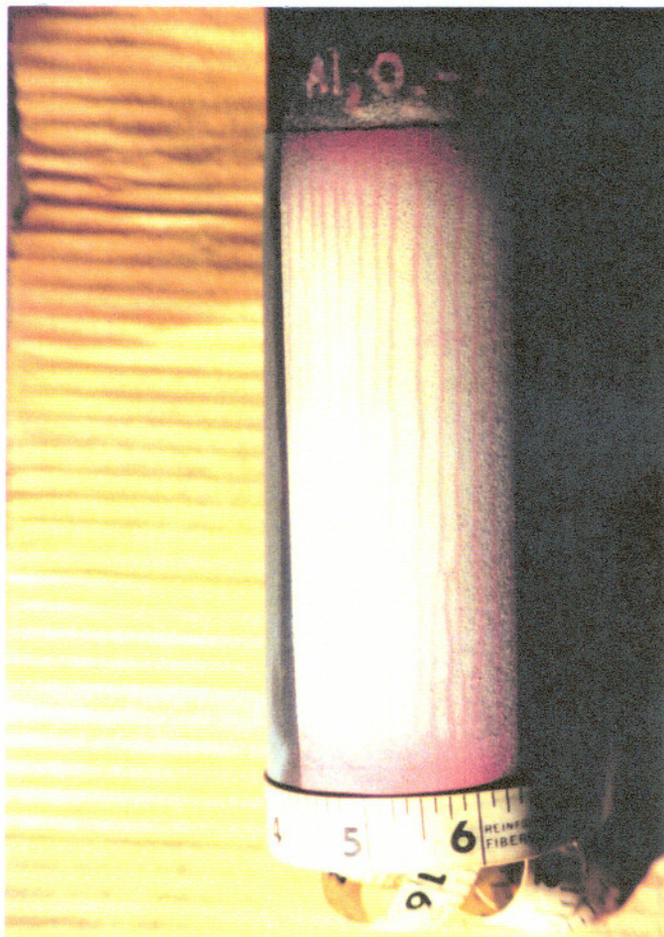
Figure 14 – DYE PENETRANT TEST FOR .030" THICK Al_2O_3 COATING
MAXIMUM STRAIN CONDITION

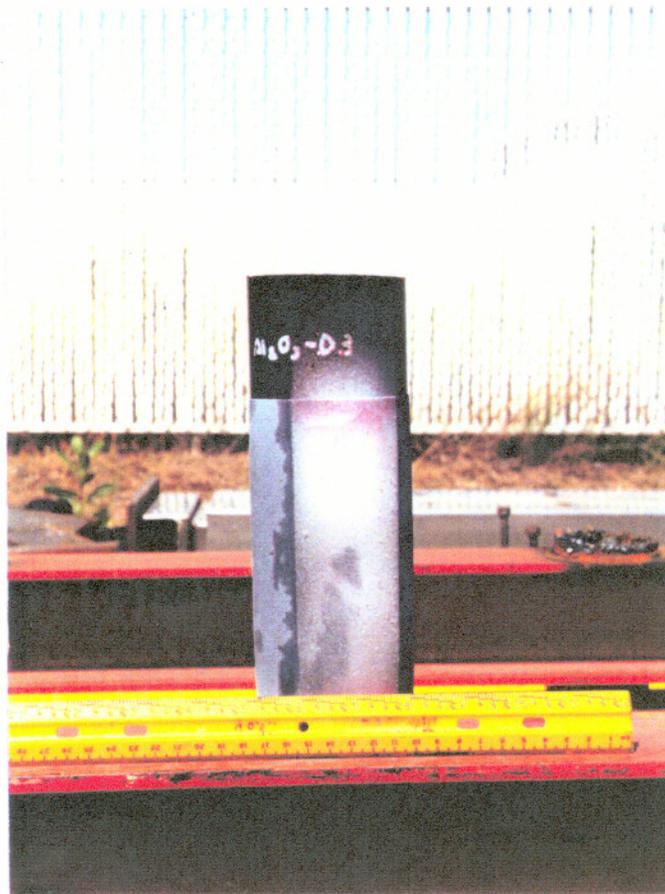
Figure 15 – DYE PENETRANT TEST FOR .045" THICK STRAINED AL₂O₃ COATING, MAXIMUM STRAIN CONDITION

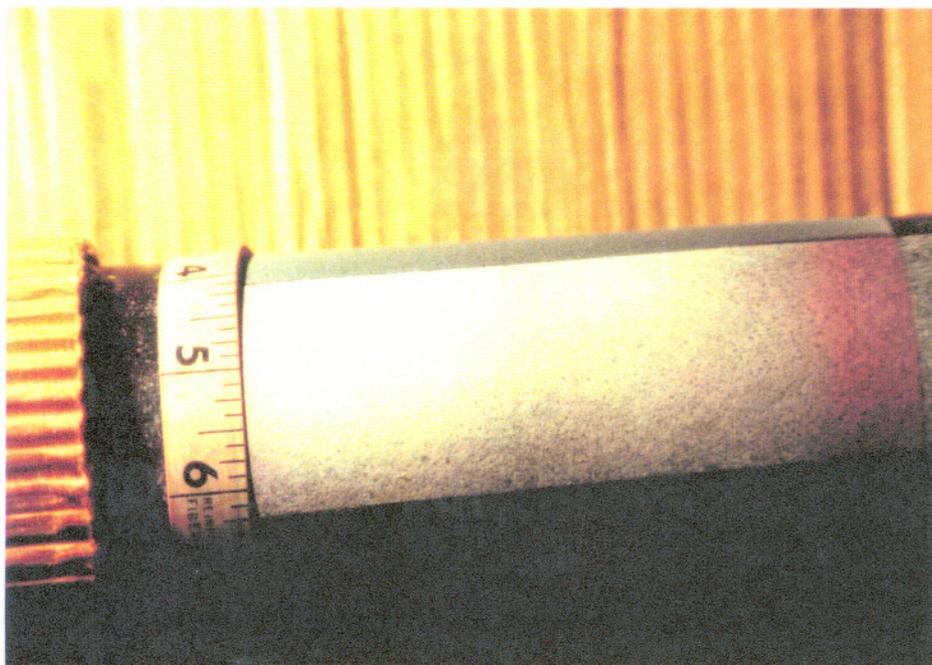
Figure 16 – DYE PENETRANT TEST FOR .045" THICK Al_2O_3 COATING, MINIMUM STRAIN CONDITION.

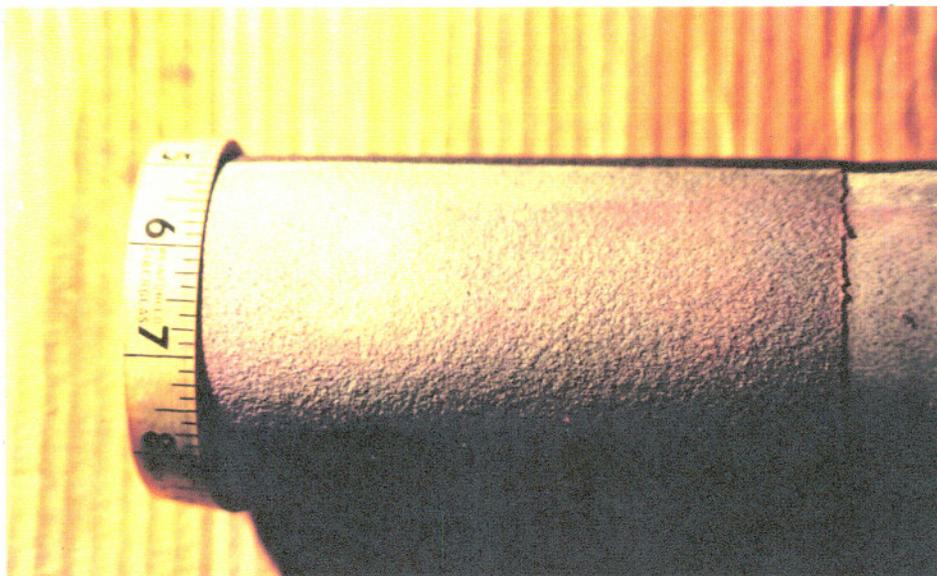
Figure 17 – DYE PENETRANT TEST FOR .030" THICK AL₂O₃ COATING, UNSTRAINED CONDITION.

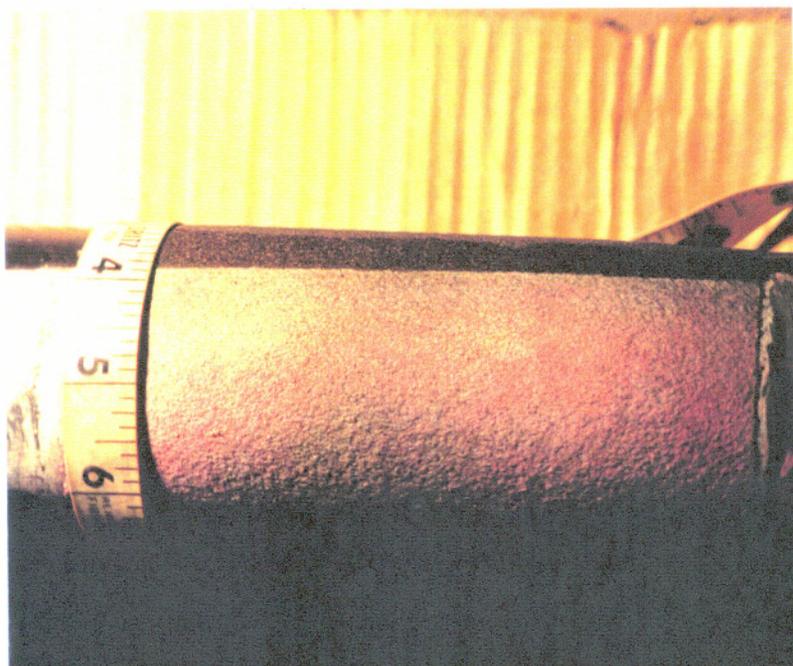
Figure 18 – TYPICAL DYE PENETRANT TEST FOR .045" THICK STAINLESS STEEL COATING, MAXIMUM STRAIN CONDITION.

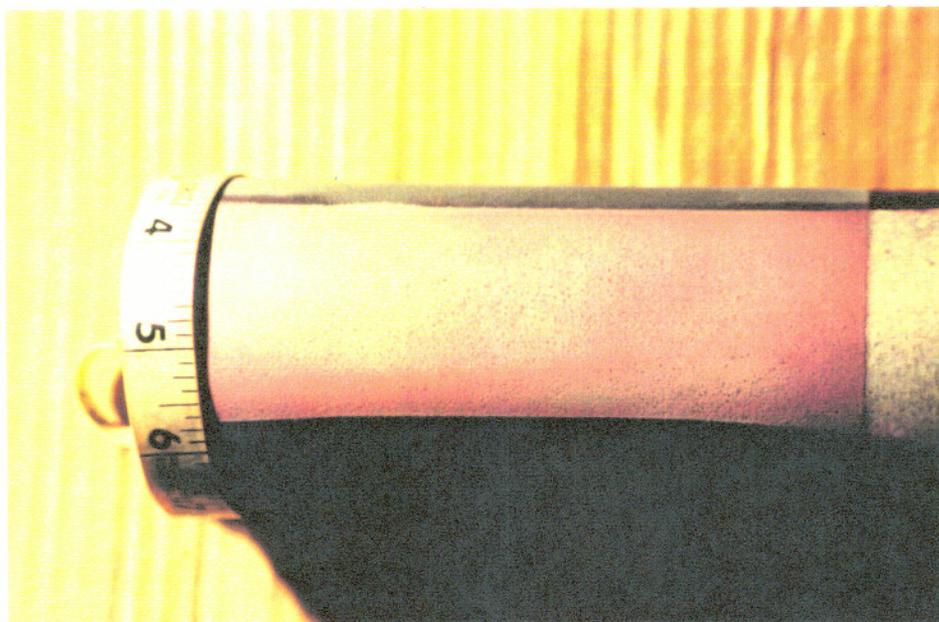
Figure 19 – TYPICAL DYE PENETRANT TEST FOR .070" THICK STAINLESS STEEL COATING, MAXIMUM STRAIN CONDITION.

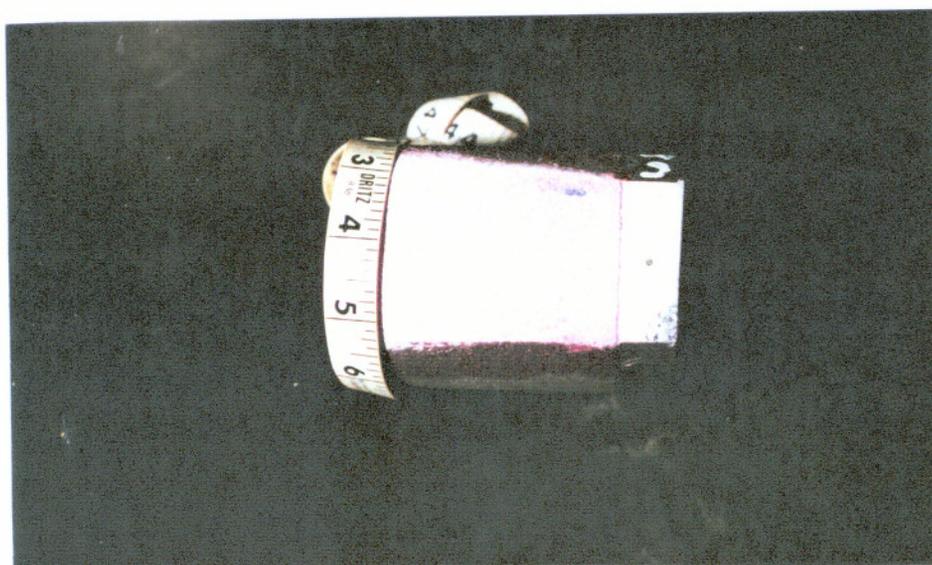
Figure 20 – TYPICAL DYE PENETRANT TEST FOR .100" THICK STAINLESS STEEL COATING, MAXIMUM STRAIN CONDITION.

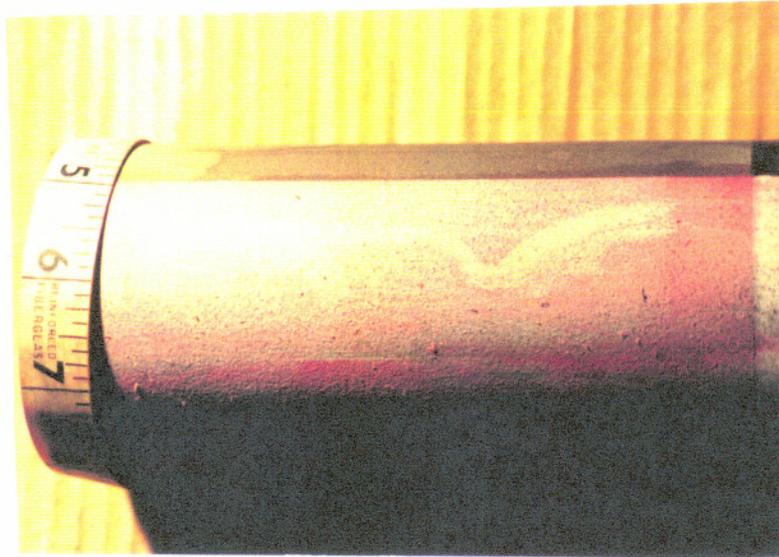
Figure 21 – DYE PENETRANT TEST FOR STAINLESS STEEL COATING, UNSTRAINED CONDITION.

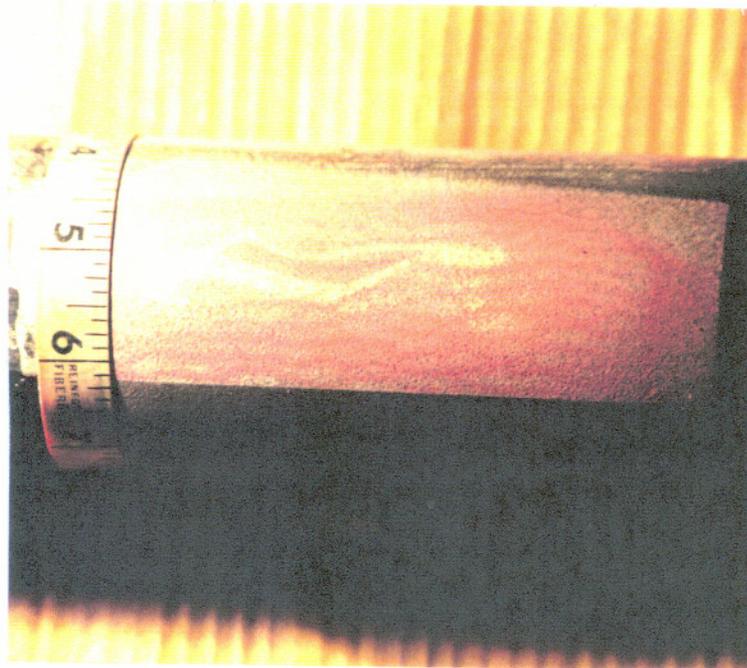
Figure 22 – DYE PENETRANT TEST .020" THICK Mo-Fe BLEND COATING, MAXIMUM STRAIN CONDITION.

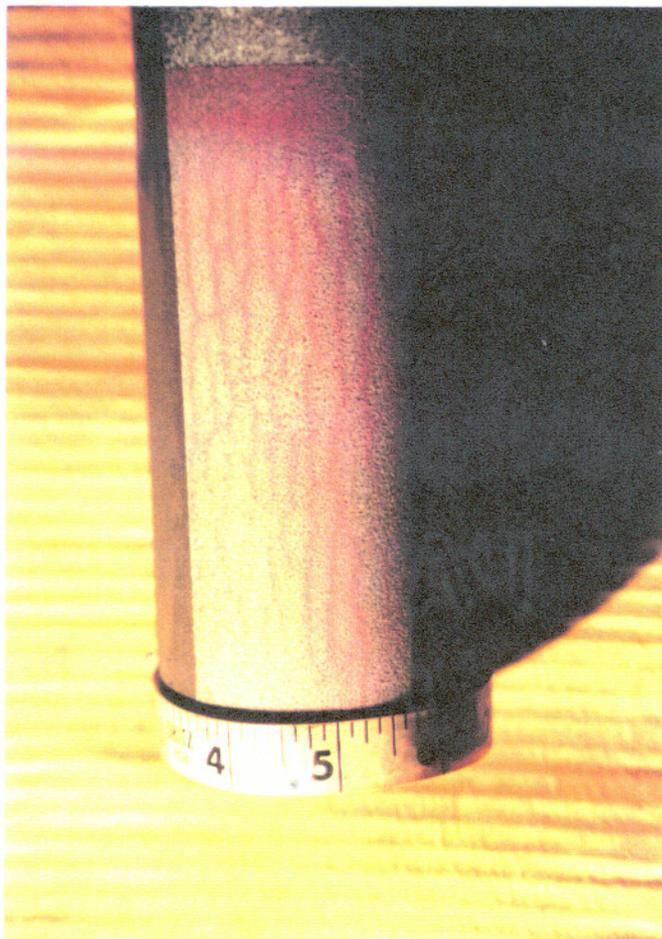
Figure 23 – DYE PENETRANT TEST .030" THICK Mo-Fe BLEND COATING, MAXIMUM STRAIN CONDITION.

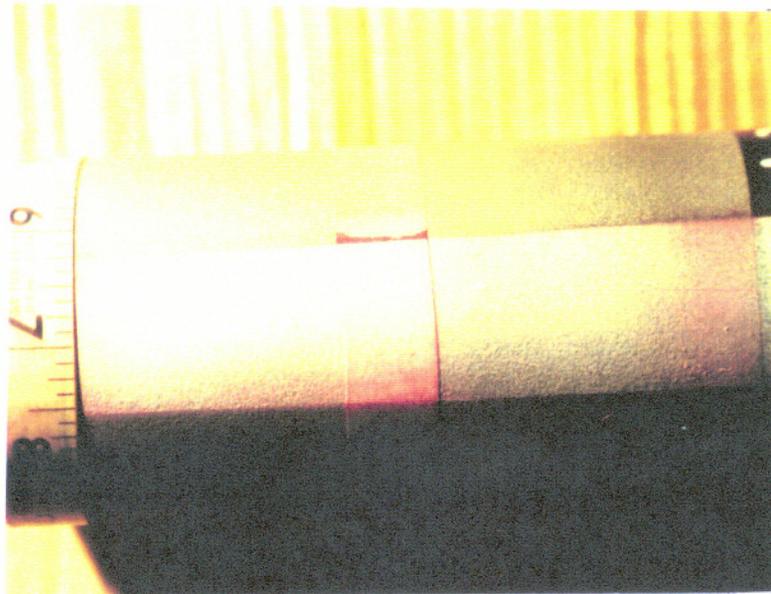
Figure 24 – DYE PENETRANT TEST FOR .040" THICK Mo-Fe BLEND COATING, MAXIMUM STRAIN CONDITION.

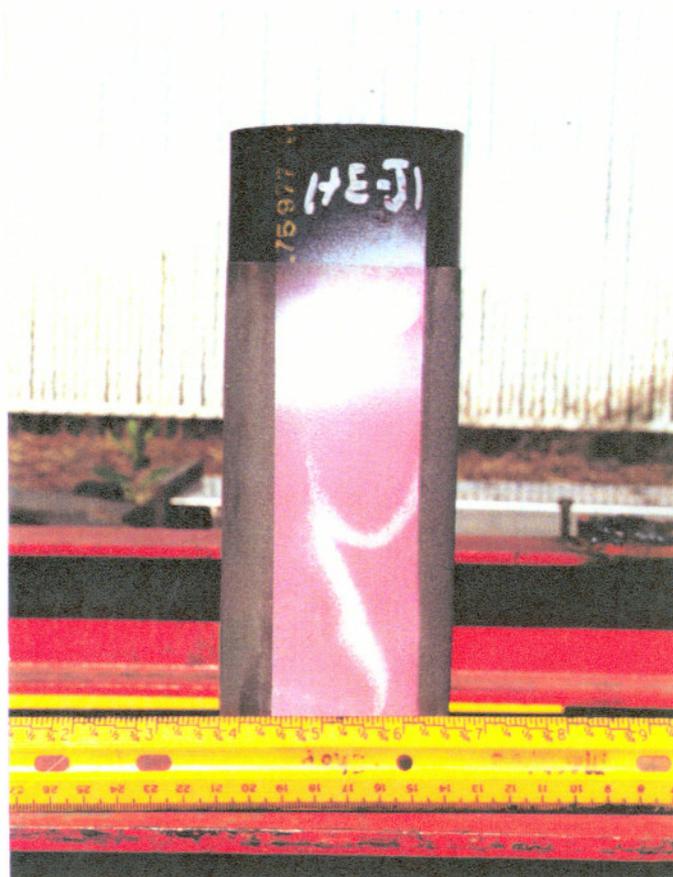
Figure 26 – DYE PENETRANT TEST FOR .030" THICK Mo-Fe BLEND COATING (STANDARD GAS ATMOSPHERE), UNSTRAINED COATING.

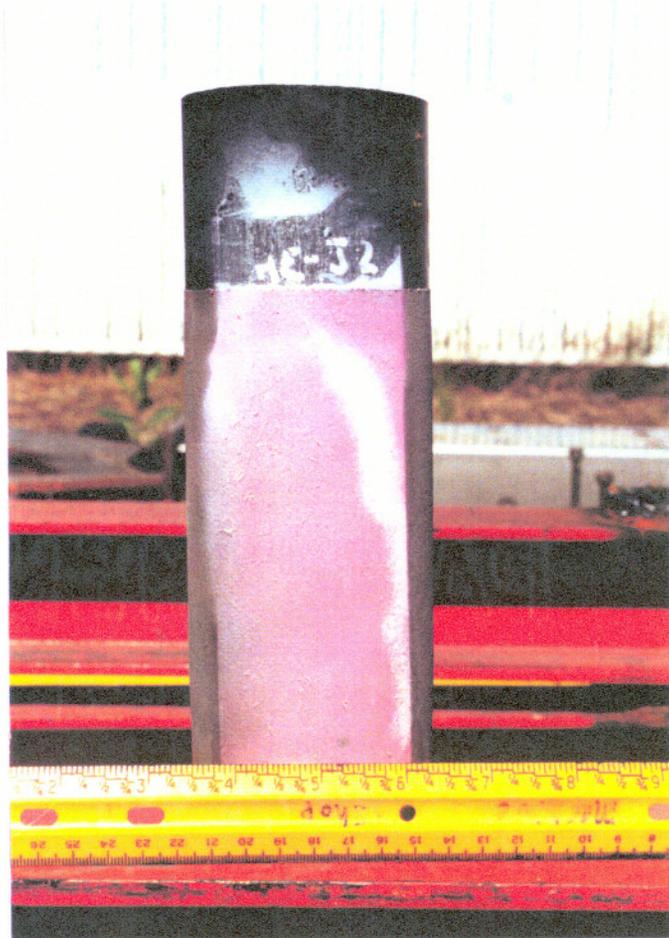
Figure 27 – DYE PENETRANT TEST FOR .020" THICK Mo-Fe BLEND COATING, MINIMUM STRAIN CONDITION.

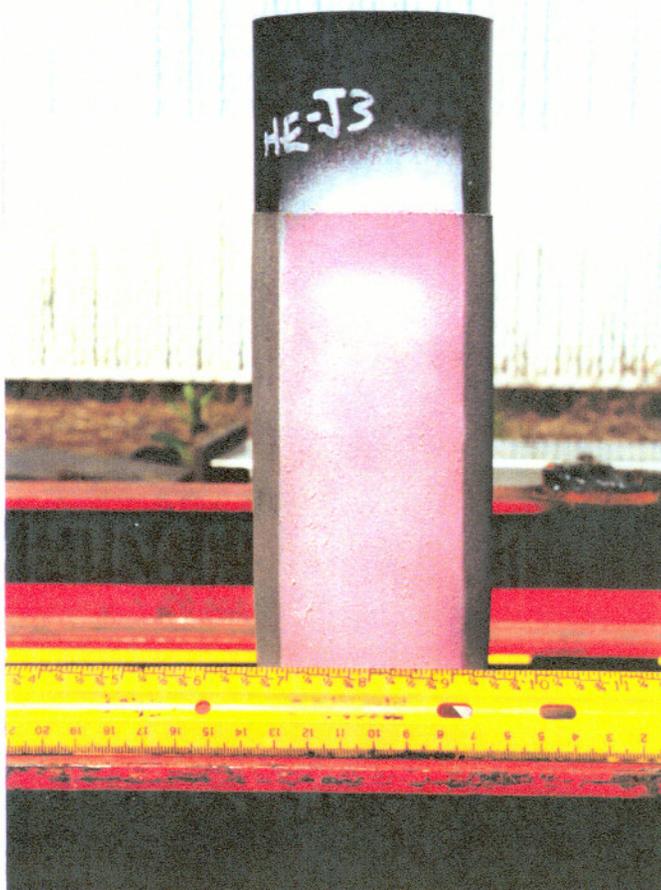
Figure 28 – DYE PENETRANT TEST FOR .030" THICK Mo-Fe BLEND COATING, MINIMUM STRAIN CONDITION.

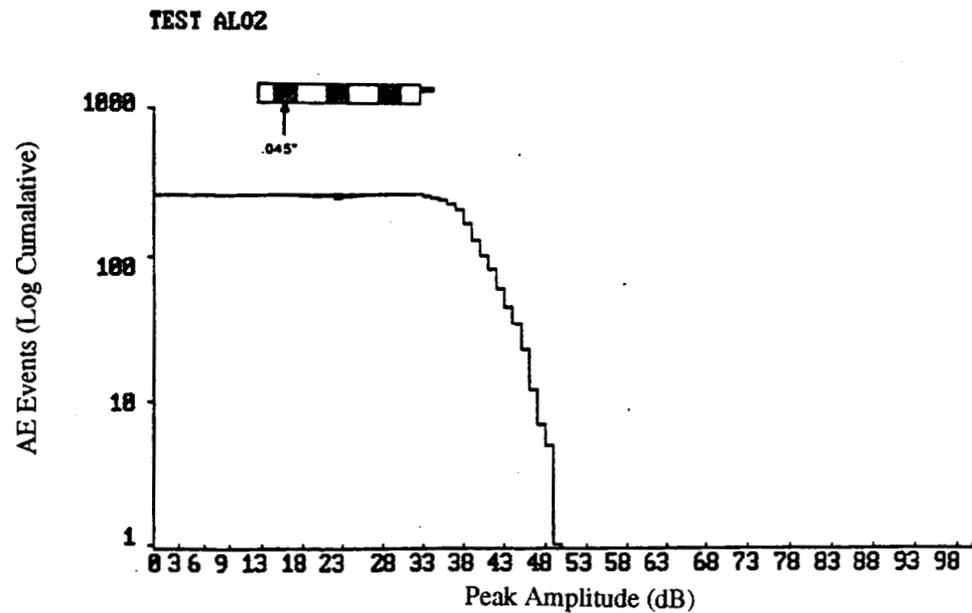
Figure 34 – TYPICAL PLOT OF DISTRIBUTION OF EVENTS BY PEAK AMPLITUDE (dB) FOR .045" THICK Al_2O_3 COATING, MAXIMUM STRAIN CONDITION.

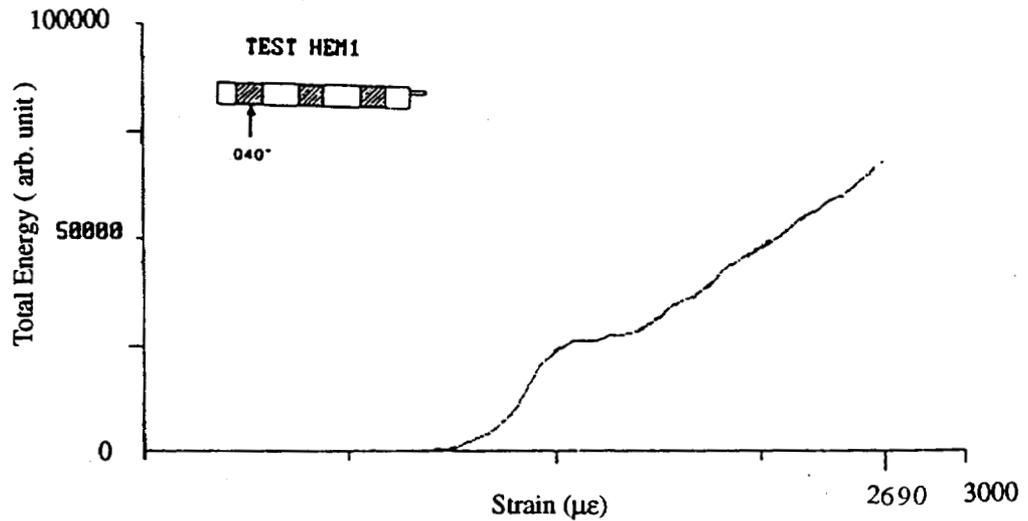
Figure 59 – TOTAL ENERGY VS. STRAIN FOR .030" THICK
Mo-Fe BLEND COATING. MAXIMUM STRAIN CONDITION.

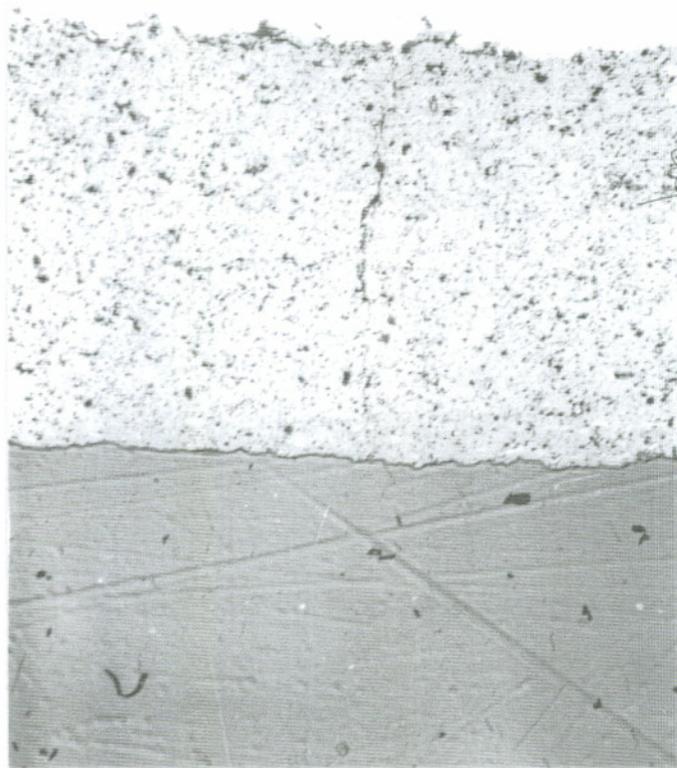
Figure 64 – SEM CLOSE UP OF A CRACK IN .045" THICK Al_2O_3 COATING 3000X.

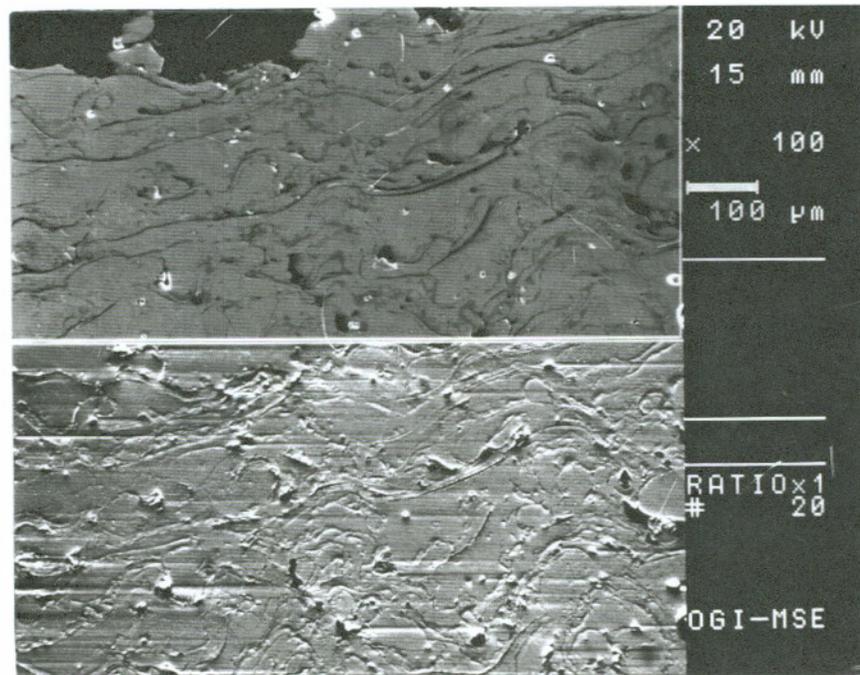
Figure 66 – SEM MICROGRAPH OF THE MICROSTRUCTURE OF .030" THICK STAINLESS STEEL COATING, UNSTRAINED CONDITION. TOP IS SEM AND THE BOTTOM IS BSE – TOPOGRAPHY. 100X.

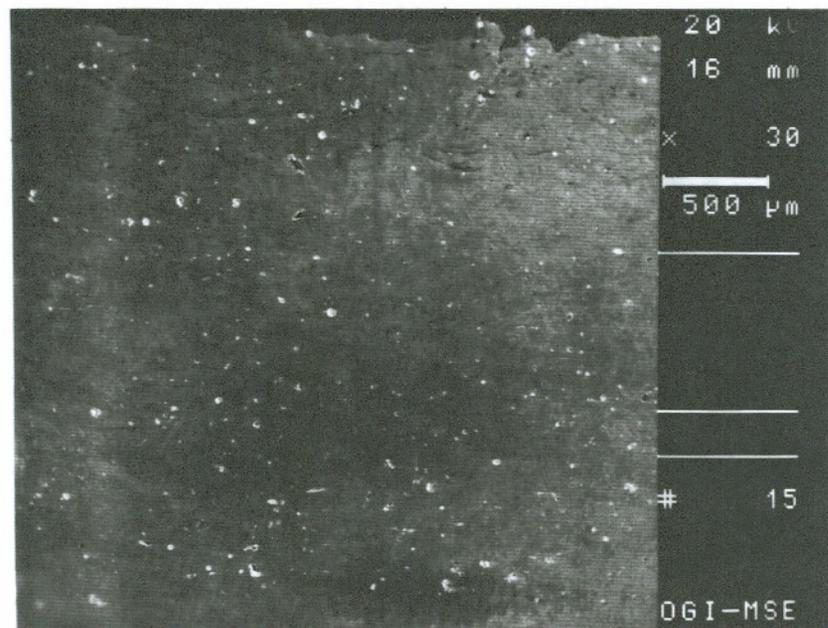
Figure 68 – SEM MICROGRAPH OF THE MICROSTRUCTURE OF .070" THICK STAINLESS STEEL COATING. STRAINED CONDITION.

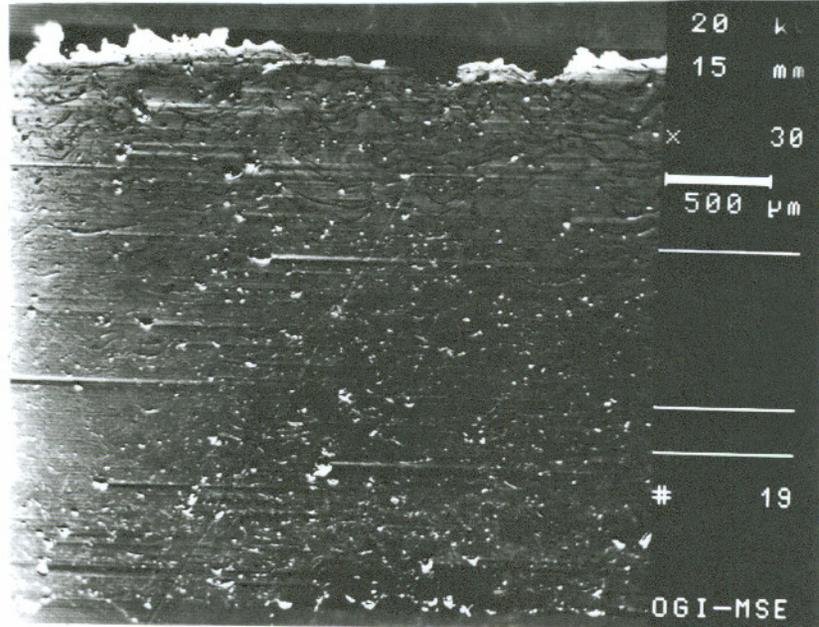
Figure 69 – SEM MICROGRAPH OF THE MICROSTRUCTURE OF .100" THICK STAINLESS STEEL COATING. STRAINED CONDITION. 30X.

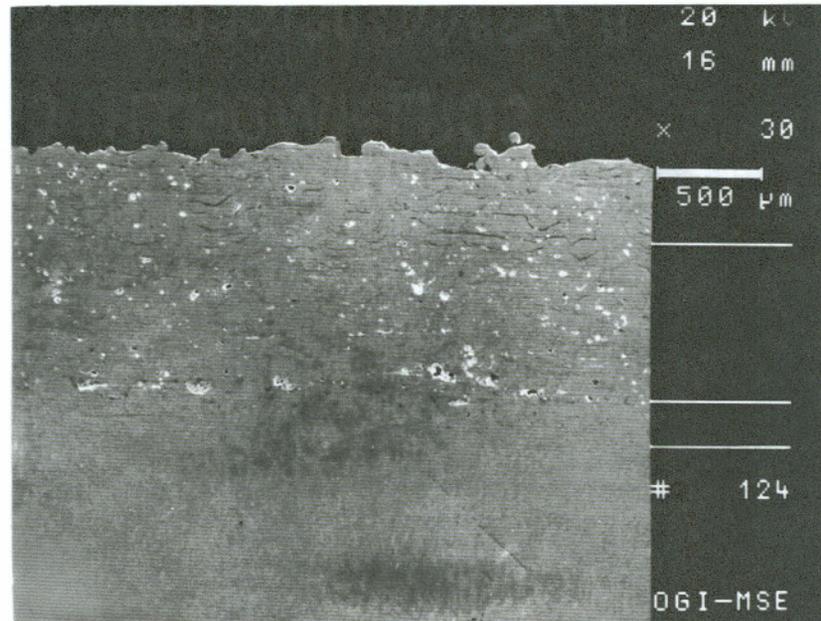
Figure 70 – SEM MICROGRAPH OF .100" THICK STAINLESS STEEL COATING. STRAINED CONDITION. BSE – TOPOGRAPHY 30X.

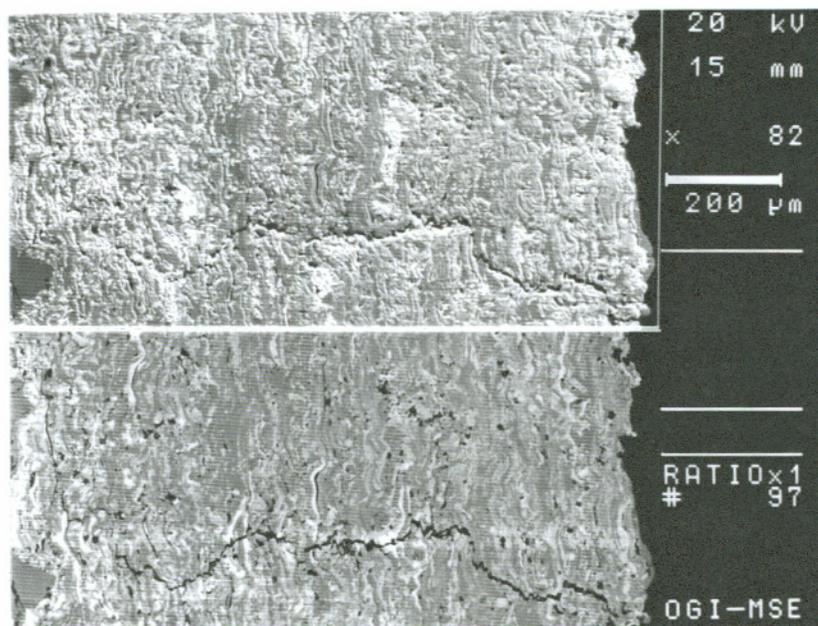
Figure 83 – SEM MICROGRAPH OF CIRCUMFERENTIAL CROSS SECTION OF COATING FROM FIGURES 84 AND 85. TOP IS SEM AND BOTTOM IS BSE-COMPOSITION 100X.

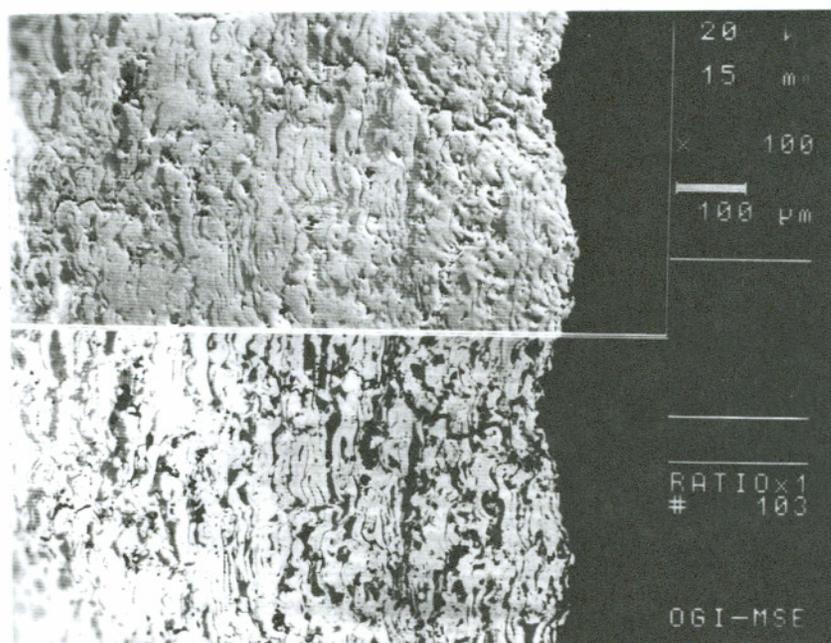
Figure 84 – SEM MICROGRAPH OF CRACKING IN .040" THICK Mo-Fe BLEND COATING. TOP IS SEM AND BOTTOM IS BSE-COMPOSITION. 100X.

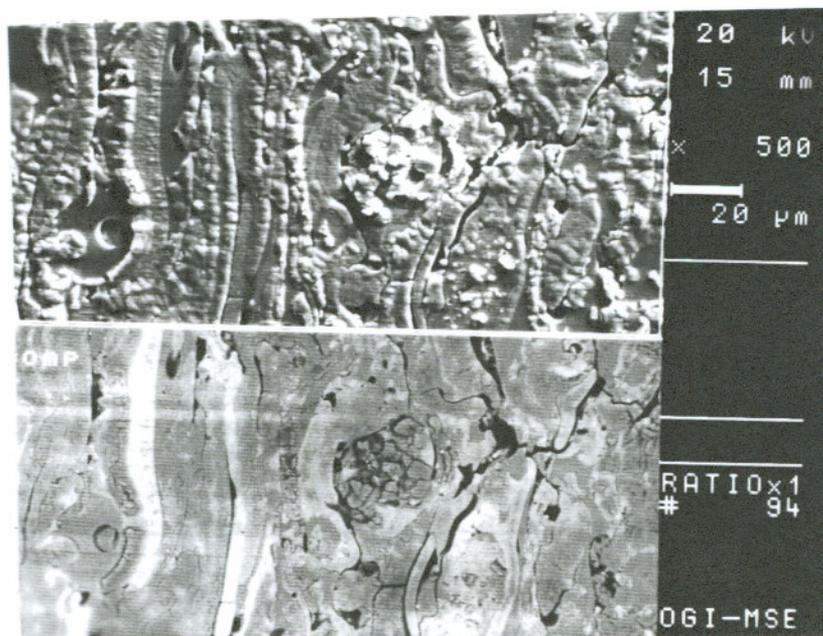
Figure 85 – SEM MICROGRAPH OF CRACKING IN .043" THICK Mo-Fe BLEND COATING. TOP IS SEM AND BOTTOM IS BSE-COMPOSITION. 100X. CIRCUMFERENTIAL DIRECTION

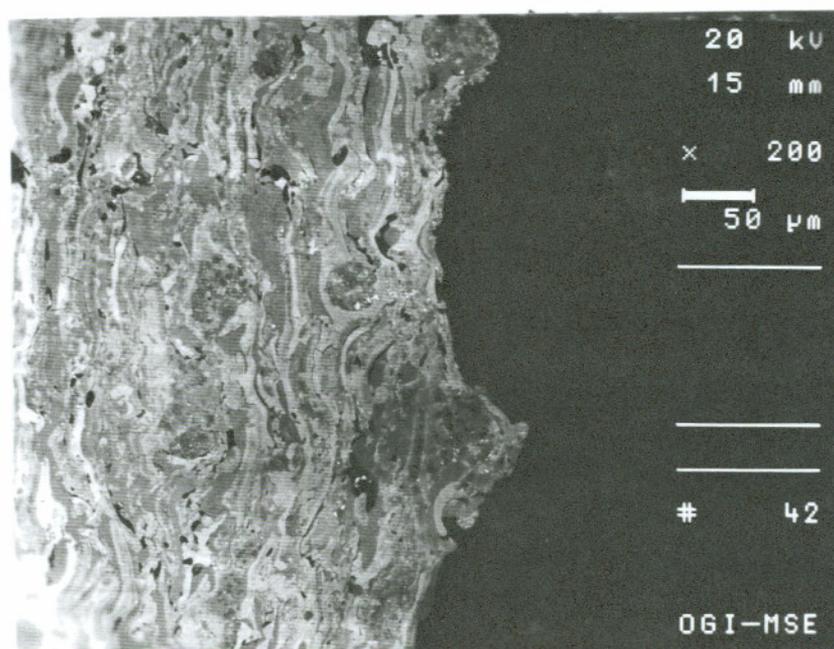
Figure 86 – SEM MICROGRAPH OF MINOR CRACKING IN .020" THICK Mo-Fe BLEND COATING, MINIMUM STRAIN. TOP IS SEM AND BOTTOM IS BSE-COMPOSITION. 500X.

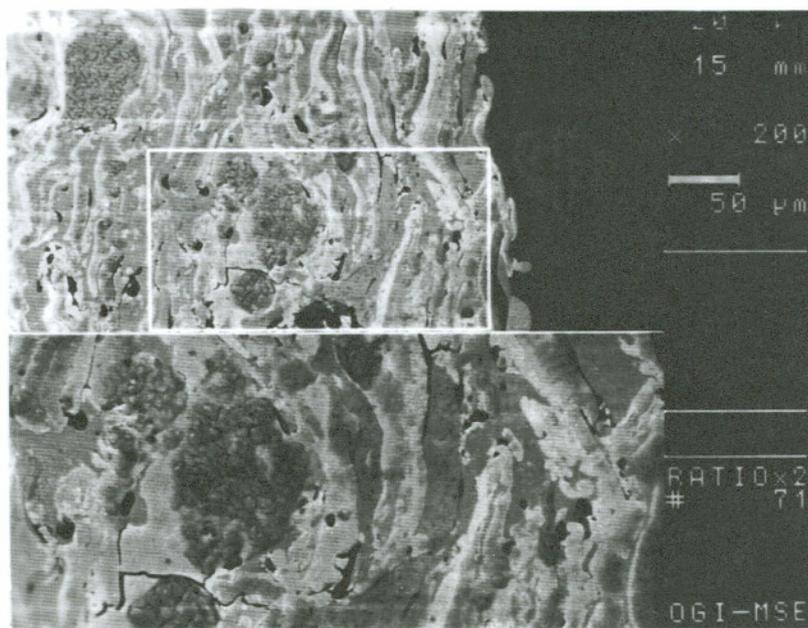
Figure 87 – SEM MICROGRAPH OF MINOR CRACKING IN .030" THICK Mo-Fe BLEND COATING, MINIMUM STRAIN. BSE-COMPOSITION. 500X.
